Name Of Dam: ② FALLING CREEK FILTRATION PLANT

Location: ④ CHESTERFIELD COUNTY, VIRGINIA

⑥ PHASE I INSPECTION REPORT

Falling Creek Filtration Plant.
Inventory Number: VA-04115
Chesterfield County, Virginia.
Phase I Inspection Report.

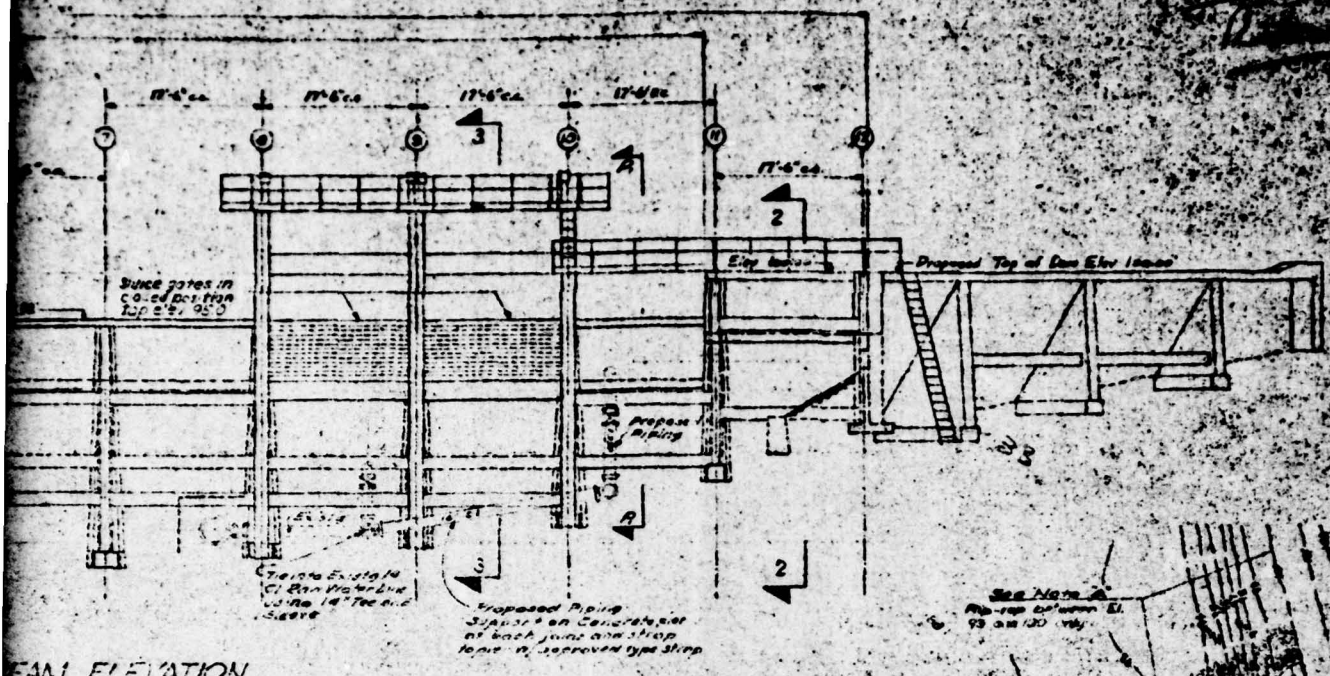
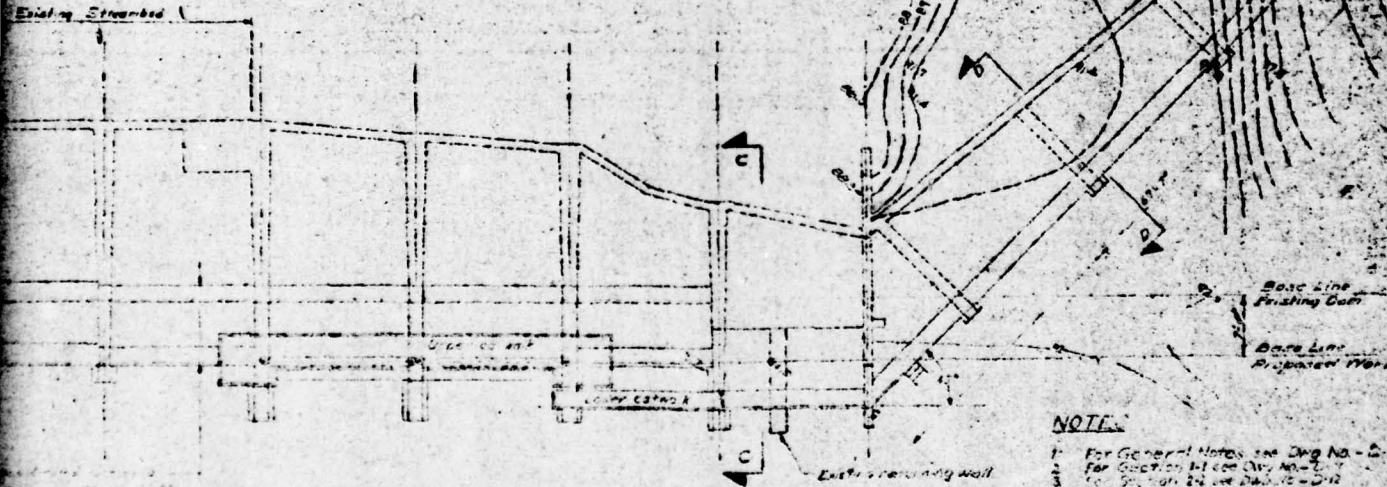
PLATE 3

The visual inspection of the foundation conditions was obscured by local ponding and debris. The findings outlined in the J. K. Timmons & Associates, Inc. March 1978 report were used as a guideline. The Corps was unable to locate the 4 seeps outlined in Section B, Geotechnical, Field Inspection. Possible reasons for missing the seeps are outlined in Appendix III, Field Observations, Concrete Dam, Foundations. However, an additional foundation seep was located at the downstream base of Buttress 6 and noted on Plate 3.

ADDITIONAL SEEP NOTED

3.3 Evaluation: The visual inspection of the foundation revealed two significant conditions that warrant attention. First, the previously identified seeps, and second, the additional seep. These seeps should be marked in the field for easy identification. They should also be monitored and treated as specified in the Timmons report. Also, the origin and significance of the iron bacteria should be determined.

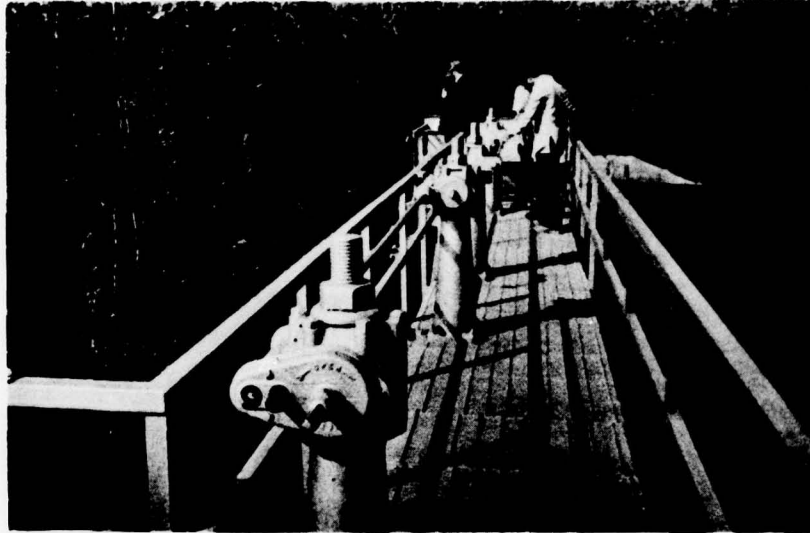
STEEL GATE LIFT ASSEMBLY

Gate lift assembly (steel) catwalk and motors appear in good shape. Hand rail noted along top of dam.

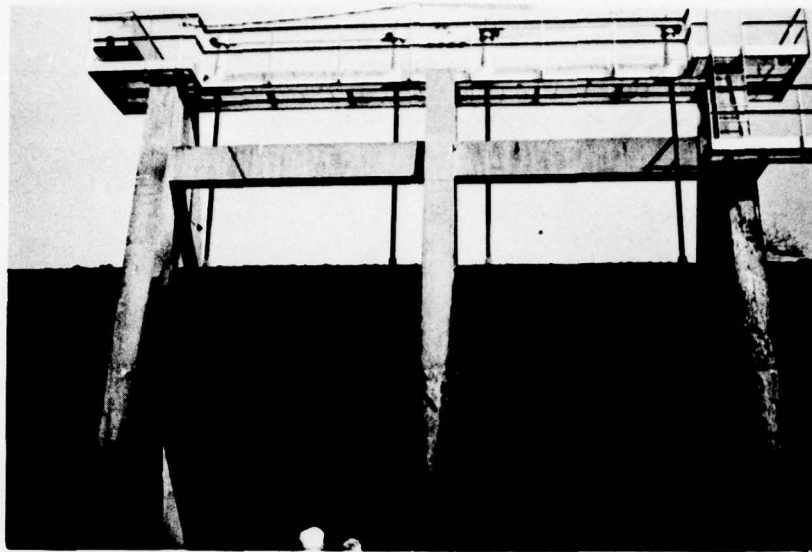
STEEL GATES AND LIFT ASSEMBLY

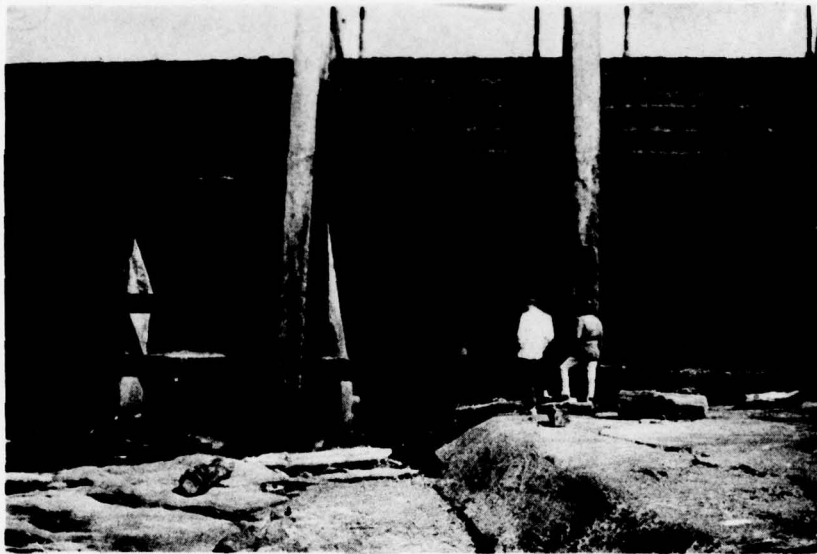
14 INCH WATER SUPPLY PIPE AND CONCRETE APRON

Vertical drop to a pool formed by large rocks and boulders some concrete work noted in left portion (apron) of d/s channel at toe of dam. It slopes to stream center, protects water supply line against erosion (channel)
