Name of Dam: Dry Run No. 102
Location: Page County, State of Virginia
Inventory Number: VA 13901

PHASE I INSPECTION REPORT
NATIONAL DAM SAFETY PROGRAM

¹¹ Feb 79

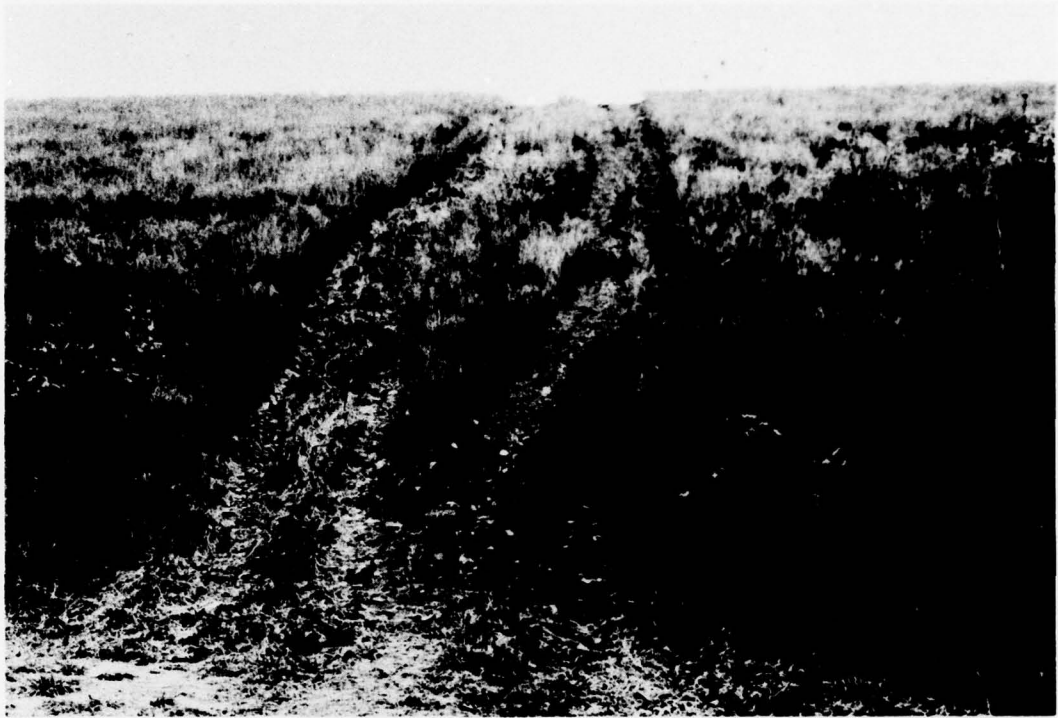
3.2 Evaluation: The only serious deficiency is the erosion in the tire tracks resulting from operation of vehicles on the downstream slope on the left side of the outlet works (see Photo 1). Topsoil should be placed in the bare areas and planted with grass seed. The access for vehicles should be blocked-off to prevent this problem from re-occurring. If restriction of vehicular traffic is not possible, then some means of embankment protection should be implemented.

PHOTO 1. Eroded Vehicular Tracks on Downstream Slope

- 7.2 Recommended Remedial Measures: The filling and reseeding of the tire tracks on the embankment should be repaired without delay to prevent erosion. Also, some means from preventing further vehicular traffic on the embankments should be considered immediately. If restricting vehicular traffic is not possible, a means of protecting the embankment against erosion should be implemented. The inspection revealed certain maintenance items listed below which should be scheduled during the annual maintenance period.

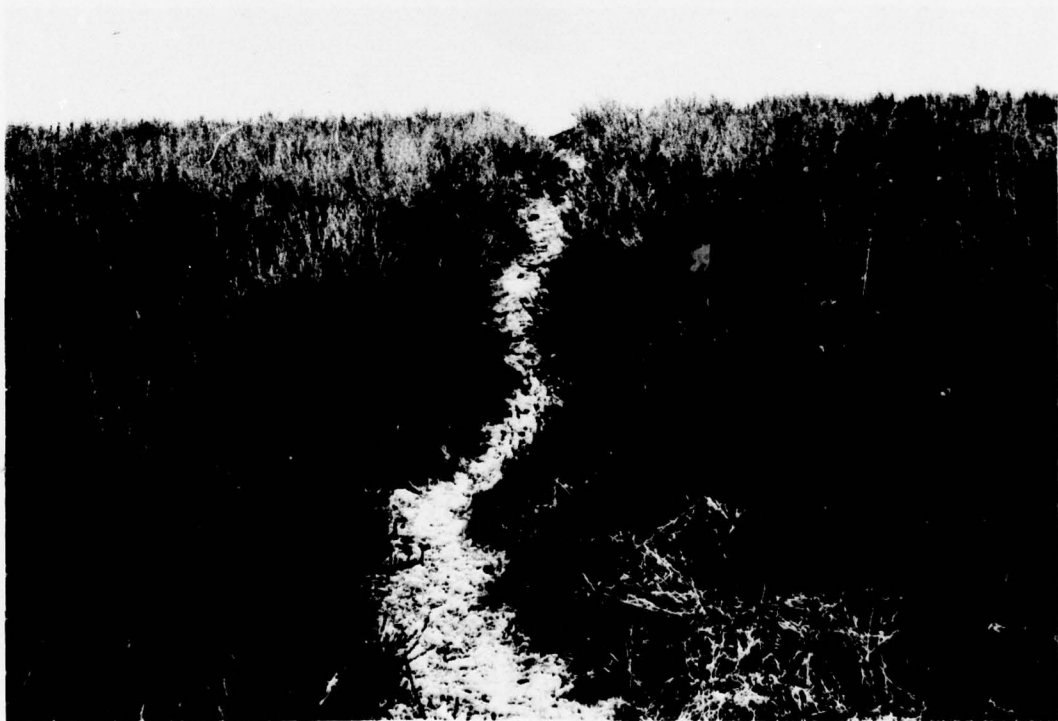
PHOTO 2. Footpath on Upstream Slope (Near Riser)

- 1) Cut all tree growth on embankment and rock toe drains.
- 2) In addition to areas already noted, reseed all bare areas on the embankment including footpath on the upstream side.
- 3) A staff gage should be installed to monitor reservoir elevations above normal pool.

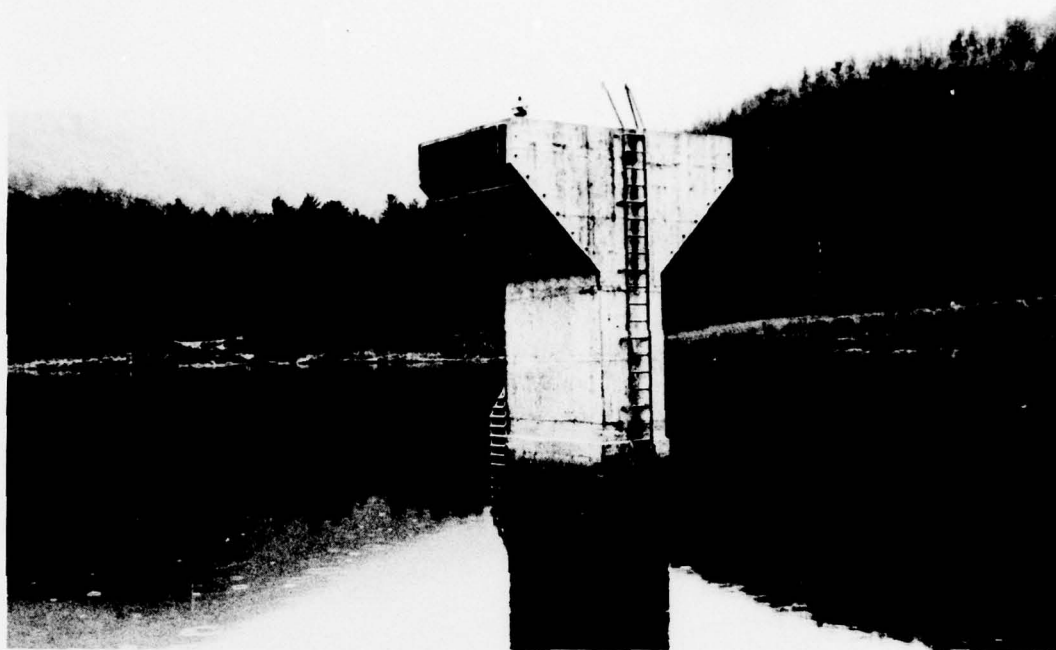
- 3.1.3 Appurtenant Structures: No structural deficiencies were observed (see Photo 3).
- 3.1.4 Reservoir Area: No serious deficiencies were observed in the reservoir. A staff gage should be installed to monitor reservoir elevations above normal pool.

PHOTO 3. View of Riser From Upstream Face of Dam

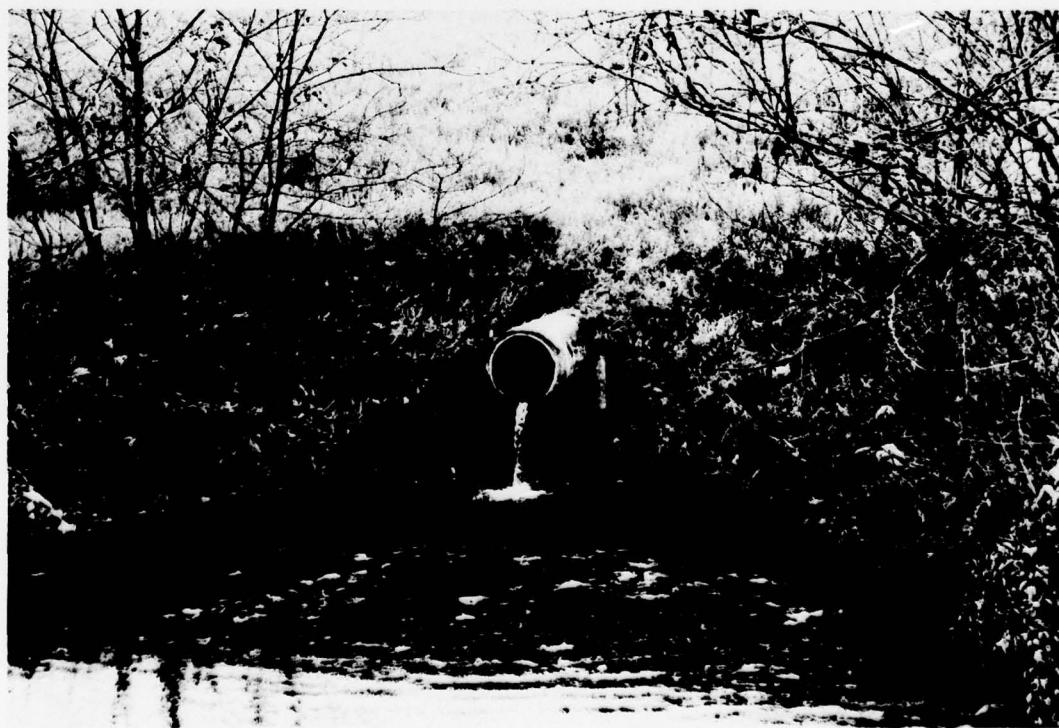
- 3.1.5 Downstream Channel: The stilling basin and outlet channel are functioning properly and the riprap is in good condition (see Photo 4).

PHOTO 4. Outlet Pipe and Stilling Basin

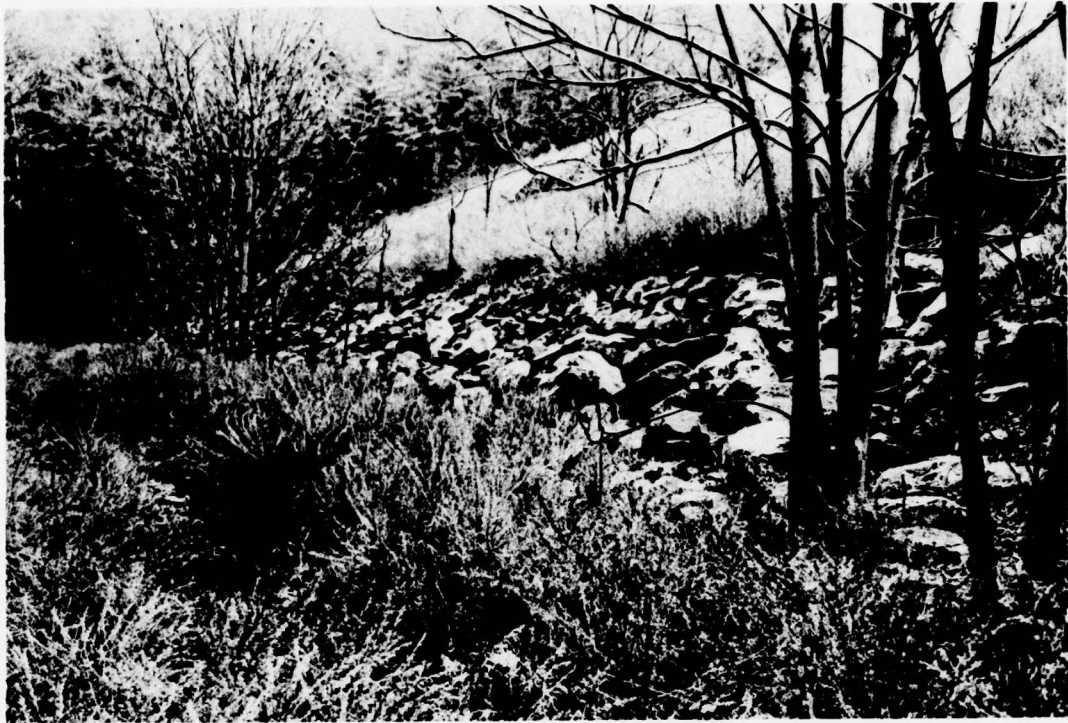
- 3.1.2 Dam: The embankment was generally in good physical condition. No cracks, unusual movement, sloughing, excessively deep erosion or seepage was observed on the embankment or abutments. There are several bare areas namely: vehicle tracks on the downstream slope of the dam and spillway slope, a path on the upstream slope near the riser (see Photo 2), and roadway tracks at the crest on the left side. There are scattered dried patches of grass and wood debris in the lower 20 feet of the upstream slope. Small trees and brush have grown in the rock toe drain and rock slope gutters (see Photo 5).

PHOTO 5. Rock Toe on Downstream Side of Dam

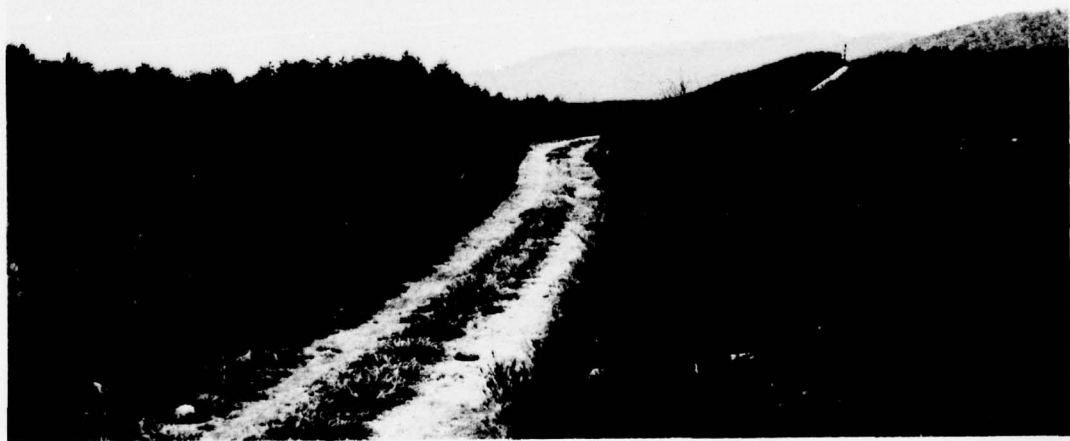
PHOTO 6. Emergency Spillway and Left Abutment
