Name Of Dam: Greene Acres

Location: Greene County, State of Virginia

Inventory Number: VA 07903

**PHASE I INSPECTION REPORT
NATIONAL DAM SAFETY PROGRAM**

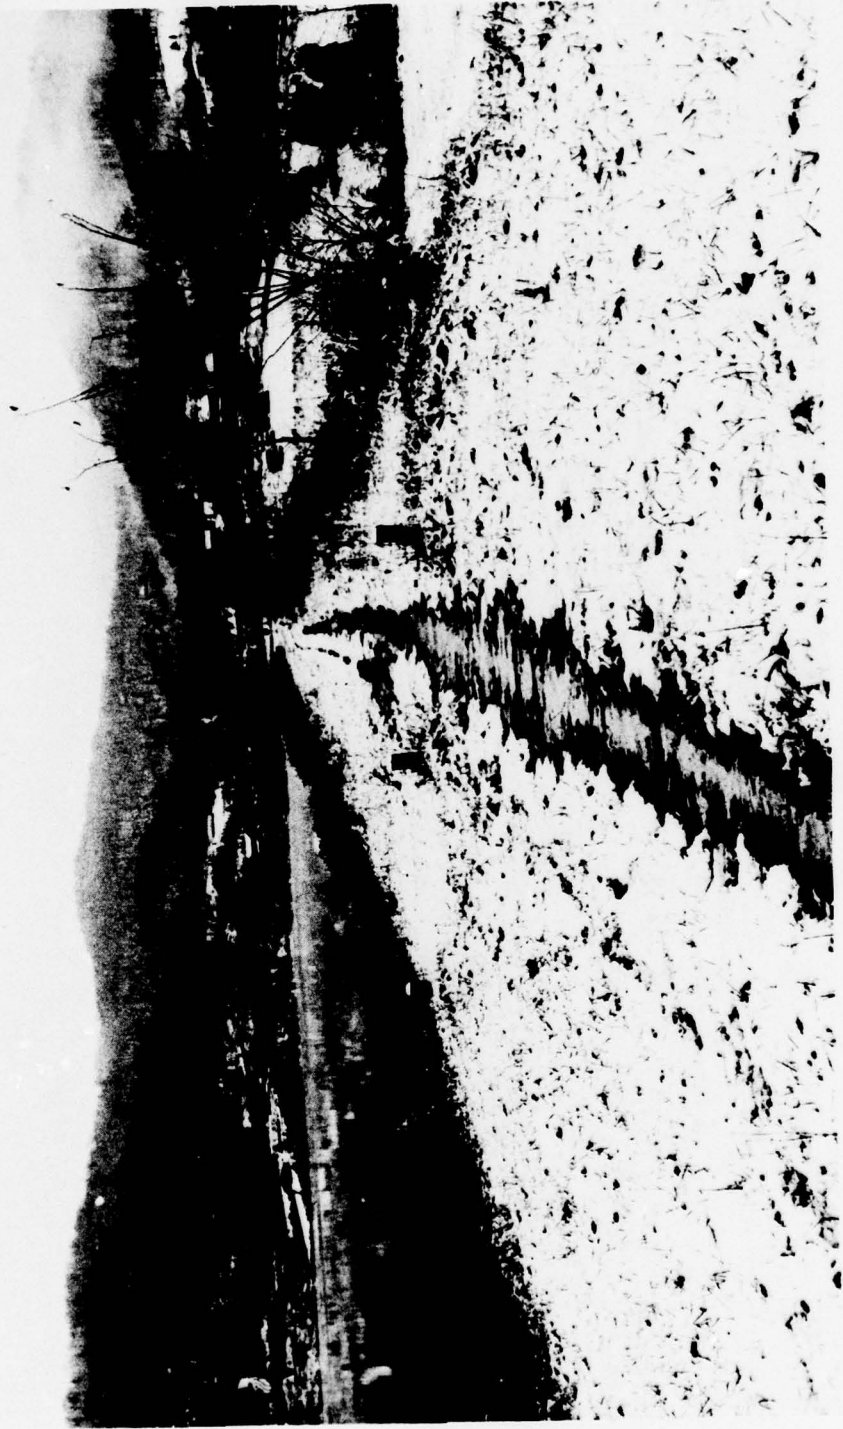
OVERALL VIEW OF DAM

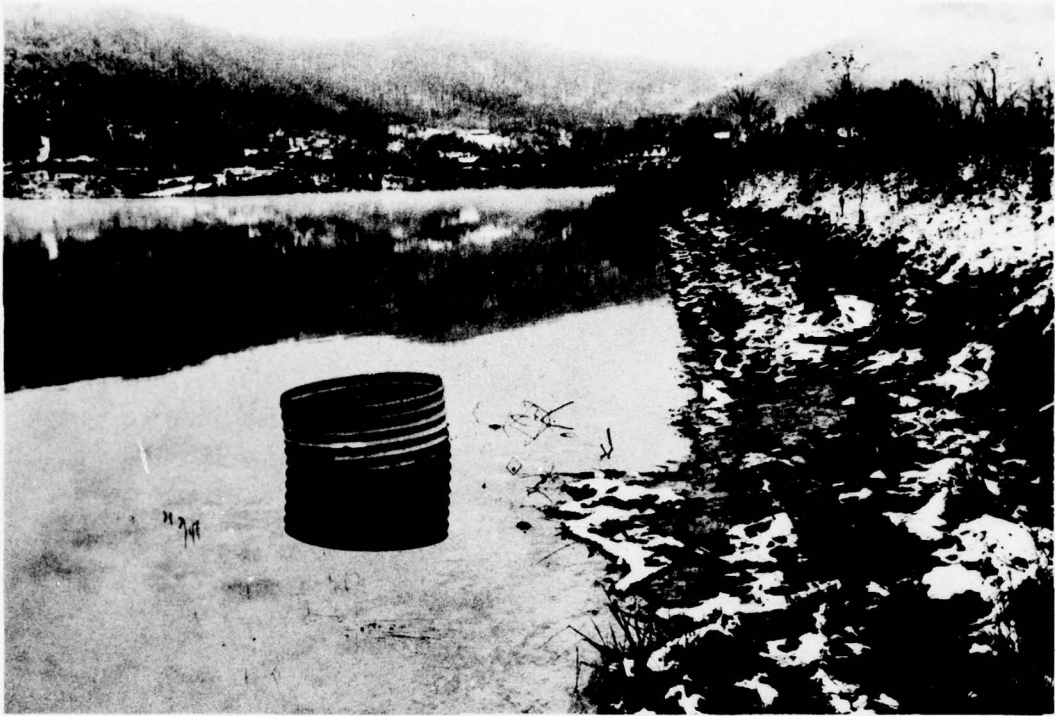
3.1.3 Appurtenant Structures: The inlet and outlet of the 24 inch C.M.P. overflow pipe appear to be in good physical condition and are able to function properly (see Photos 1 and 2). Water was about 0.5 foot below the crest of the overflow pipe. The 10 inch submerged blow-off pipe with a closed gate valve appears to be functional (see Photo 4). Water is ponded at the outlet of the pipe toe drain.

PHOTO 1. Corrugated Outlet Pipe Near Right Abutment

VISUAL EXAMINATION OF	OBSERVATIONS	REMARKS OR RECOMMENDATIONS
CRACKING AND SPALLING OF CONCRETE SURFACES IN OUTLET CONDUIT	Normal outlet conduit is a 24 in. C.M.P. through the embankment which discharges into a "v" shaped concrete channel which runs along the downstream right abutment of the dam. Concrete in this channel shows no unusual cracking or spalling.	
INTAKE STRUCTURE	The intake structure consists of a vertical section of 24 in. diameter C.M.P. (invert elevation of 95.0 ft. P.D.) turning 90°, running 73 ft. through the embankment near the right abutment, and exiting at an elevation of 88.0 ft. P.D. The 24 in. inlet has a 2 ft. section of 36 in. diameter C.M.P. around it which serves as a trash shield.	
OUTLET STRUCTURE	The 24 in. C.M.P. exits into the "v" shaped channel which runs toward the toe of the dam along the right abutment near the junction with the dam embankment (see Photo 1).

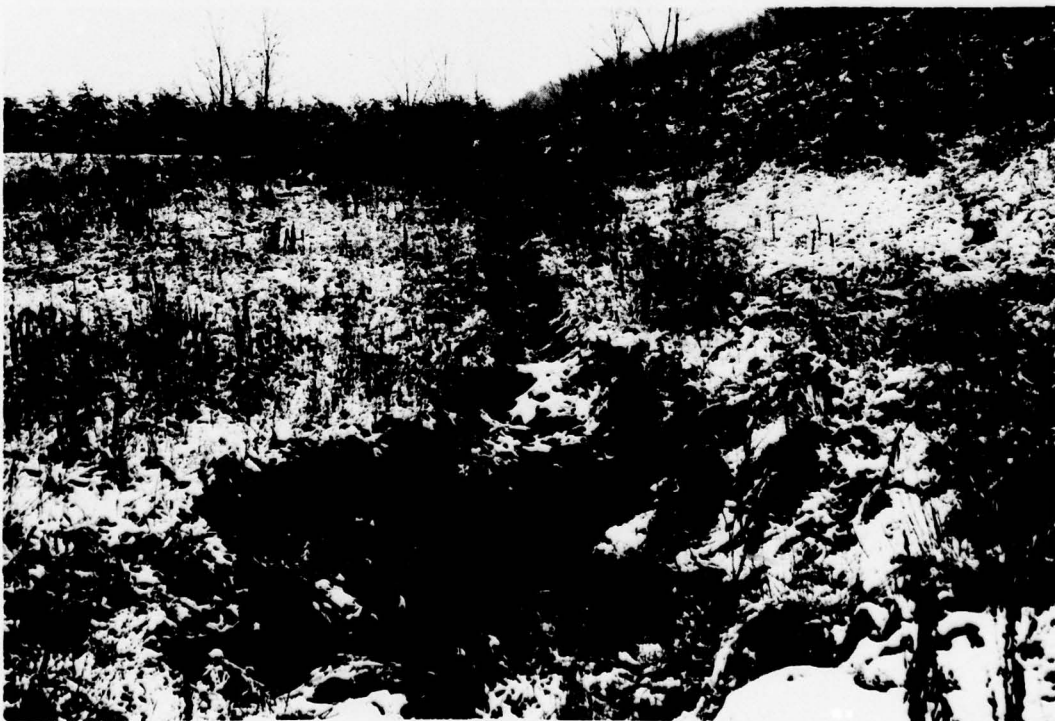
Erosion was evident where the open concrete channel from the overflow pipe ends and the natural channel begins. Although the natural channel appears to have eroded to rock, any erosion at or near the toe of an earth dam is not desirable and should be remedied. Severe erosion from wave action was also evident on the upstream slope of the embankment along its entire length and has created a steep condition above normal pool. There was some erosion observed in the emergency spillway due primarily to the lack of adequate grass cover. However, the spillway size and discharge slope is sufficient to divert high discharges away from the embankment.

PHOTO 2. Concrete Lined Drainage Channel From Outlet Pipe and Eroded Area

The owner should provide wave erosion protection on the upstream slope, and repair and protect eroded sections of the downstream toe near the overflow pipe.

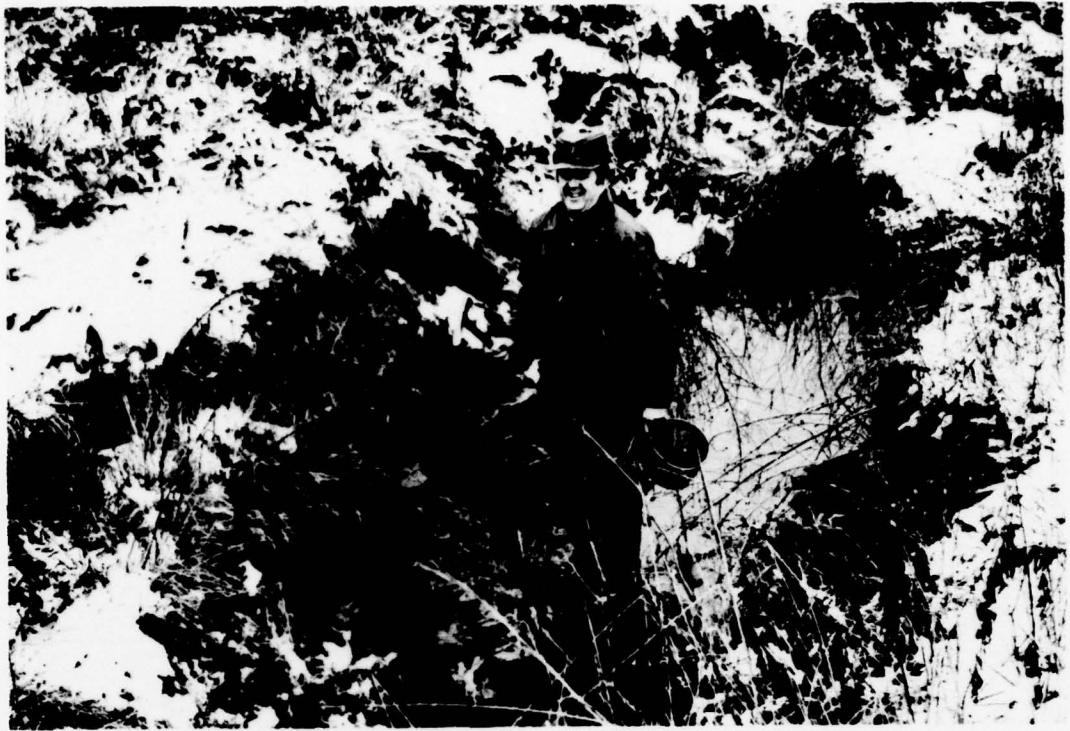
Clear seepage was observed for a 50 foot width at the toe of the embankment 50 feet right of the reservoir drain. The clear seep has no defined flow and flow was too minimal to estimate (less than 1 g.p.m.). A small stream originates in the ditch just downstream from the end of the paved overflow ditch in the vicinity of the clear seepage (see Photo 3).

PHOTO 3. Clear Seepage at End of Concrete Drainage Channel

OUTLET CHANNEL	The paved overflow ditch outlets into loose rocks and weathered quartz monzonite bedrock near the downstream toe of the dam where a stream is formed from clear seepage and/or a small spring in the area (see Photo 3). No water was flowing in the paved ditch which has some cracks (see Photo 2).	
RESERVOIR DRAIN AND CHANNEL	The 10 in. blow-off drainpipe (invert elevation 72.7 ft. P.D.) outlets in a low wet area with some brush. Some of the water flows into the stream channel downstream from the overflow ditch. The outlet valve is closed. Apparently, the water comes from the outlet of the toe drain (see Photo 4).	The channel for the outlets of the blow-off pipe and toe drain should be well-formed to conduct the water into the adjacent stream channel. A stone riprap basin would prevent erosion near the outlets. The consulting geologist Adoif Honkala expressed "apprehensions" about the contractor's use of gasoline pipe for the blow-off drain in the fill.

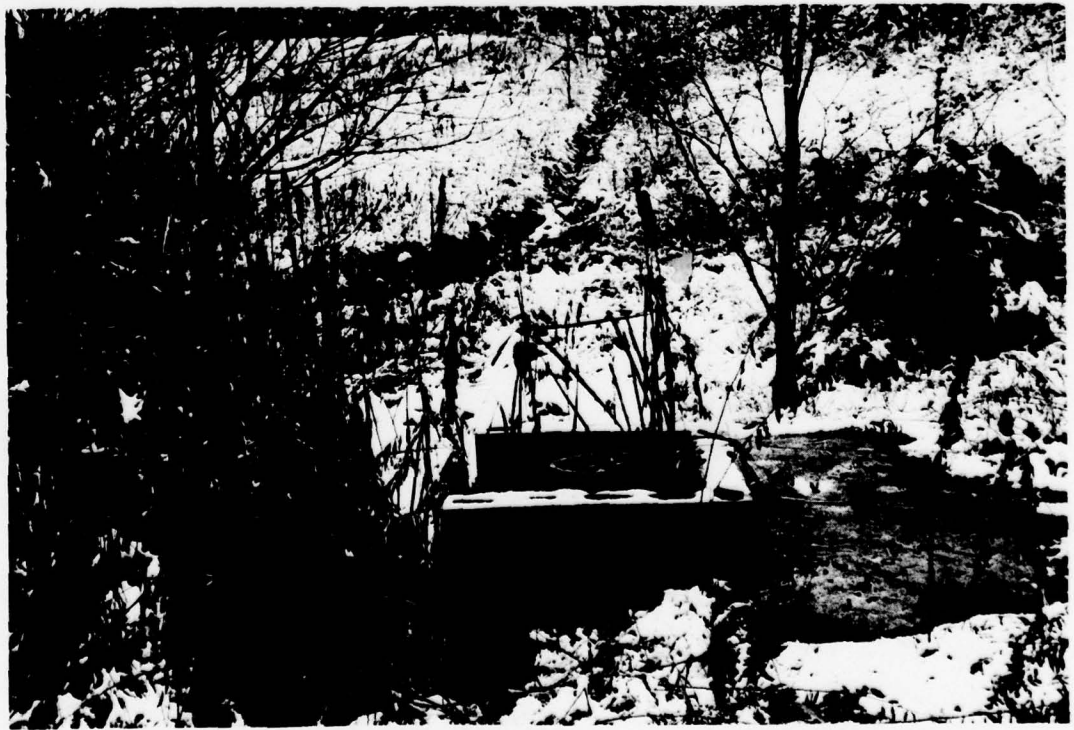
PHOTO 4. Gate Valve on Outlet of Reservoir Drainpipe

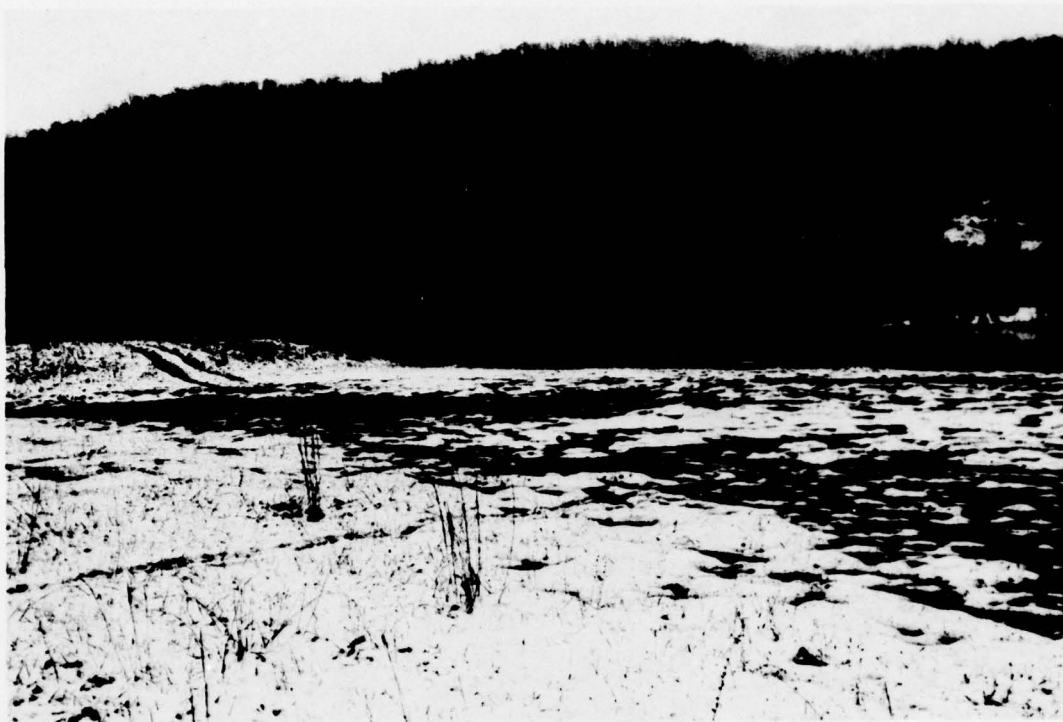
There is minor surface erosion, which has removed portions of the grass cover, in the emergency spillway (see Photo 5). Some clear seepage was observed from the end of the sod in the discharge channel of the emergency spillway (see Photo 6). There are several bare areas on the left cut slope.

PHOTO 5. Left Abutment of Dam and Emergency Spillway
