Name Of Dam: White Oak

Location: Madison County, State of Virginia

Inventory Number: VA 11301

PHASE I INSPECTION REPORT NATIONAL DAM SAFETY PROGRAM

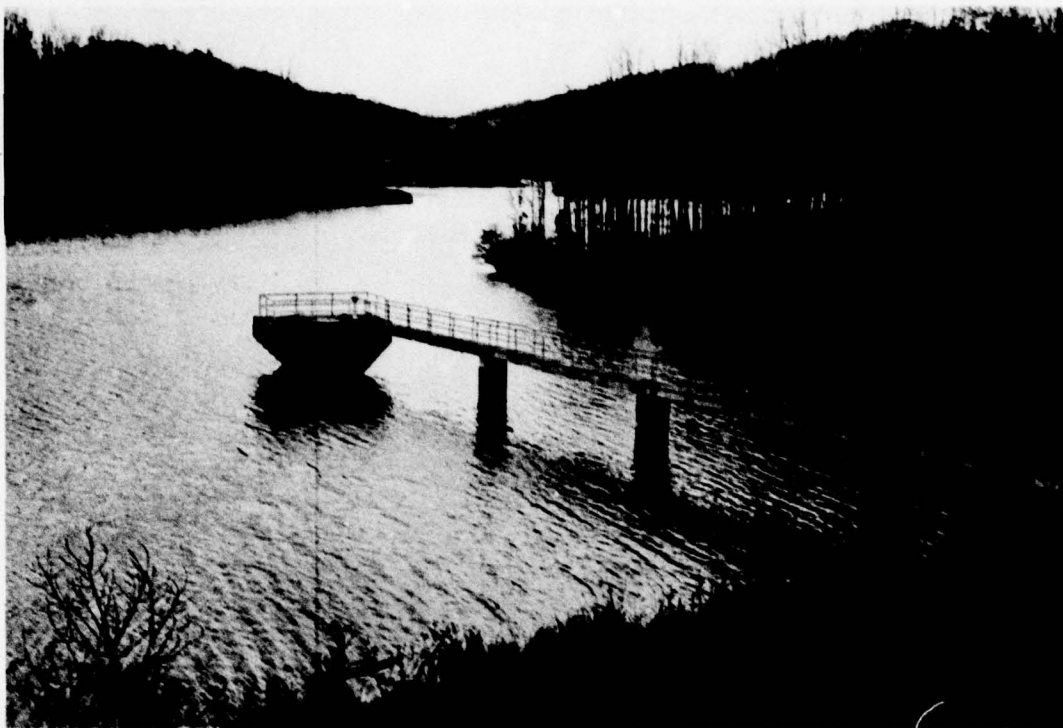
PHOTO 1. Reservoir Area, Riser and Walkway

- 3.1.4 Reservoir Area: No serious deficiencies were observed in the reservoir area (see Photo 1). However, some wood debris near the left shoreline of the dam was observed.

Recommended remedial measures to be scheduled during the annual operation and maintenance inspection program are to: remove debris from the reservoir area, remove small trees and brush from the embankment, and repair animal burrows.

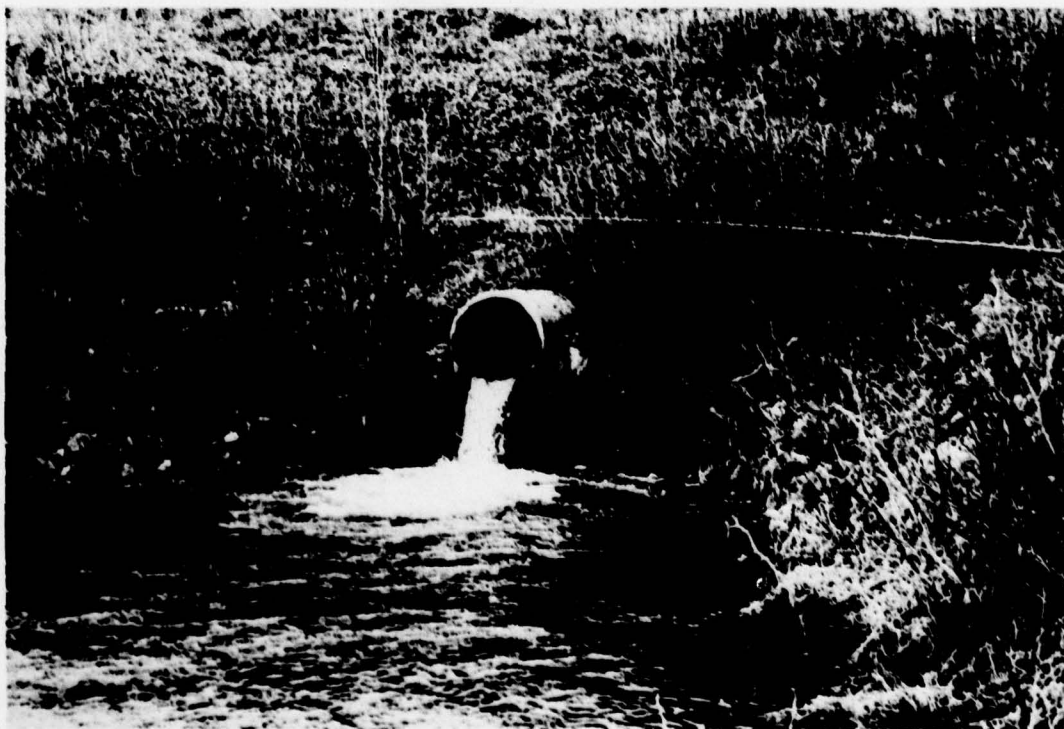
PHOTO 2. Concrete Outlet Pipe and Stilling Basin

- 3.1.5 Downstream Channel: The stilling basin (see Photo 2) and outlet channel are functioning properly, and the riprap is generally in good overall condition. A slide-erosion area 20 feet wide by 18 feet high (see bottom of Photo 4) occurs on the right of the stilling basin approximately 30 feet from the toe of the dam. The slide-erosion area has displaced some riprap.
