NATIONAL DAM SAFETY PROGRAM. MINK CREEK DAM (ID NUMBER VA-00352--ETC(U)  
FEB 79 M BAKER

Name Of Dam: Mink Creek

Inventory Number: VA 00352

# PHASE I INSPECTION REPORT NATIONAL DAM SAFETY PROGRAM

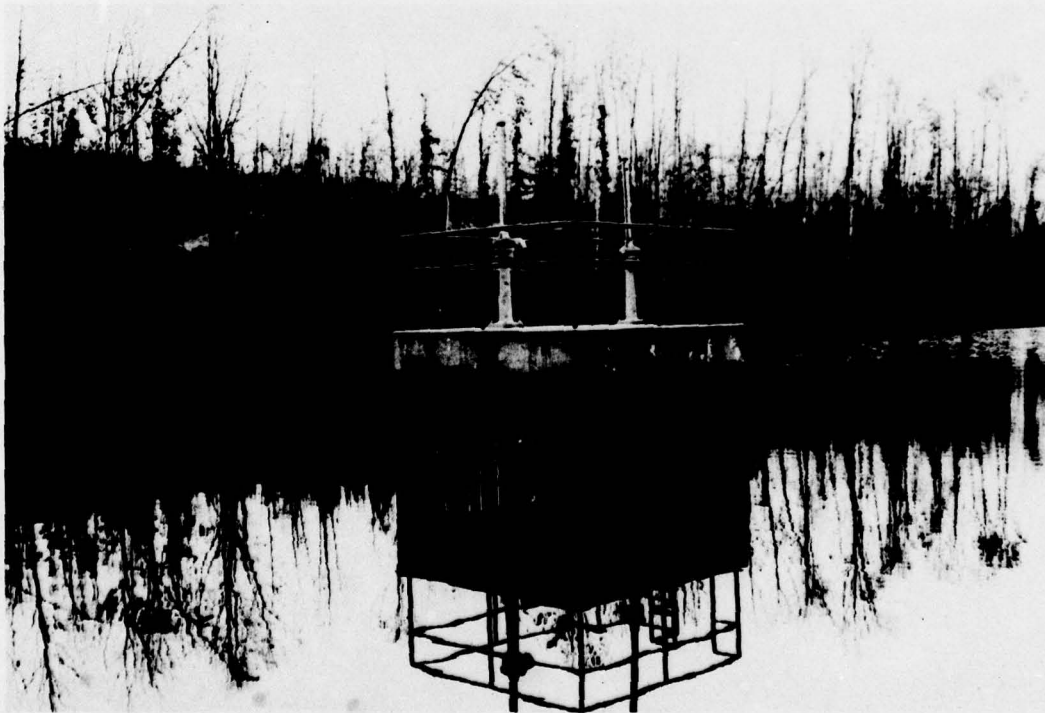
- 3.1.3 Appurtenant Structures: The concrete structures including the riser (see Photo 2) and impact basin (see Photos 3 and 4) are intact without damage. The only deficiency observed was some minor settlement and erosion of the earth backfill near the ends of the concrete walls for the impact basin.

**PHOTO 2. Riser of Outlet Structure in Reservoir**

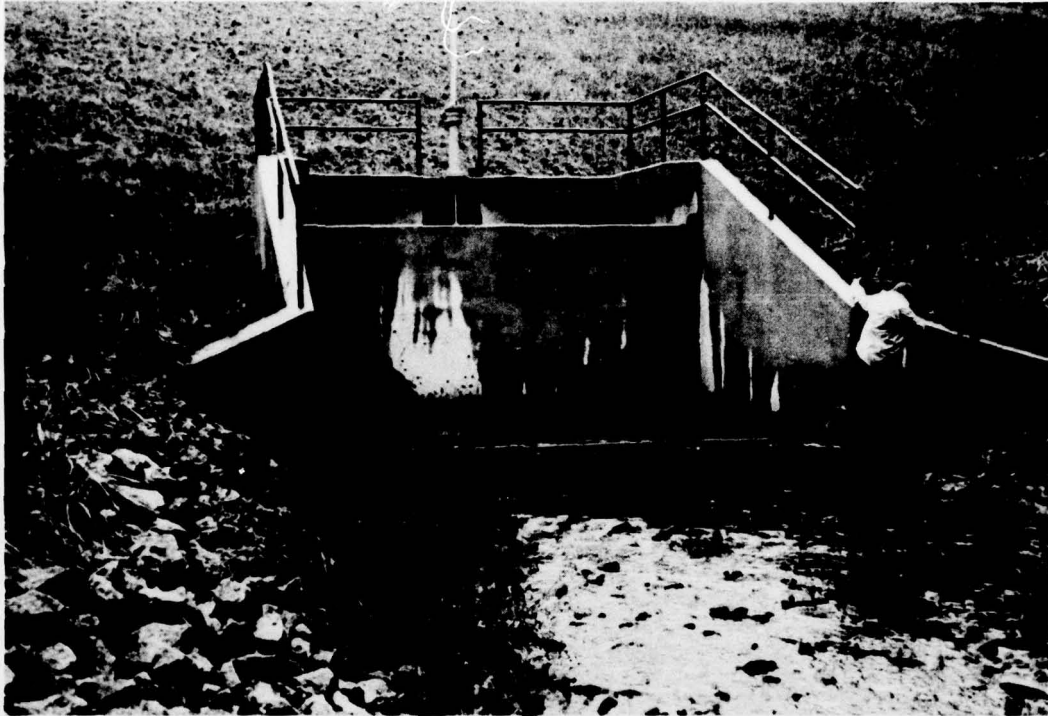
**PHOTO 3. Impact Basin Showing Baffle Wall, End Sill and Riprapped Exit Channel**

- 3.2.4 Appurtenant Structures: The settlement and erosion of the backfill adjacent to the walls of the impact basin should be repaired with compacted soil and the area should be reseeded. Surface runoff should also be diverted.

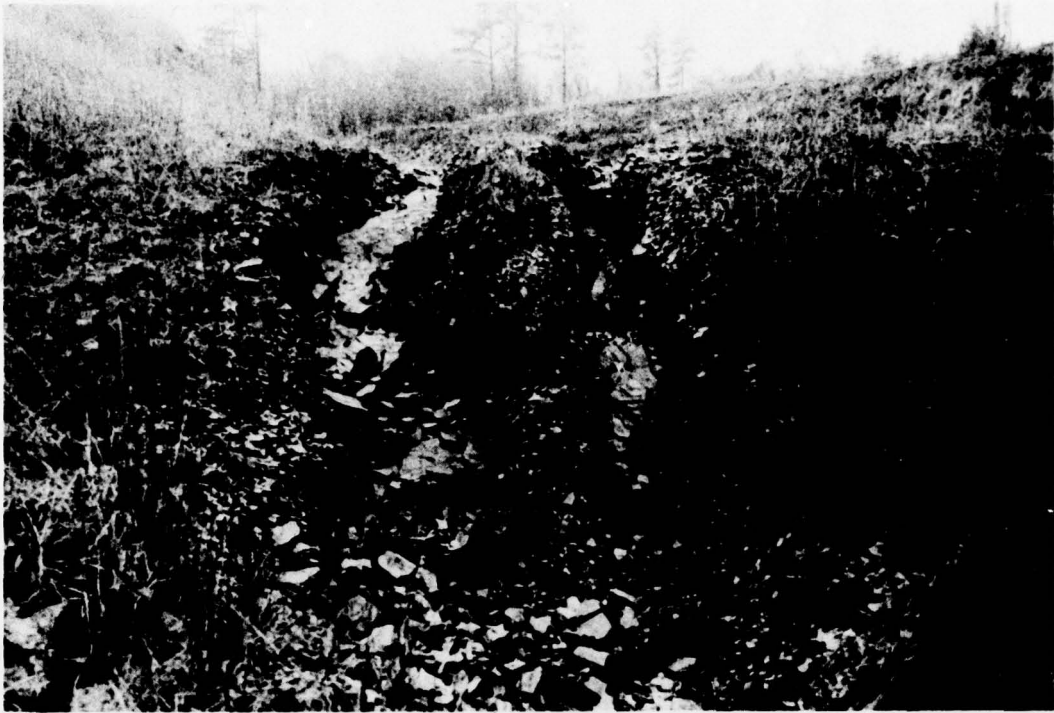
- 3.1.4 Emergency Spillway: The spillway can function for overflow conditions as designed, but there are some deficiencies which include erosion gullies (see Photo 5) in the approach channel at the shoreline, minor clear seepage in the discharge channel and moderate erosion with rock breakage in the cut slopes. The discharge channel of the emergency spillway is shown in Photo 6.

**PHOTO 5. Erosion at Approach Channel to Emergency Spillway**

| VISUAL EXAMINATION OF | OBSERVATIONS | REMARKS OR RECOMMENDATIONS |
|---|---|--|
| APPROACH CHANNEL | <p>Erosion has cut several gullies 2.5 ft. deep x 2 ft. wide in clayey silt with rock fragments down to phyllite which dipped at 30°-40° into the reservoir at the shoreline. Thin slabs have been loosened and a 15 ft. long delta has been formed in the reservoir. The soil cover decreases to 0.1 ft. further down the channel. The approach channel has an adverse slope of about 1.5%.</p> | <p>The gullies should be filled, compacted and seeded to prevent further erosion. It may be necessary to divert drainage with a cross ditch.</p> |

- 3.2.2 Emergency Spillway: The erosion gullies in the approach channel should be repaired and protection against erosion from surface runoff should be provided. Surface runoff should be diverted by drainage ditches for erosion protection in both the approach and exit channels. The erosion and sloughage in the cut slopes do not appear to be serious at this time.

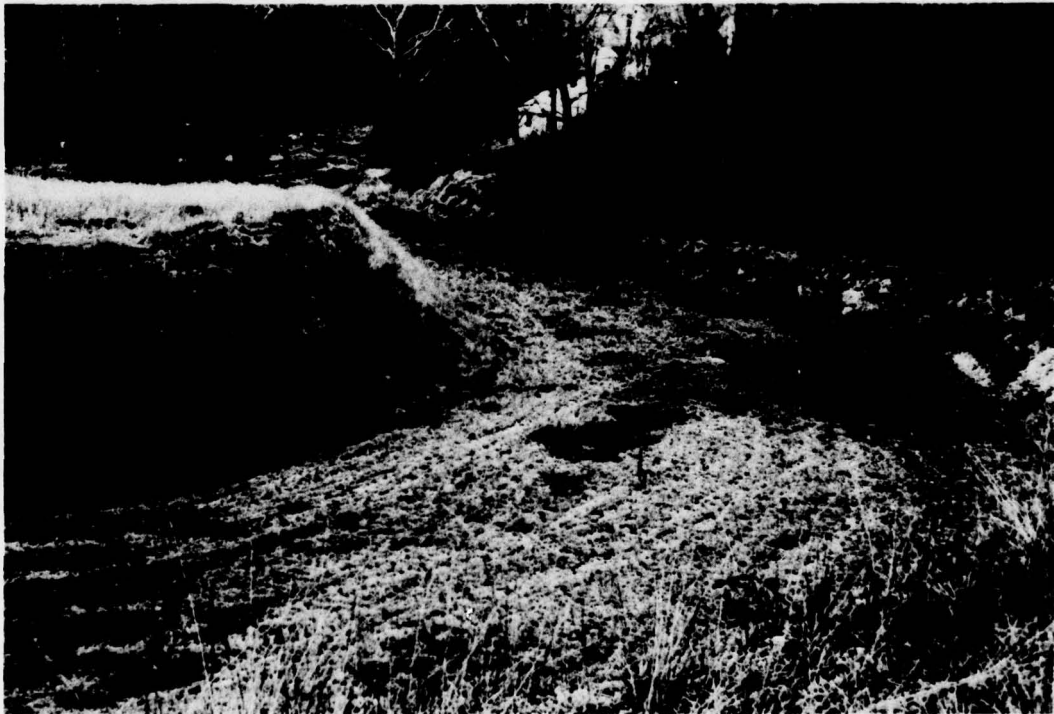
**PHOTO 6. Downstream View of Emergency Spillway**
