BROAD RUN DAM

PHASE I INSPECTION REPORT

NATIONAL DAM SAFETY PROGRAM.

BROAD RUN DAM
PRINCE WILLIAM COUNTY, VIRGINIA
INVENTORY NO. VA 15302

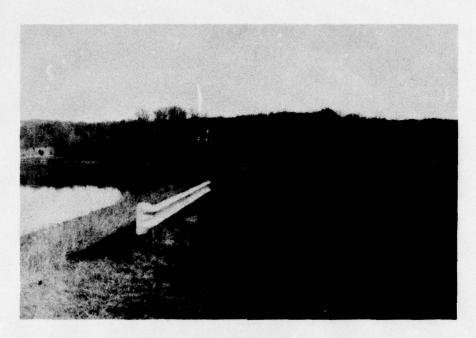
Top of Dam

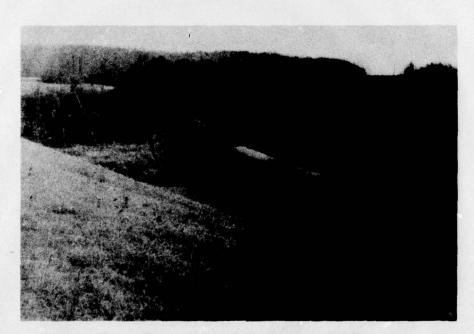
Front Face of Dam & Downstream Bridge

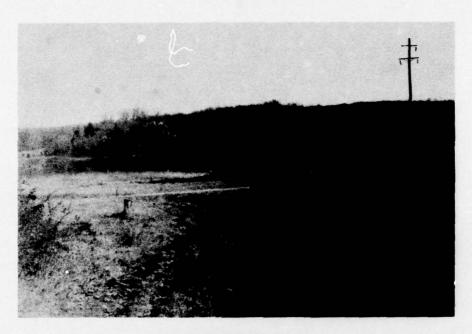
PHOTOGRAPH NO. 1
Back Face of Dam & Emergency Spillway

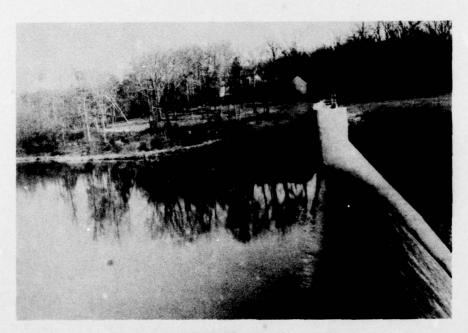
- Stains were showing through the thin film of water going over the spillway. These stains are about 44 feet from the left end of the principal spillway and 10 to 15 feet below the crest.

PHOTOGRAPH NO. 2 Principal Spillway Crest

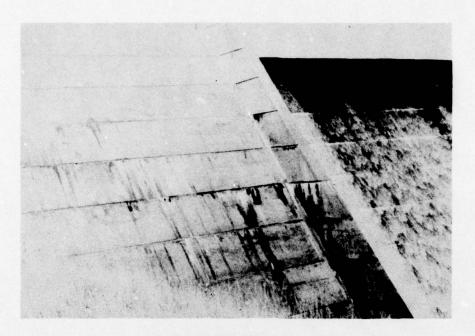
- The left wall has hairline cracks showing calcium deposits.
 The crack is located at about elevation 250 and about 10 feet left of the principal spillway.

PHOTOGRAPH NO. 3
Spillway & adjacent Wall

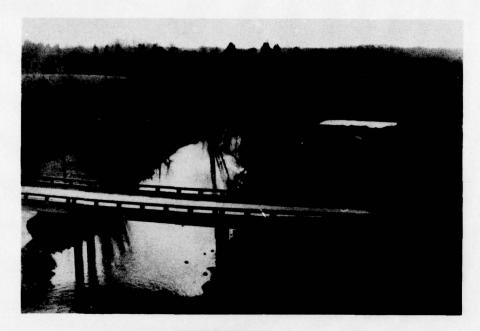
PHOTOGRAPH NO. 5 Downstream Channel

VISUAL EXAMINATION OF	OBSERVATIONS	REMAINS OR RECOMMENDATIONS
CCNDITION (OSSIRUCTIONS, DEBRIS, ETC.)	Bridge 200-300 ft. below dam. Channel has riprap washed from bridge piers.	
STOPES	Narrow channel at bridge 150' wide, 4'-6' deep. Wide flood plains.	
APPROXIMATE NO. OF HOMES AND POFULATION	Water Treatment Plant 400' downstream, approximately 7 farm homes in 1,200 ft. below dam. Manassas airport approximately 9 miles downstream.

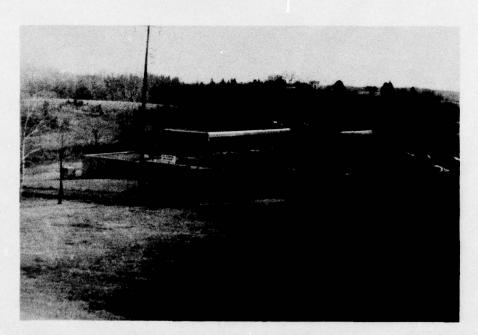
PHOTOGRAPH NO. 6 Waterworks below Dam
