Upper Ragged Mountain Number 1,
Inventory Number: VA-00356. James River
Basin. Albermarle County, State of
Virginia. Phase I Inspection Report.

PHASE I INSPECTION REPORT
NATIONAL DAM SAFETY PROGRAM

NAME OF DAM: UPPER RAGGED MOUNTAIN NO. 1

PHASE I INSPECTION REPORT
NATIONAL DAM SAFETY PROGRAM
NAME OF DAM: UPPER RAGGED MOUNTAIN NO. 1 ID# VA 00356

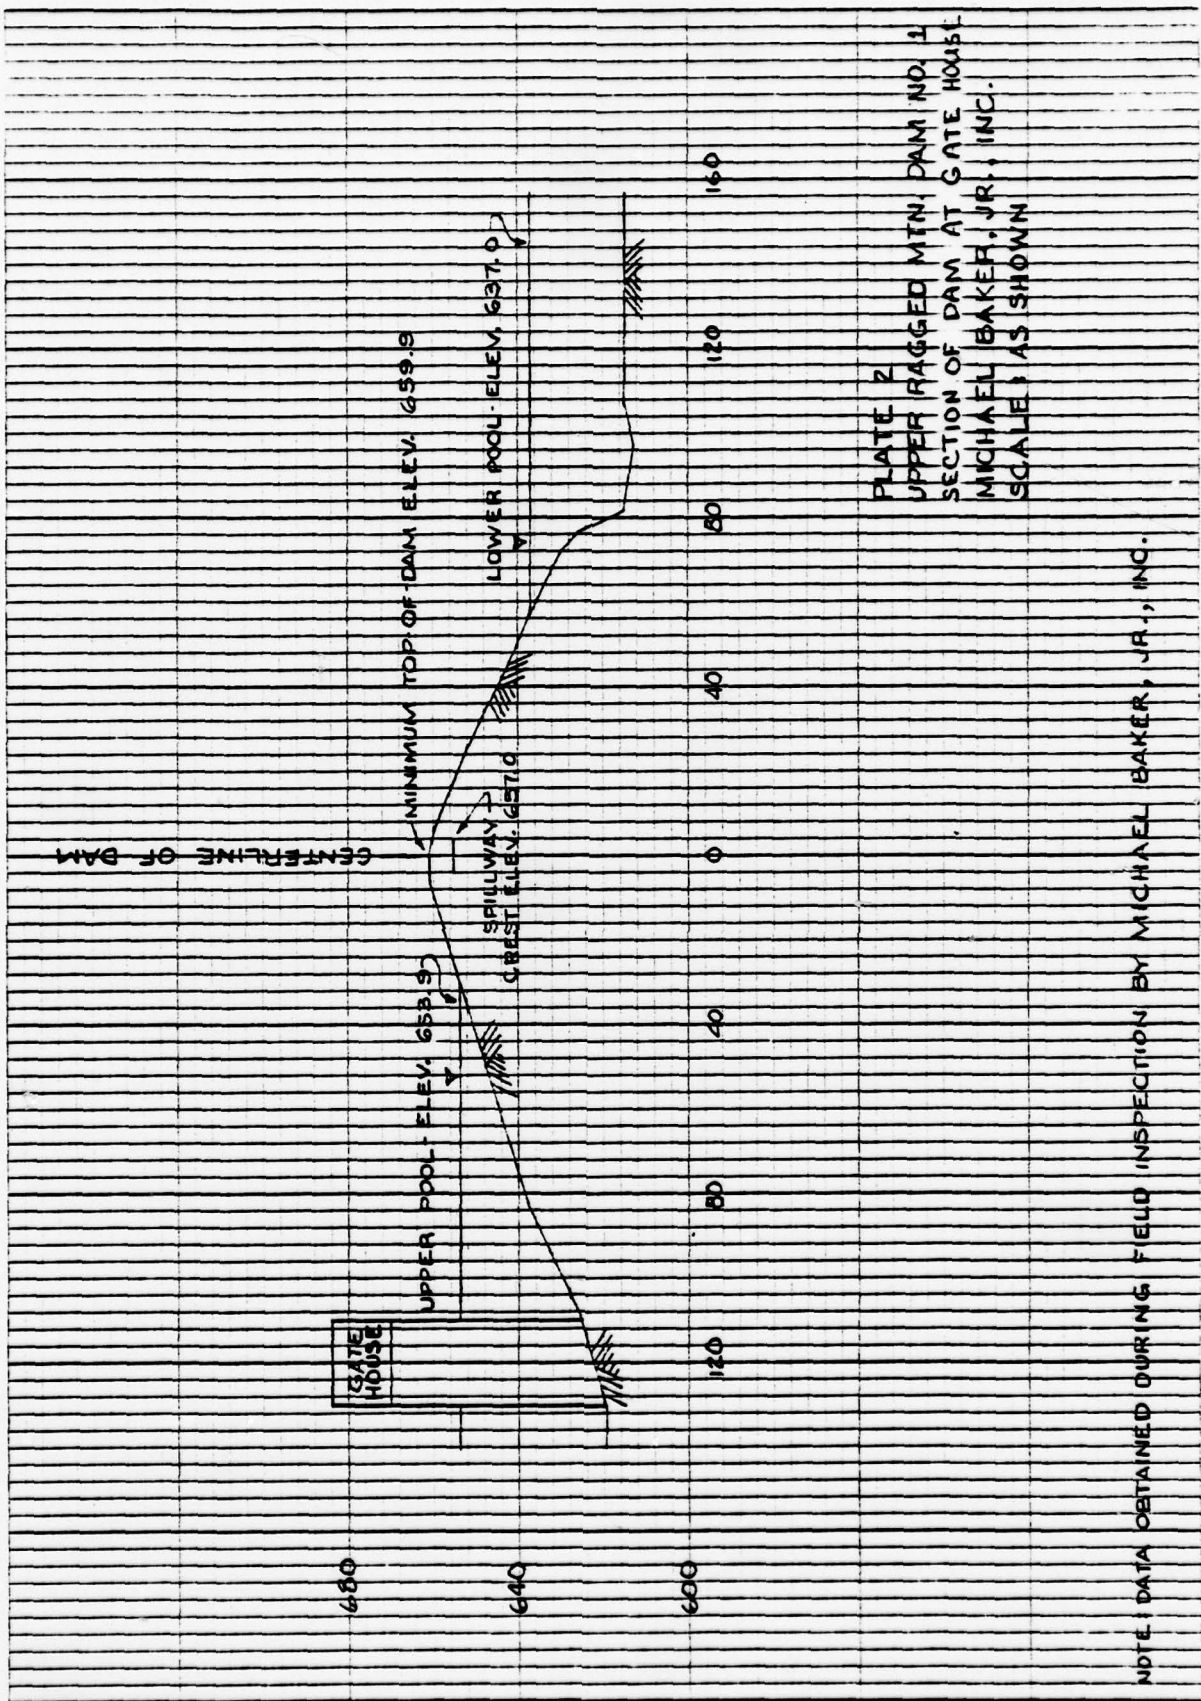
PLATE 2
 UPPER RAGGED MTN. DAM NO. 1
 SECTION OF DAM AT GATE HOUSE
 MICHAEL BAKER, JR., INC.
 SCALE AS SHOWN

3.1.2 Dam: The embankment was in poor condition with several deficiencies that require attention. Sounding of the submerged portion of the downstream slope at the only location measured (see Plate 2) indicated a very steep condition (1H:2V). There is clear seepage (3 to 4 g.p.m.) on the downstream slope at the right abutment causing erosion and sloughing in a 20 by 30 foot area. Minor seepage occurs on the shore at the left abutment. A 50 to 100 foot fill separation occurs along the downstream face of the stone core wall near the right embankment. The separation, which formed an irregular "trench" approximately 4 feet deep and 3 feet wide, is caused by either slumping and/or erosion near a low point in the dam crest profile. Most of the dam is covered by thick vegetation. Several animal burrows were observed on the dam. Evidence of beaver activity was observed at the dam and along the edges of the reservoir. Wood debris is scattered on both upstream and downstream shorelines.

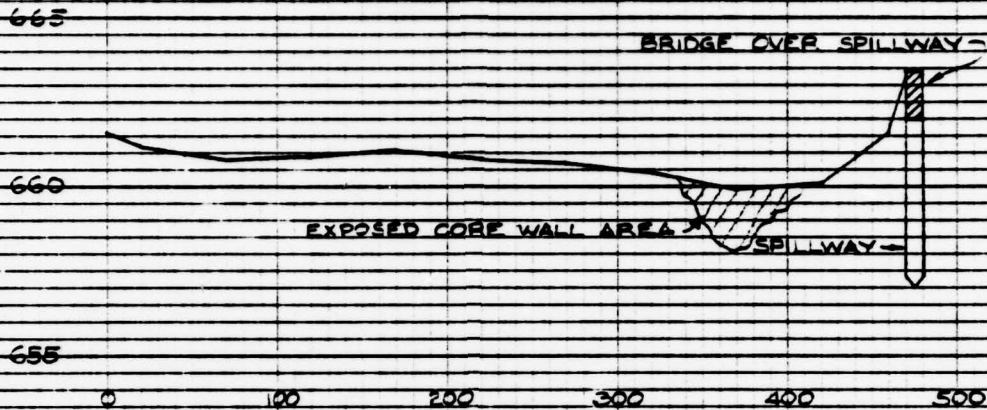
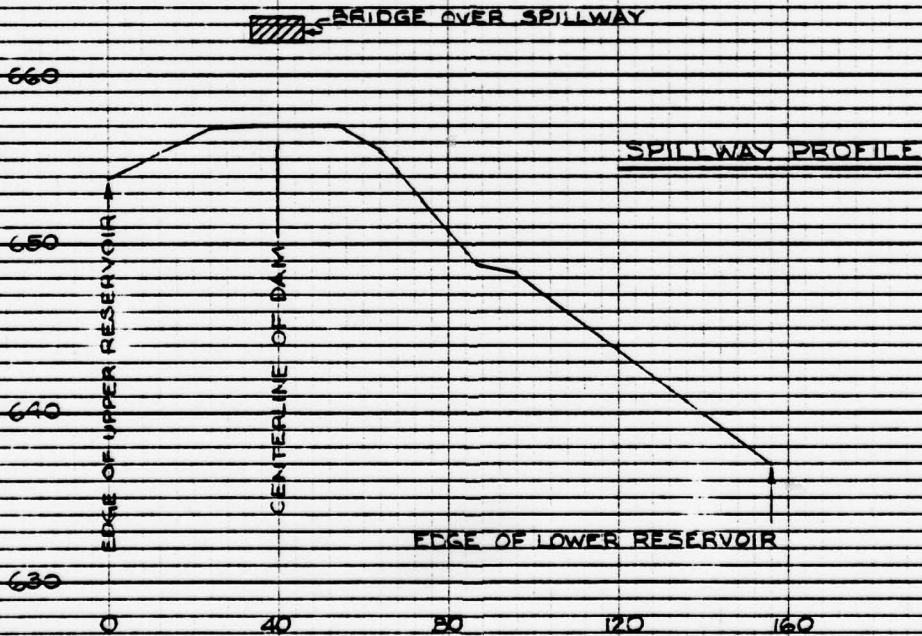
PLATE 3
UPPER RAGGED Mtn. DAM NO. 1
MICHAEL BAKER, JR., INC.
SCALE: AS SHOWN

6.3 Evaluation: Since stability analyses were not available, a detailed stability assessment cannot be made. The clear seepage on the right side is in line with the low point of the dam (see Plate 3) where the earth has slumped or eroded from the downstream face of the stone core wall. The deficient conditions in this area may be related to an old slide. It is recommended that further field inspection be done in the right abutment area after the thick vegetation has been removed so that detailed remedial measures can be planned. It is suggested that test borings be drilled in the suspected slide area and piezometers be installed. The record of the boring or borings that had been drilled in the dam and any related data should be obtained if possible. A slope stability analysis should be performed on those sections of the embankment with the very steep toe using test results from the boring samples.

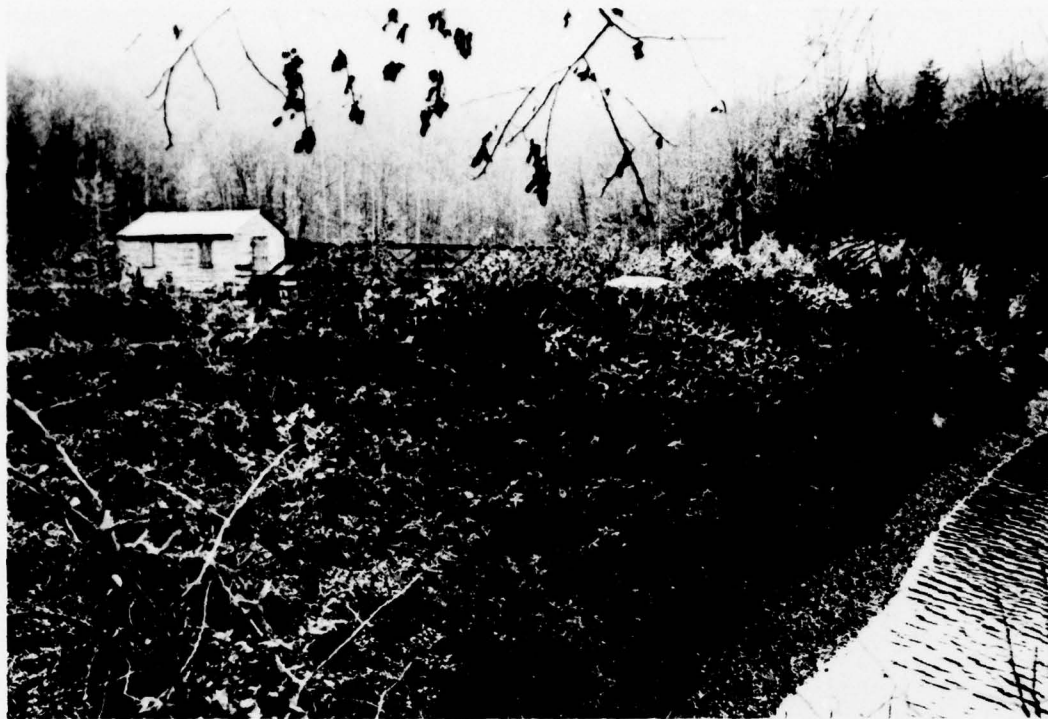
Photo 1. Outlet Works Downstream Embankment and Edge of Downstream Reservoir

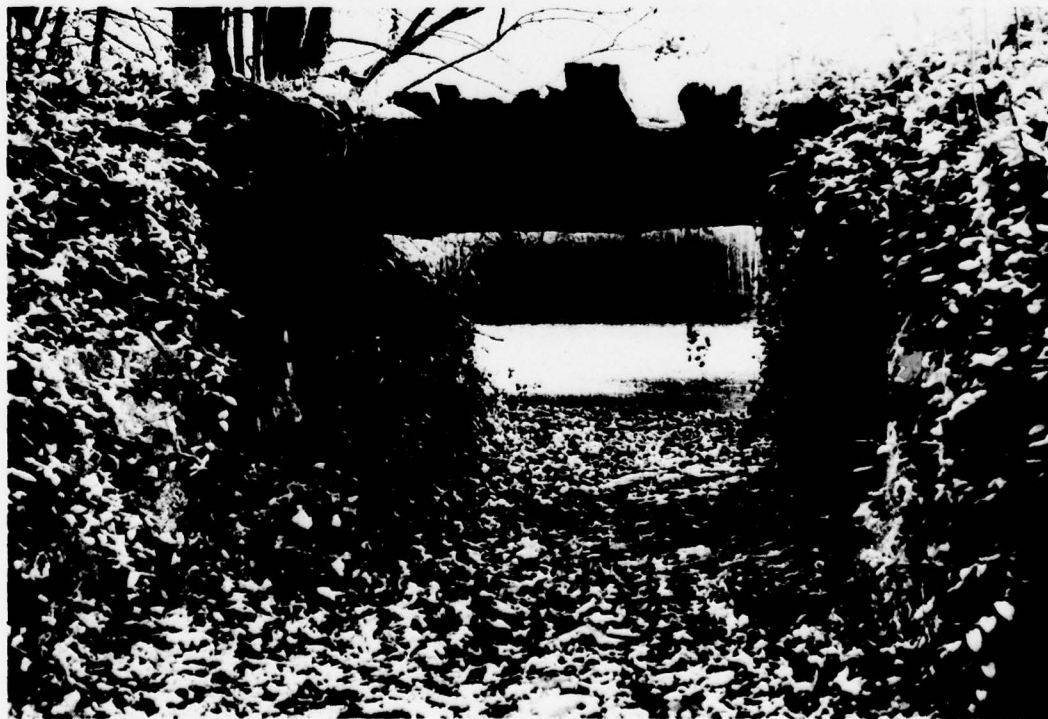
3.1.3 Open Channel Spillway: The stone masonry lined approach channel is in good condition. Some debris (branches and small logs) were piled along the spillway banks after removal from the channel by water authority personnel. This debris is a result of the beaver activity. The discharge channel is deeply incised in soil to weathered quartz monzonite. The discharge channel is uneven, and there are accumulations of wood debris and boulders in

PHOTO 2. Looking Upstream at Spillway in Right Abutment of Dam

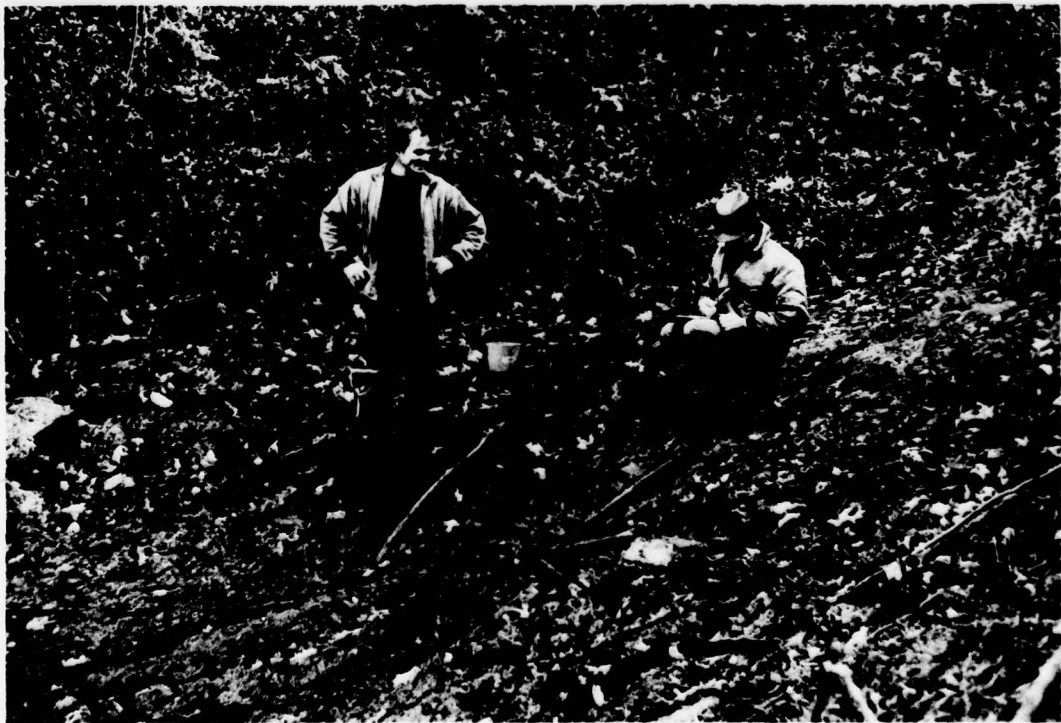
- 6.2.1 Visual Observations: The steep slope (1H:2V), which was measured by soundings only at one location at the downstream toe of the embankment, represents an undesirable condition. There is clear seepage (3 to 4 g.p.m.) on the downstream slope at the right abutment where erosion and sloughing have occurred. Minor seepage also occurs on the shore at the left abutment. Either slumping and/or erosion has exposed a portion of the stone core wall on the right side at the crest. The profile run of elevations along the crest of the dam (see Plate 3) shows a low area in the vicinity of the slump. Thick vegetation on the slopes of the dam hindered a thorough inspection of the surface conditions (see Photos 3, 4, and 5).

PHOTO 4. Clear Seepage Area at Downstream Right Abutment

Until further investigations can be conducted and remedial measures recommended and completed, the seepage areas should be monitored to watch for unstable conditions, especially when the reservoir is at higher pool levels.

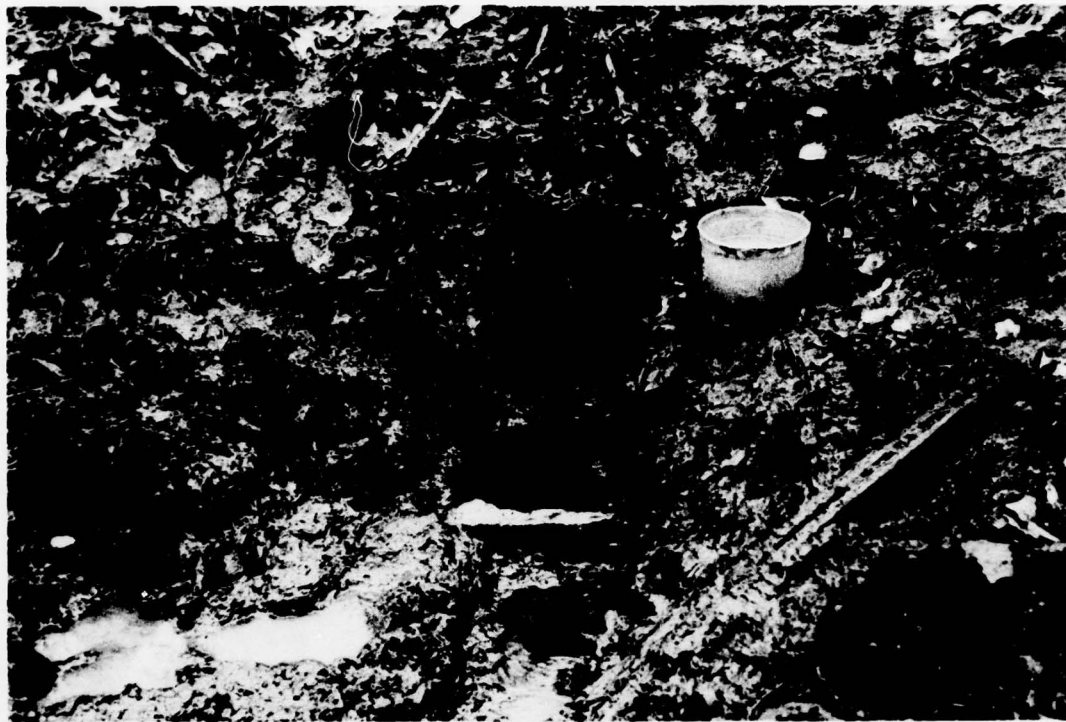
**PHOTO 5. Excavated Trench in Clear Seepage Area at Right Abutment
(Used to Determine Flow)**
