Name Of Dam: GOSHEN DAM  
Location: ROCKBRIDGE COUNTY, VIRGINIA  
Inventory Number: VA. NO. 16301

# PHASE I INSPECTION REPORT

## NATIONAL DAM SAFETY PROGRAM

Goshen Dam, Inventory Number: VA-16301.  
Rockbridge County, Virginia. Phase I  
Inspection Report.

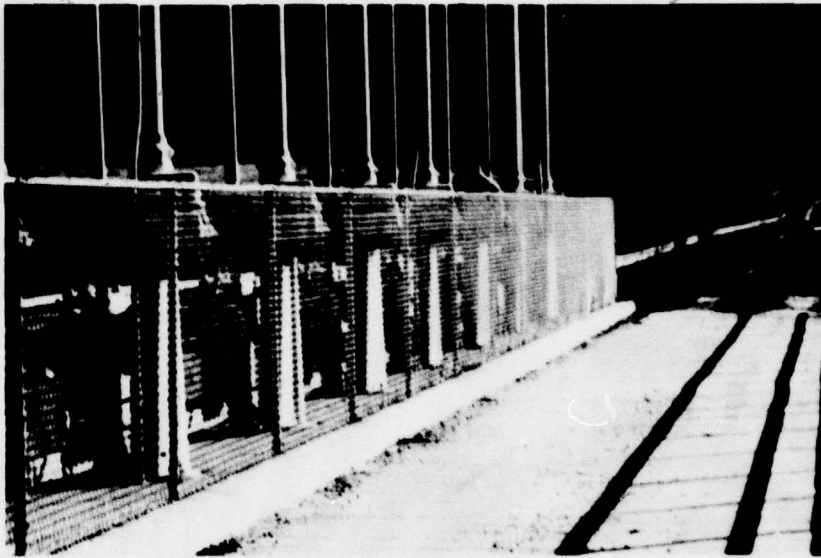
Photo #1

VIEW OF GATE MOTOR ATOP  
SPILLWAY BRIDGE

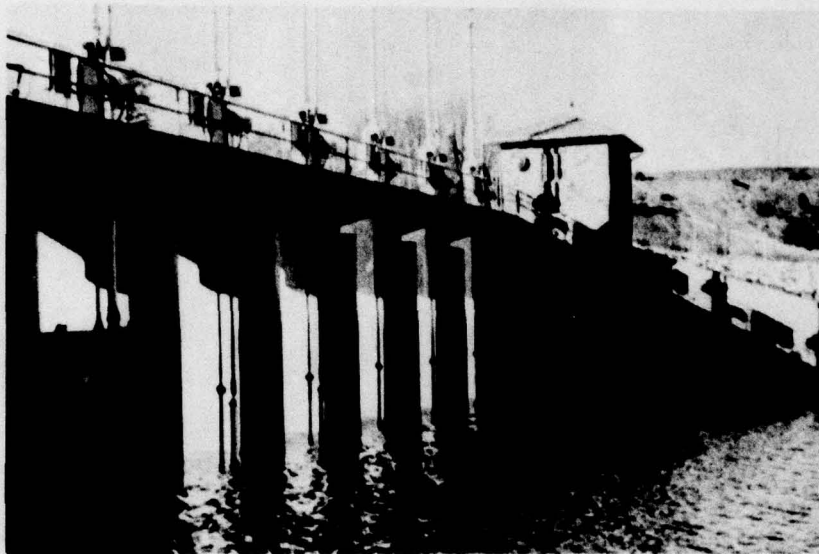
UPSTREAM VIEW OF GATES  
(Control Building in Background)  
Photo #3
