Name Of Dam: LAKE MONTCLAIR DAM
Location: PRINCE WILLIAM COUNTY
Inventory Number: VA. 15302

PHASE I INSPECTION REPORT

Lake Montclair Dam. Inventory Number:
VA-15302. Prince William County, Virginia.
Phase I Inspection Report.

MARCH 1979

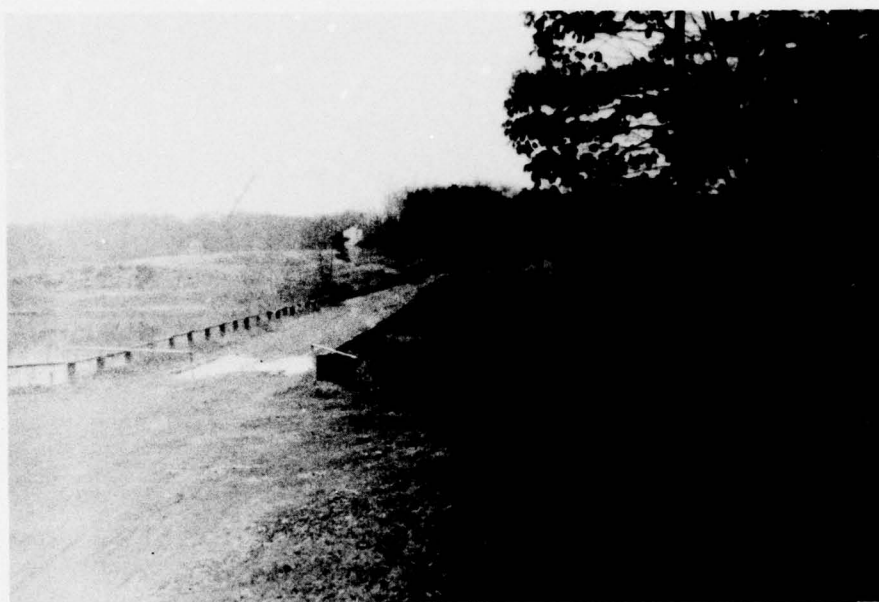
TOP OF DAM
(Looking North)

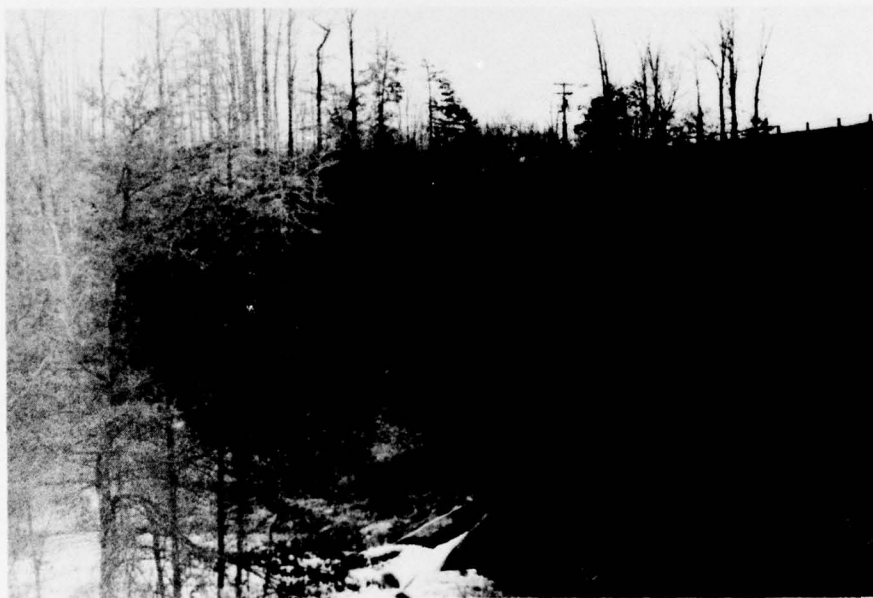
DOWNSTREAM FACE

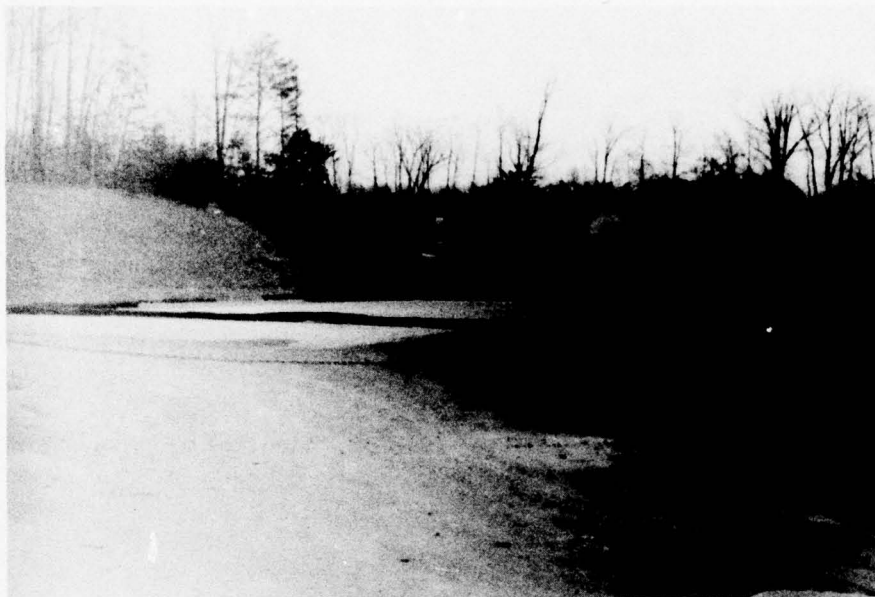
PHOTOGRAPH NO. 5
Emergency Spillway

7.1.3 The emergency spillway channel curves to the left about 400 feet below the crest. The crest had 4 feet depth of water during the Tropical Storm Agnes in 1970. This depth of water caused erosion and water over Spillway Drive to a depth of 1 foot. The erosion of the spillway and the curve in the channel endanger the spillway area and safety of the homes along Spillway Drive.

Consideration in view of these soil test results should be given to erosion of the natural earth abutment along the left side of the emergency spillway and to safety of containing flood waters at the crest and along the course of the spillway channel to avoid damage to property and life along Spillway Lane. The emergency spillway should be improved accordingly. A warning procedure needs to be established so that the downstream residents can be alerted in case of an emergency. A staff gage should be installed to permit documentation water level.
