Name Of Dam: Lake of the Woods

Location: Orange County, State of Virginia

Inventory Number: VA 13701

PHASE I INSPECTION REPORT NATIONAL DAM SAFETY PROGRAM

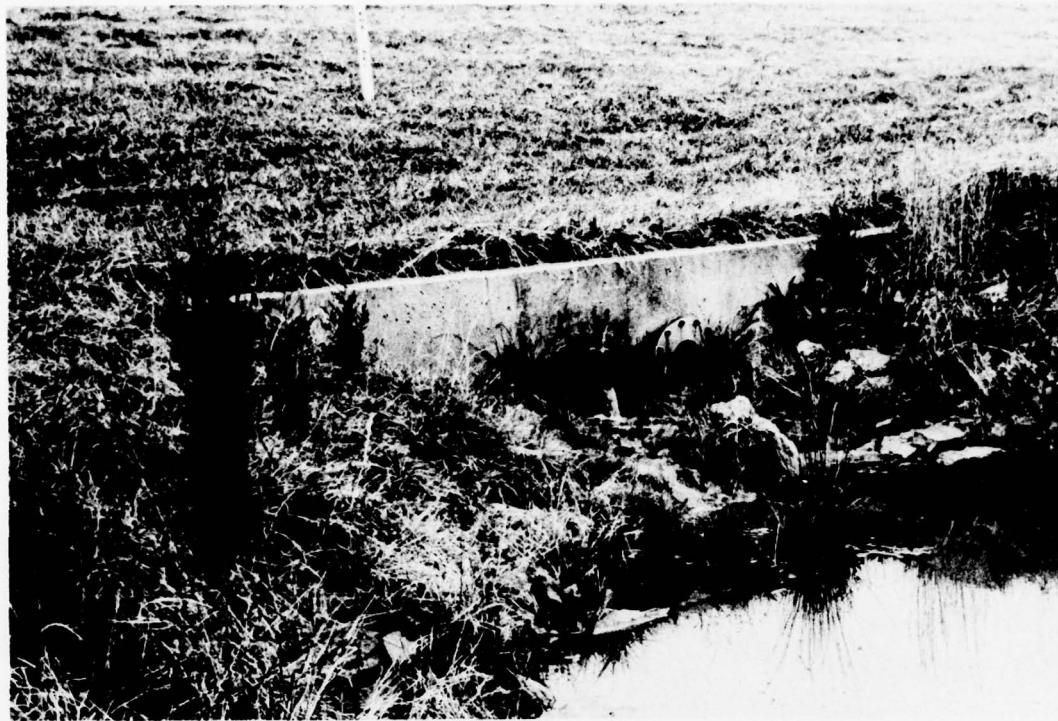
3.1.3 Appurtenant Structures: The intake portion of the reservoir drain is submerged. The plug valve and outlet pipe appear to be in good condition. There was no flow from the outlet pipe (Photo 1).

PHOTO 1. Head Wall Containing Filter Drainpipe (Left Side of Photo) and Reservoir Drainpipe (Right Side of Photo)

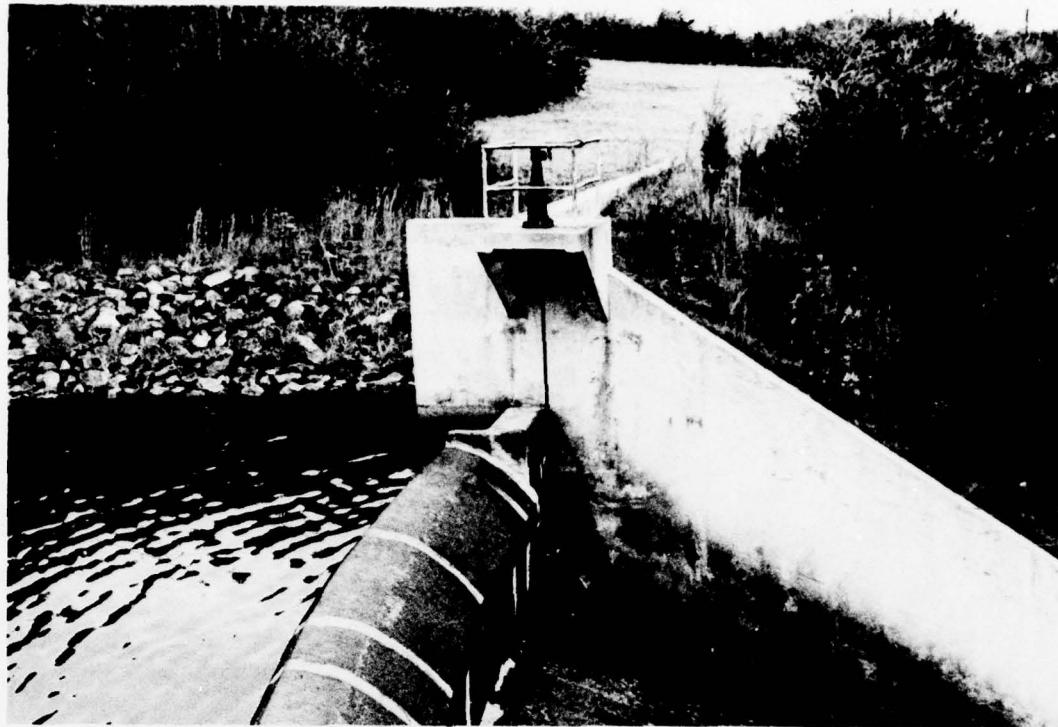
The concrete spillway functions adequately in spite of minor deterioration which includes epoxy patching in nine areas with clear leakage at two locations. There are small popouts of aggregate on the crest of the weir and in the spillway. Minor settlement (less than 2 feet) of the backfill adjacent to the left (north) wall should be corrected by the addition of compacted soil and seeding. The clear seepage and eroded area at the end of the right wall beside the stilling basin should be covered with rock to prevent further erosion. There is some clear leakage in the patched stem of the weir adjacent to the slide gate. Photos 2-6 show the deterioration of the spillway.

PHOTO 3. Riprapped Approach Channel, Concrete Overflow Weir, Lift Pedestal and Slide Gate

It is recommended that the finger drain outlets at the toe be located and opened into the drainage channel along the toe of the dam. The epoxy patches in the spillway that are no longer adhering to the concrete should be repaired, especially around the sluice gate. Rock should be placed over the seepage and erosion area at the end of the right spillway wall beside the stilling basin. The area behind the left spillway wall, where settlement has occurred, should be filled with soil, compacted, and seeded. The following minor maintenance items should be accomplished as part of the yearly maintenance program: fill and seed bare areas on the embankment, remove small trees from the drainage ditch at the toe, replace dislodged or missing riprap, remove

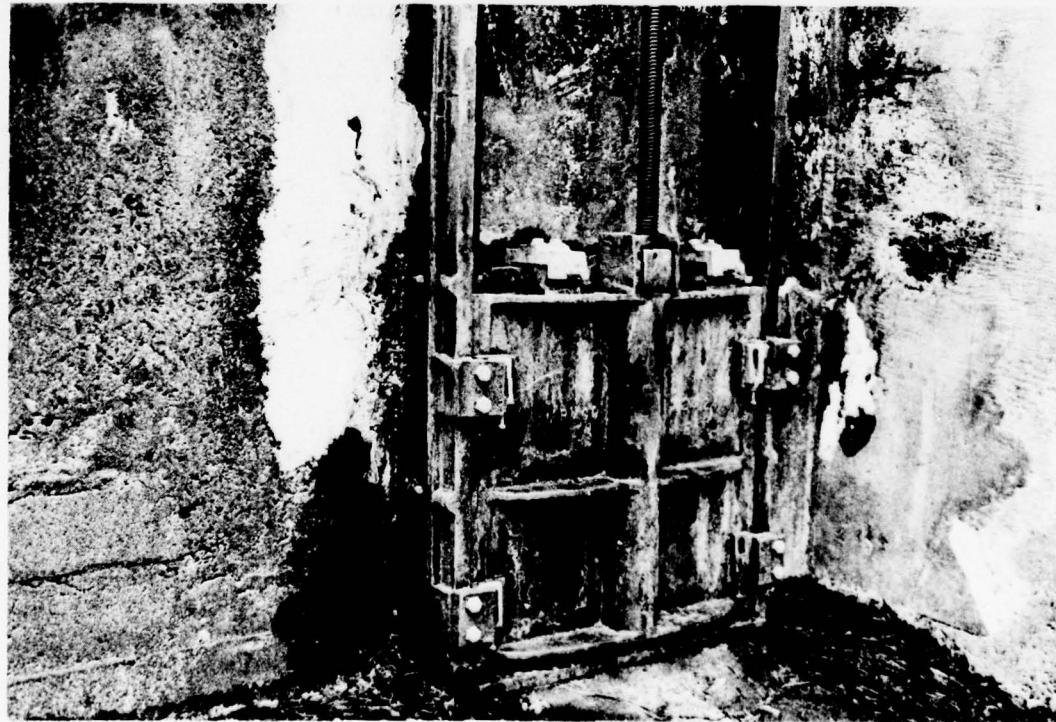
PHOTO 4. Slide Gate on Downstream Face of Weir.

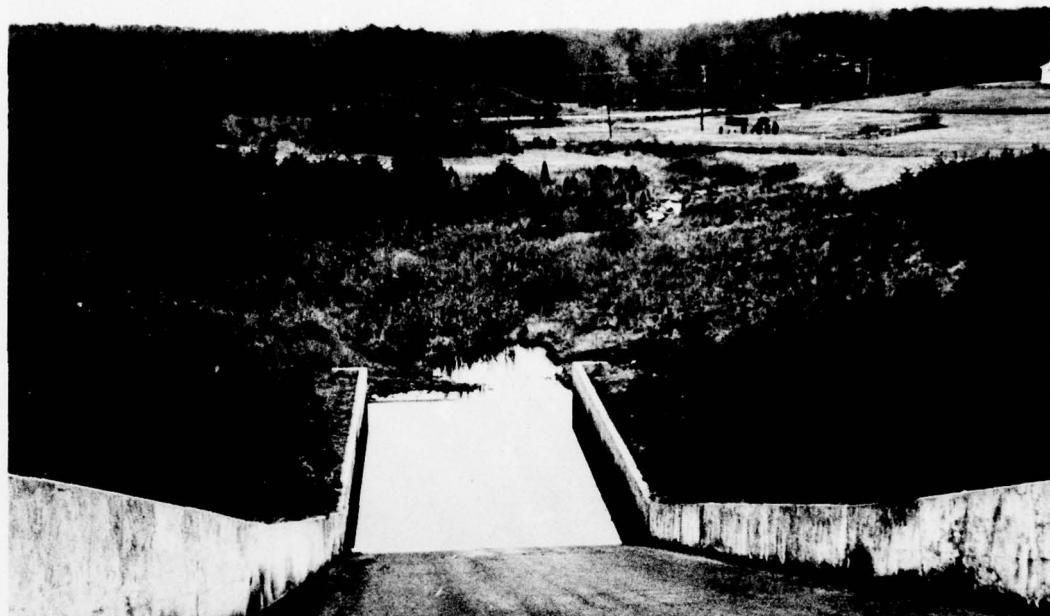
PHOTO 5. Spillway, Stilling Pool and Downstream Channel

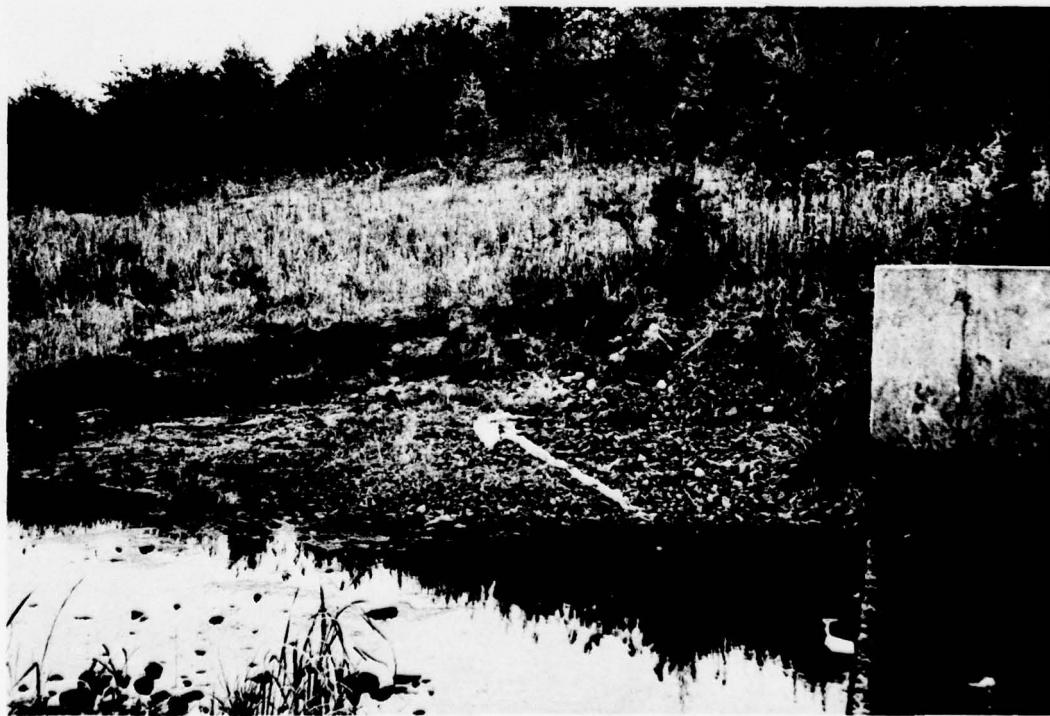
PHOTO 6. Large, Wet Area on Left Abutment to Right of Spillway
