Name Of Dam: BEDFORD RESERVOIR DAM

Location: BEDFORD COUNTY, VIRGINIA

# PHASE I INSPECTION REPORT

## NATIONAL DAM SAFETY PROGRAM

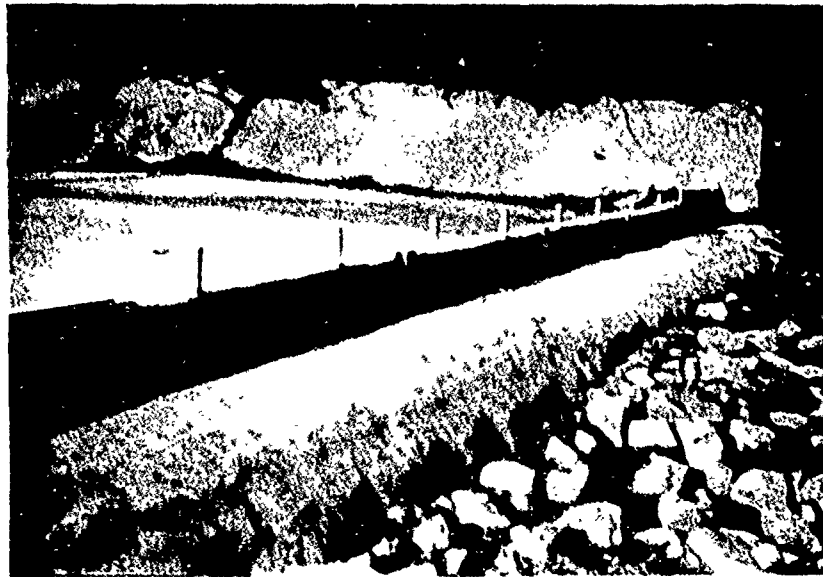
3.1.4 Emergency Spillway: The spillway is in good condition except for the following deficiencies: portions of the flashboards are missing near the right abutment, a tree is growing out of one joint, the riprapped discharge channel has eroded away on the left side, the right side is overgrown with vegetation, and debris has blocked the right wall subsurface drain.

CREST OF SPILLWAY-MISSING FLASHBOARDS
