Name Of Dam: KINLOCH FARM DAM  
Location: FAUQUIER COUNTY  
Inventory Number: VA. 06109

PHASE I INSPECTION REPORT  
NATIONAL DAM SAFETY PROGRAM

KINLOCH FARM DAM  
FAUQUIER COUNTY, VIRGINIA  
INVENTORY NO. VA 06109

Name of Dam : Kinloch Farm Dam  
State : Virginia  
County : Fauquier  
Stream : Mill-Run - Tributary to Broad Run  
Date of Inspection : December 7, 1978

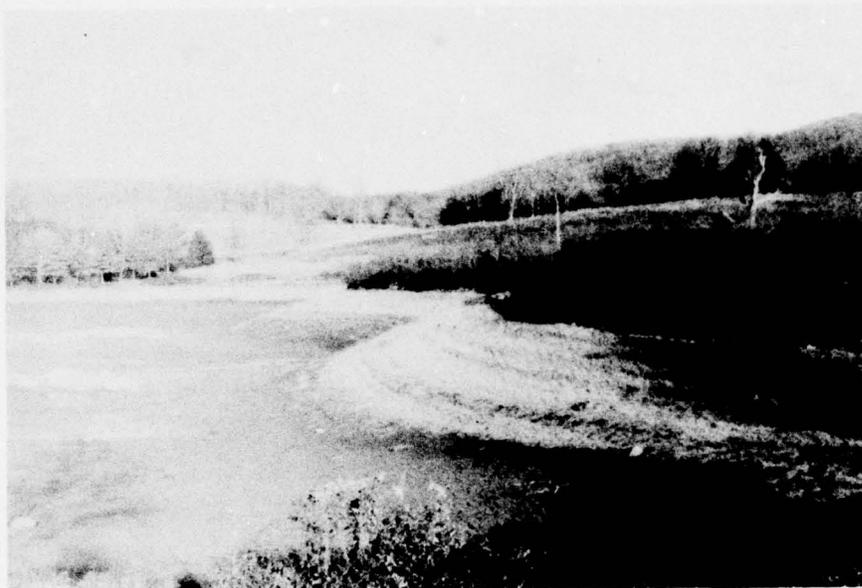
Upstream Face of Dam

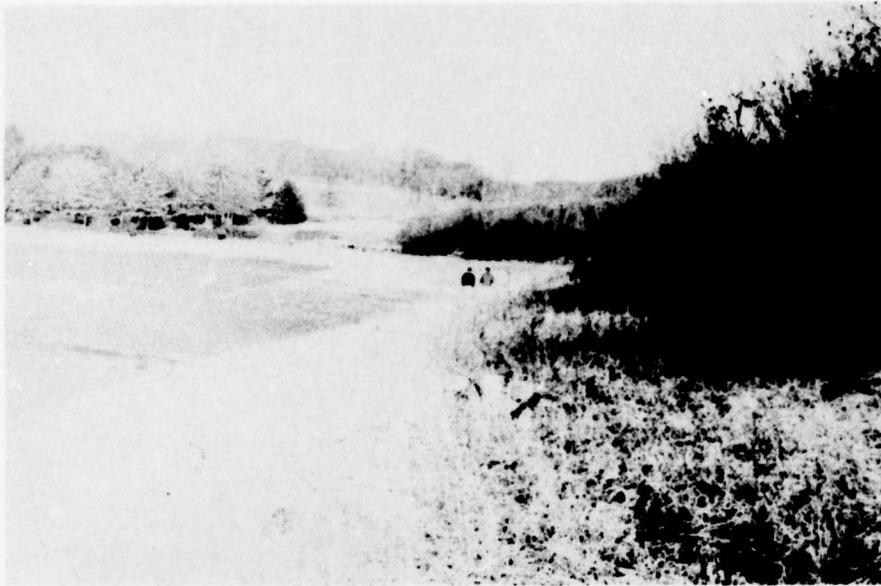
PHOTOGRAPH NO. 1  
Back Face of Dam

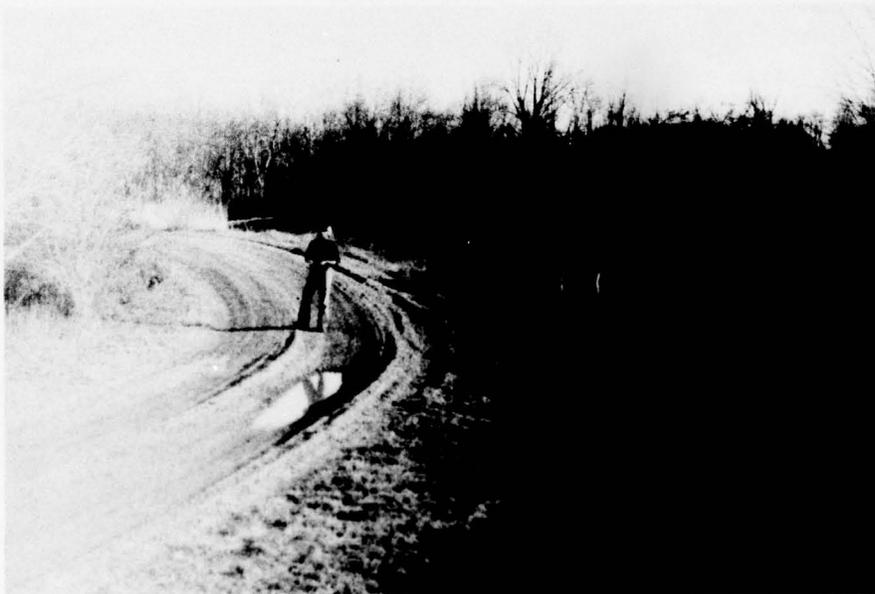
PHOTOGRAPH NO. 4  
Emergency Spillway

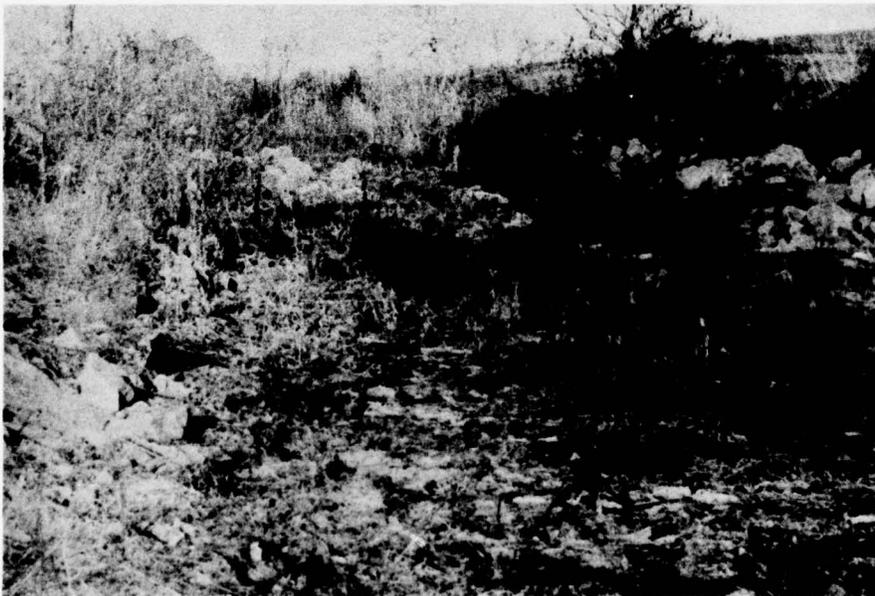
3.2 Evaluation: The visual inspection revealed no apparent problems requiring immediate attention other than the wet area of the downstream reaches of the secondary spillway channel. Since the pool was drained during the site inspection and since the seepage area reportedly existed prior to construction of the dam, it is believed that the seepage water is supplied from the hillside to the left of the dam. The two rock outcrops along either side of the spillway suggest that the basalt may form a cradle along which water from the adjacent hillside is routed. It is not felt that this seepage will adversely affect the dam, although the source of the seepage should be checked.

PHOTOGRAPH NO. 6  
Downstream Channel of Secondary Spillway

7.2 Remedial Measures/Recommendations: It is recommended that geotechnical exploration and evaluation of the dam be conducted, at the owner's expense, as outlined in Section 6.3. In addition, the source of the seepage in the secondary spillway shall be determined. The combined capacity of the spillways must be increased to pass the  $\frac{1}{2}$  PMF without overtopping the embankment. A warning system procedure should be established to alert residents in case of an emergency.
