Name of Dam: Aquia Dam - Lake Smith Impoundment
Location: Stafford County
Inventory Number: VA 17911

PHASE I INSPECTION REPORT

National Dam Safety Program

**Deward M. Martin & Associates, Inc.
January 1979**

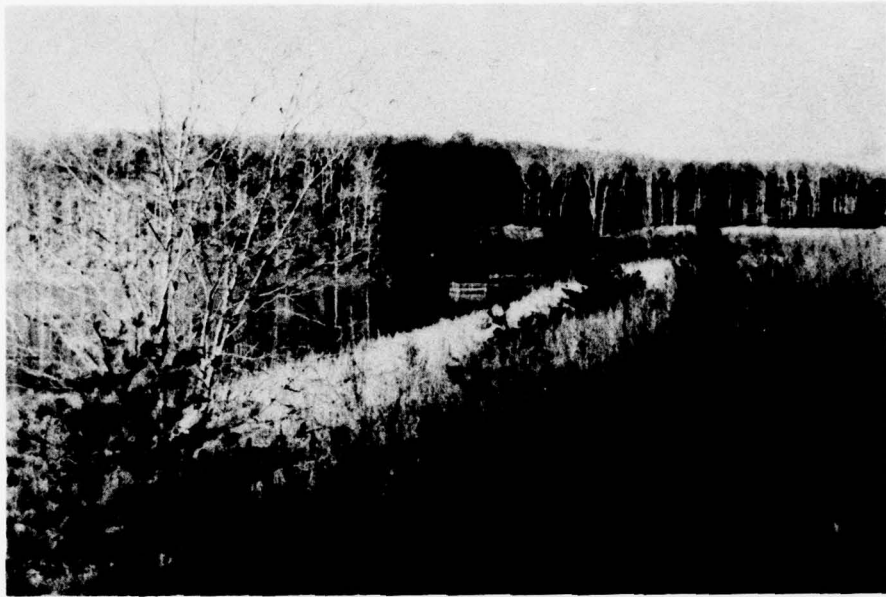
PHOTOGRAPH NO. 1
Upstream Face of Dam
Principal Spillway Intake Structure

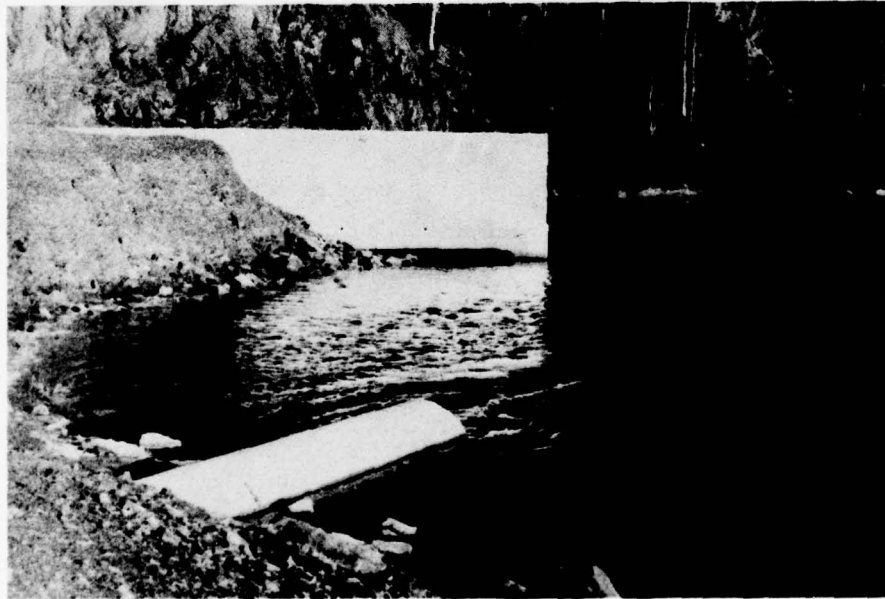
The 60-inch diameter principal spillway outlet pipe is located in such a position that together with the lack of sufficient riprap, the discharge erodes under the emergency spillway structure. The outlet area needs protection against discharge erosion by an addition of riprap.

7.1.4 There is insufficient riprap in the area around the end of the principal spillway pipe and the velocity of the discharge water is sufficient to cause erosion under the emergency spillway structure. Riprap must be installed and the erosion repaired.

PHOTOGRAPH NO. 2
Principal Spillway Outlet Pipe
& Erosion under Emergency Spillway

7.2 Remedial Measures/Recommendations: The spillway capacity must be increased to pass the PMF and geotechnical data obtained to establish the design and stability of the embankment. The riprap at the discharge pipe must be installed, erosion under the emergency spillway repaired, and rock debris in the downstream channel cleared.

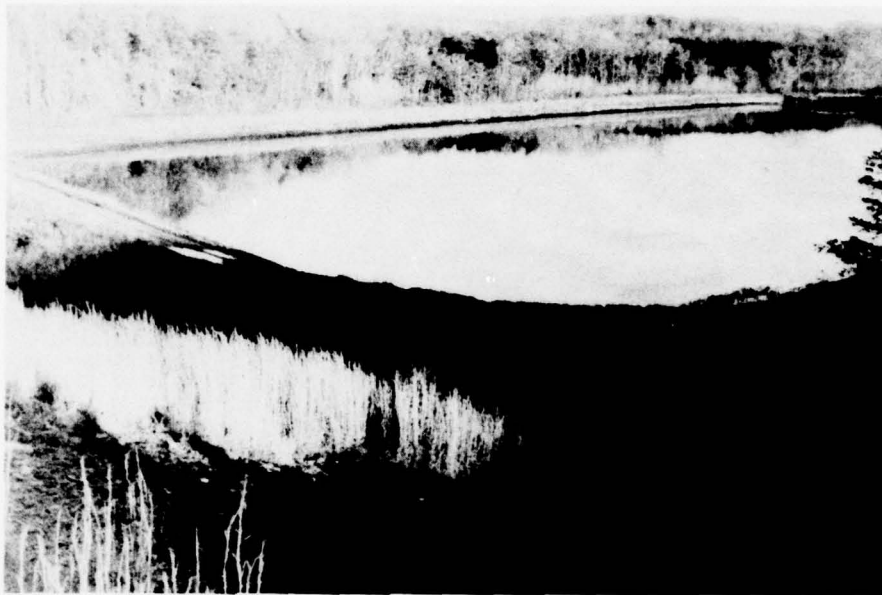
PHOTOGRAPH NO. 3
Lagoon Below Dam
