**ATTICA DAM
WYOMING COUNTY NEW YORK
INVENTORY NO 445**

**PHASE I INSPECTION REPORT
NATIONAL DAM SAFETY PROGRAM.**

Name of Dam Attica Dam No. 3 NY445

State Located New York
County Located Wyoming
Stream Crow Creek
Date of Inspection June 15, 1978

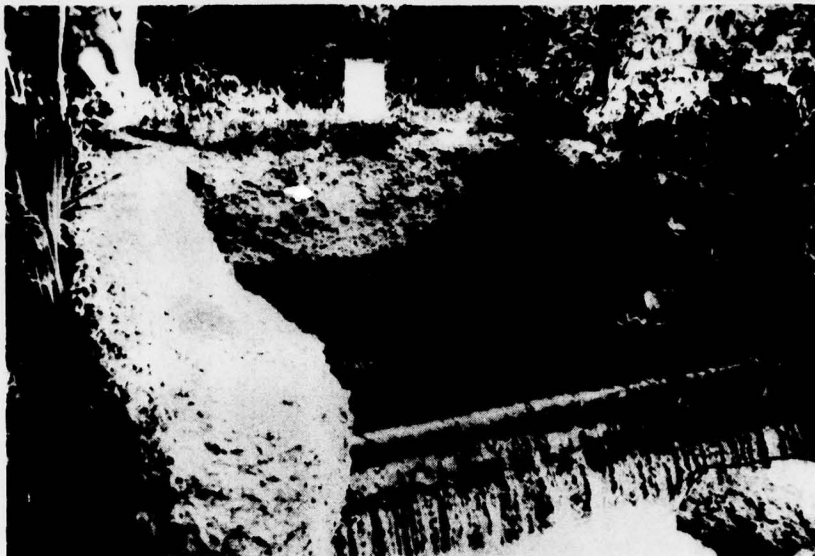
9. Detail of outlet box, pipe is submerged. Notice deteriorated condition of concrete. Weir width 84 inches, depth of flow 1-1/2 inches.

VISUAL EXAMINATION OF	OBSERVATIONS	REMARKS OR RECOMMENDATIONS
CRACKING AND SPALLING OF CONCRETE SURFACES IN OUTLET CONDUIT	None observed.	
INTAKE STRUCTURE	None observed.	
OUTLET STRUCTURE	Partially clogged with rocks. Ex- cessive deterioration of concrete. Very severe scaling of outlet box.	Replace outlet box.
OUTLET CHANNEL	Clear, unobstructed.	
EMERGENCY GATE	None.

(5) Deteriorated concrete in the spillway and the outlet box should be repaired and investigation of the possibility of voids under the emergency spillway should be conducted.

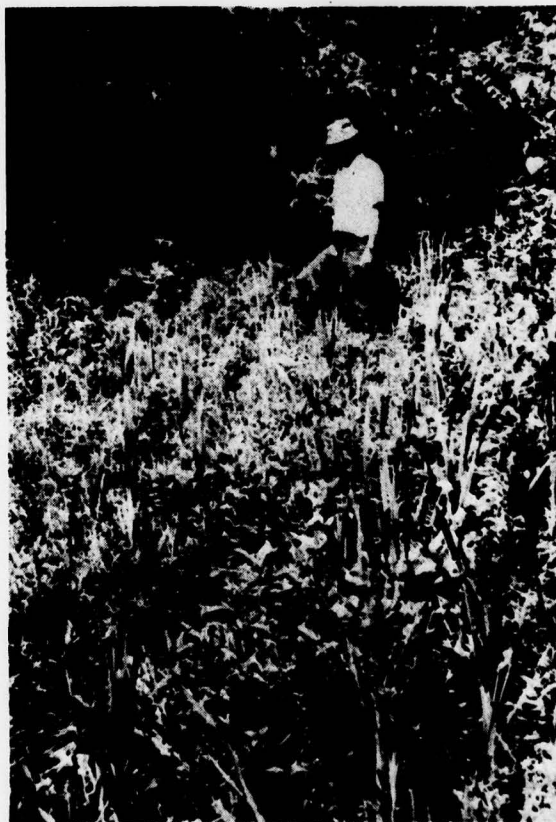
10. Overbank area below toe of dam on south side. Growth indicative of wetness.
