OSWEGO RIVER BASIN

JAMESVILLE RESERVOIR DAM

ONONDAGA COUNTY, NEW YORK
INVENTORY NO.418

PHASE I INSPECTION REPORT
NATIONAL DAM SAFETY PROGRAM

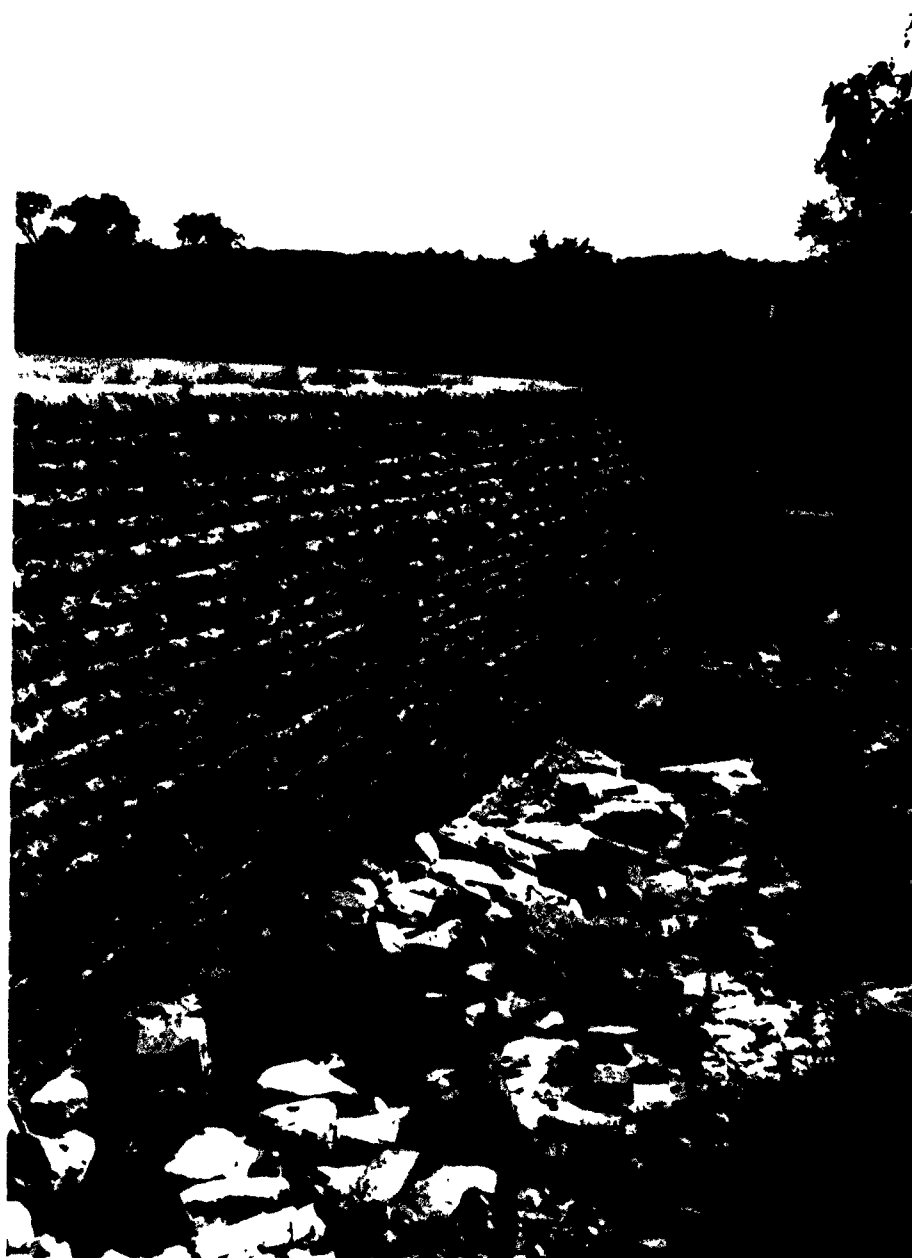
OVERVIEW OF MASONRY DAM

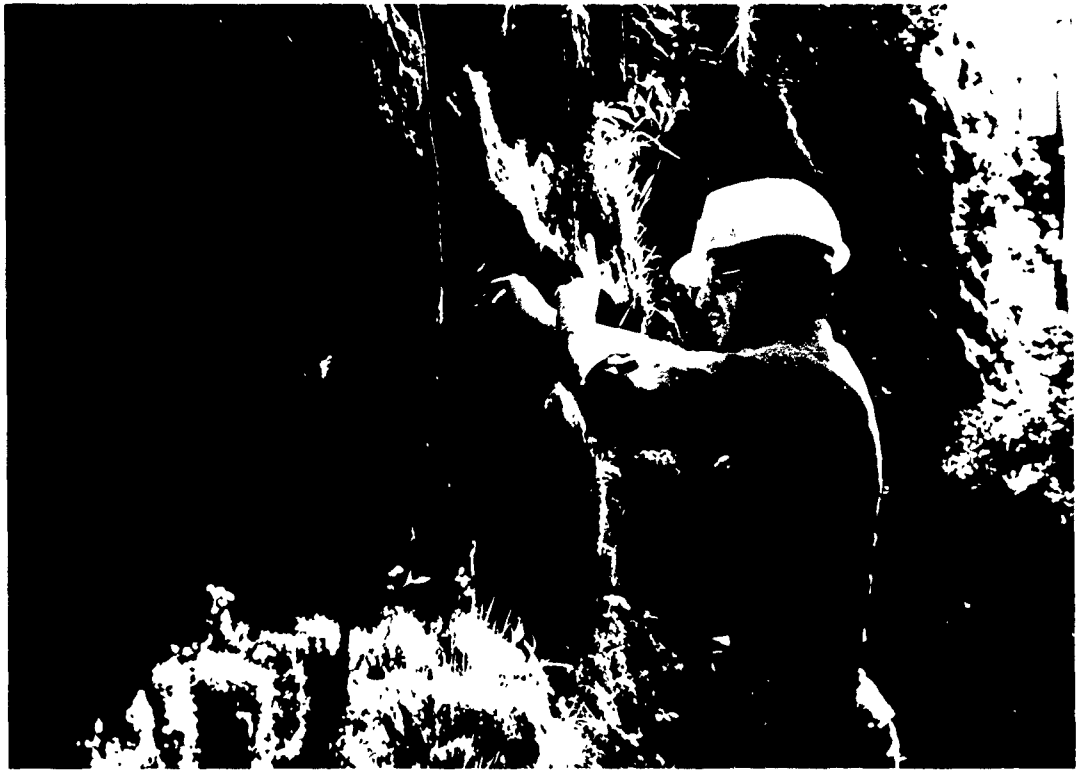
"Bulging" of the downstream face of the dam is clearly visible. There is a relative horizontal displacement between adjacent courses of stone of up to 5 inches. Most of the mortar between masonry blocks on the downstream face is missing, exposing openings between blocks up to 3 feet deep.

DOWNSTREAM FACE OF DAM, LOCATION A

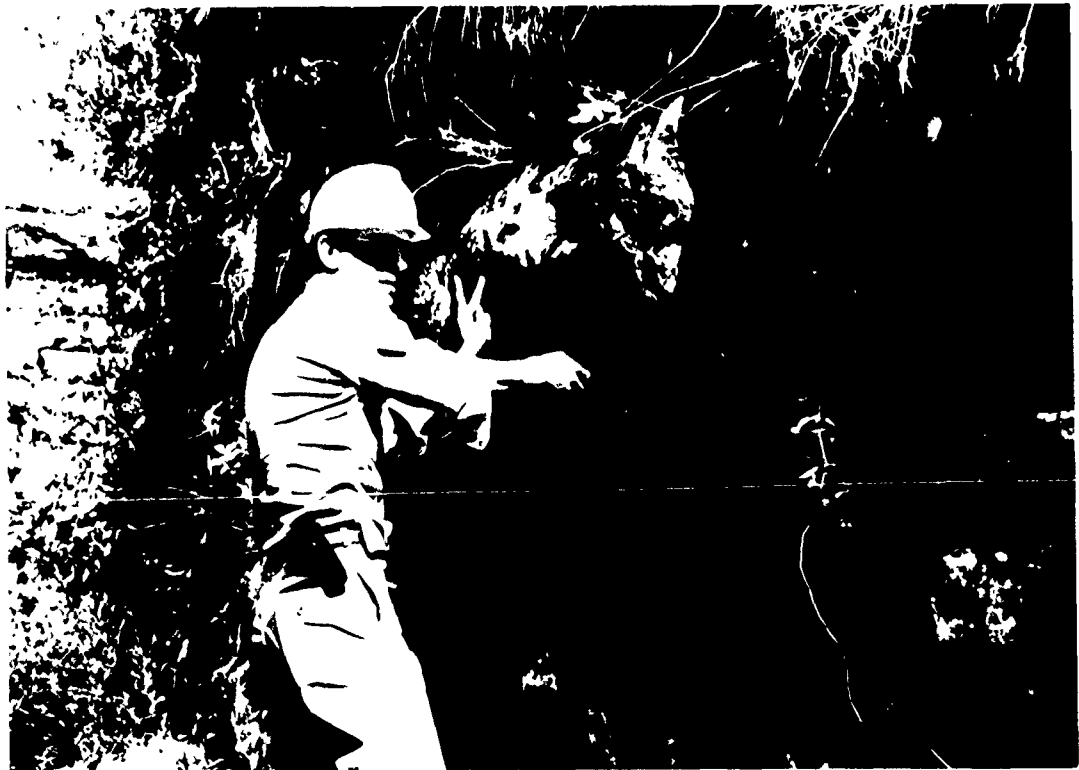
DOWNSTREAM FACE OF DAM, LOCATION B

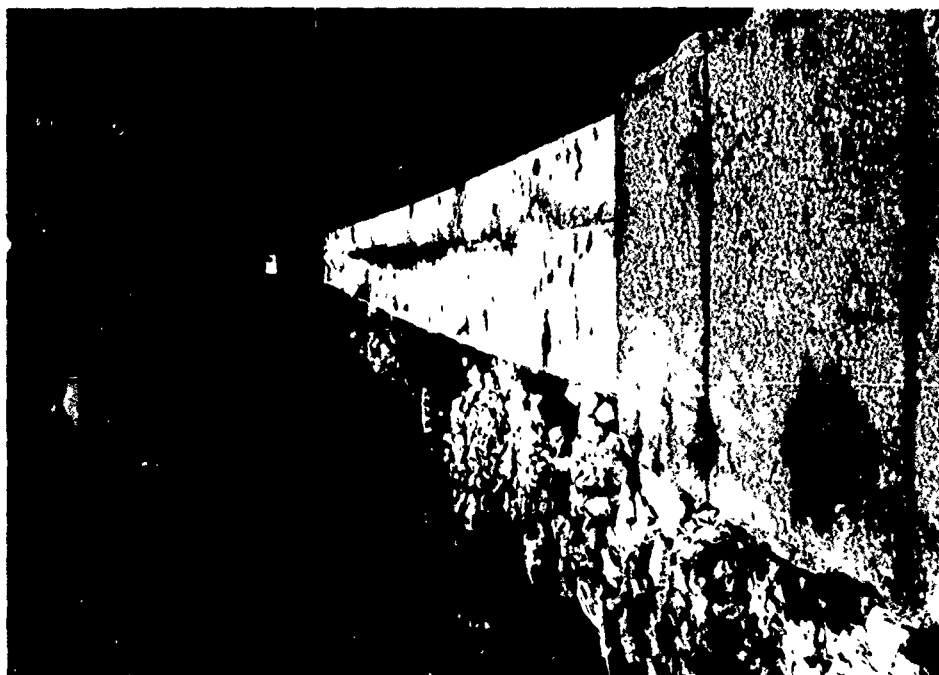
SHUTTER SHOWING DISPLACEMENT DOWNSTREAM
OF TOP COURSES OF STONE.

Max downstream (D/S) movement of downstream stones approximately 9"-10" occurs 135-140 ft west of East limit of spillway. Gap between U/S and D/S stones filled with mortar; stones were reported to be pinned in place after movement.

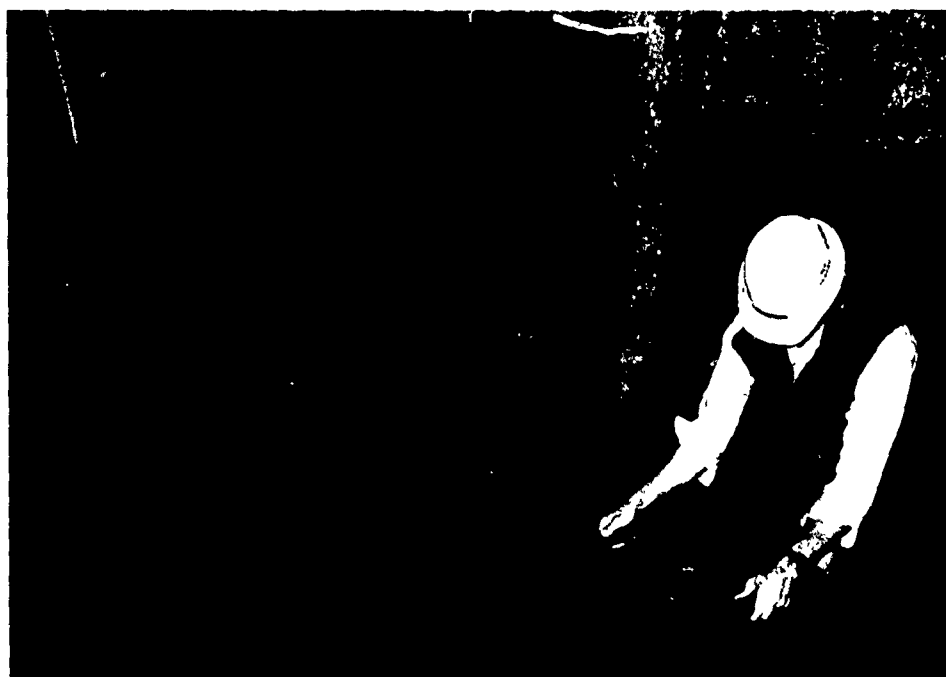
Close inspection of the valve stems indicated deterioration and metal loss at the lower threaded sections. The top threads appeared to be in good, lubricated condition. It was estimated that Valve Nos. 2 and 3 could not be opened more than three-quarters full, with Valve No. 1 being operable to a slightly greater extent. Should the valves be opened to these limits, however, it is questionable whether they could be reclosed because of the poor condition of the lower threads.

The valves in the gatehouse appear to be operable in opening to about three-quarters full. However, closing them subsequently may not be possible due to deteriorated threads on the lower part of the stem on each valve.

GATE VALVES IN GATE 10-31

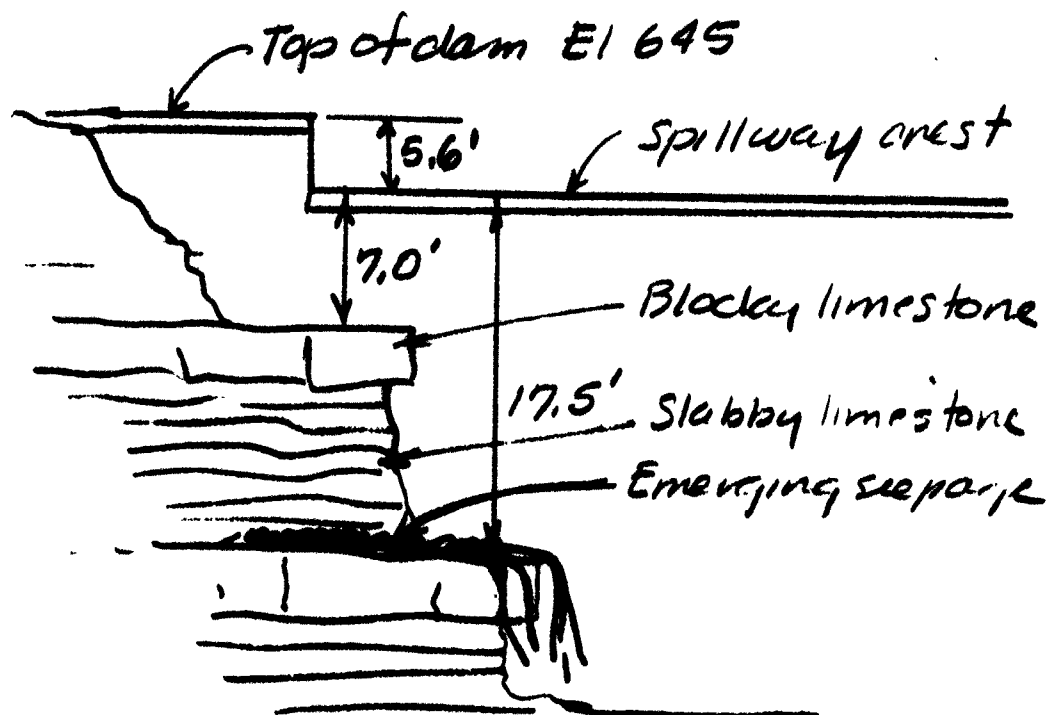
ELEVATION LOOKING UPSTREAM
AT EAST ABUTMENT

7. There is seepage emerging from the east abutment rock, immediately adjacent to the dam.
