# COUNTRY LAKES DAM NO. 3 NJ 00052

## PHASE 1 INSPECTION REPORT NATIONAL DAM SAFETY PROGRAM

Name of Dam: Country Lakes Number 3 Dam ID #NJ 00052  
State Located: New Jersey  
County Located: Burlington  
Stream: Cranberry Brook  
Coordinates: Latitude 39° 57'30" Longitude 74° 32'30"  
Date of Inspection: April 12, 1979

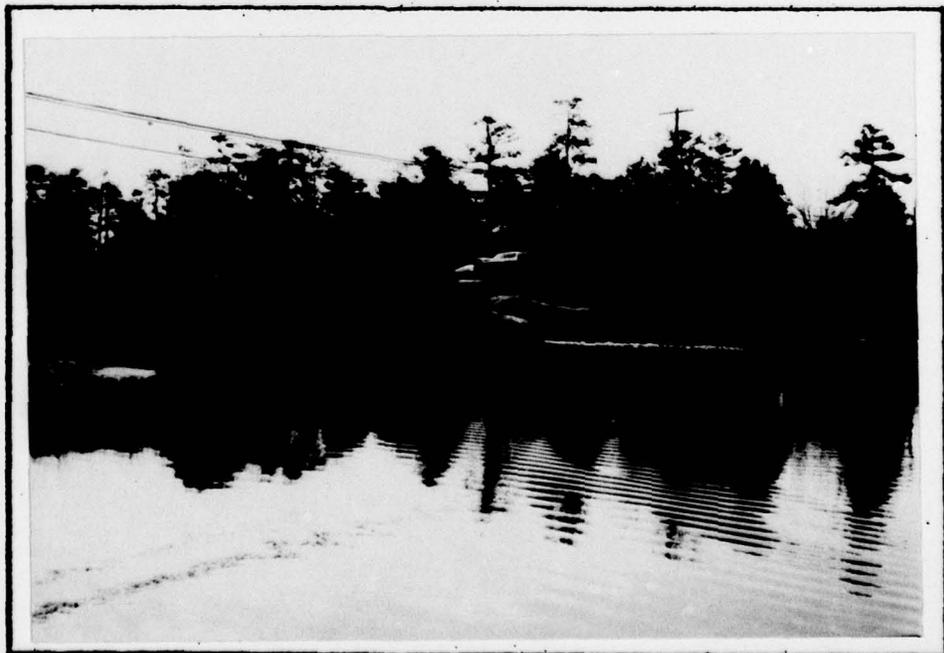
*DOWNSTREAM FACE OF THE DAM  
FROM THE RIGHT ABUTMENT 4/12/79*
