MISCELLANEOUS PAPER SL-79-18

NONDESTRUCTIVE TESTING OF CONCRETE T-WALLS, ATCHAFALAYA BASIN PROTECTION LEVEES, NEW ORLEANS DISTRICT

14 August 1979
Final Report

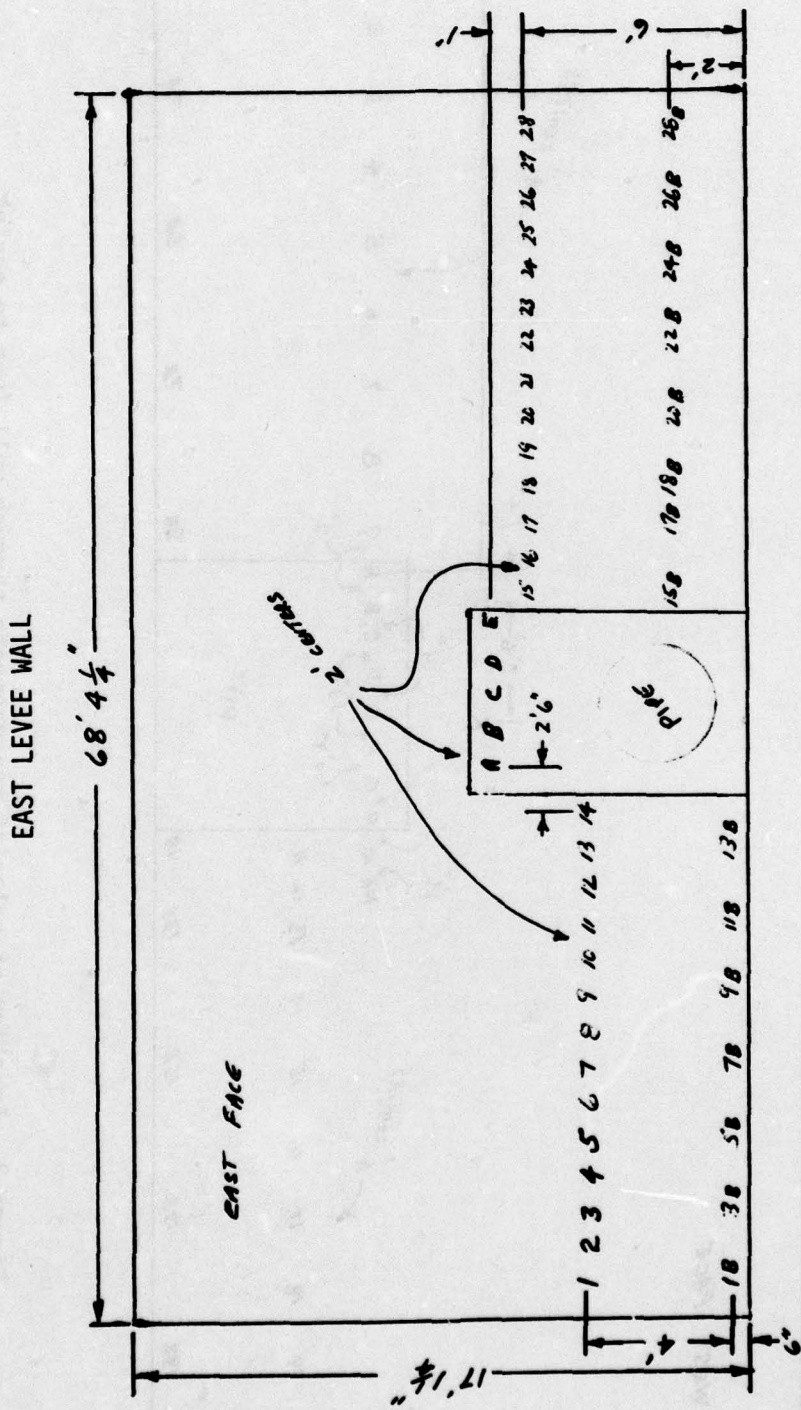
Figure 1. Location of velocity measurements through wall (not to scale)

4. Table 1 gives the results of the ultrasonic velocity measurements made through the T-wall on the east levee. Five groups of velocities are reported. Each group represents a series of measurements made through the wall at one elevation (see Figure 1). The distances through which each group of measurements was made are as follows:

Of the 28 measurements (groups 1 and 2) made through or near the visible seam, only station No. 25 produced a velocity that is indicative of concrete of questionable quality. The 15 measurements made along the base of the vertical wall (groups 3 and 4) were indicative of excellent quality concrete. Stations A through E (group 5) were located in an area where the wall surface was alleged to have been patched and smoothed with a neat cement grout (see Photo 2). Velocities obtained at these stations confirm the presence of inferior quality material. The mean velocity for group 5 is 13 percent lower than that of groups 1-4 collectively.

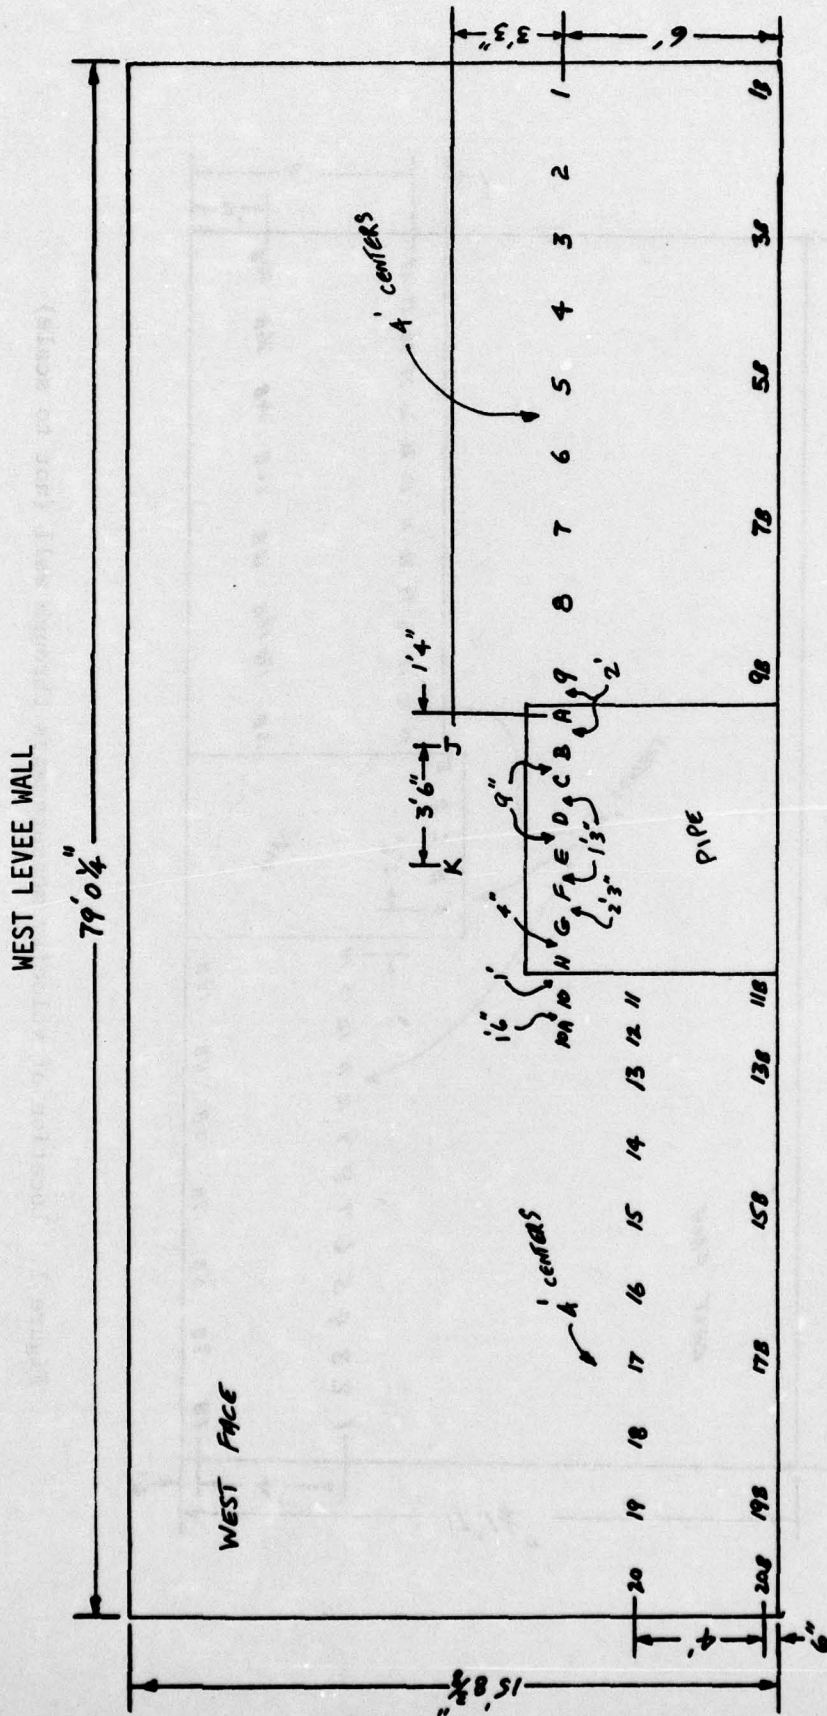
Figure 2. Location of velocity measurements through wall (not to scale)

5. Table 2 gives the results of velocity measurements made through the T-wall on the west protection levee. These velocities are reported in four groups with path lengths through the wall as follows:

Velocities obtained at stations 3, 11, and 15 of groups 1 and 2 indicate areas of inferior quality concrete located along the visible seam in the west wall. The 11 measurements made along the base of the vertical wall (group 3) produced 1 velocity (station 11B) which is considerably lower than the others. This anomaly goes without explanation except for the possibility of incomplete consolidation. It is noted that station 11, which is directly above station 11B, also produced a low velocity. It is also noted that stations 9B and 10 are very near the lowest velocities in their respective groups, although they are within one standard deviation of their respective group means. The point is that these stations are all very close to that section of concrete which houses the casing collar (see Photo 7 and Figure 2). The additional steel reinforcing and irregular form shape could have contributed to incomplete consolidation in this area. Stations A through K were established to provide data in the allegedly patched and smoothed-over area in the west wall (see Photo 3 and Figure 2). As in the east wall, the velocities obtained from this group of stations generally confirm the presence of inferior quality concrete. The mean velocity for group 4 is 15 percent lower than the mean of groups 1-3 collectively.

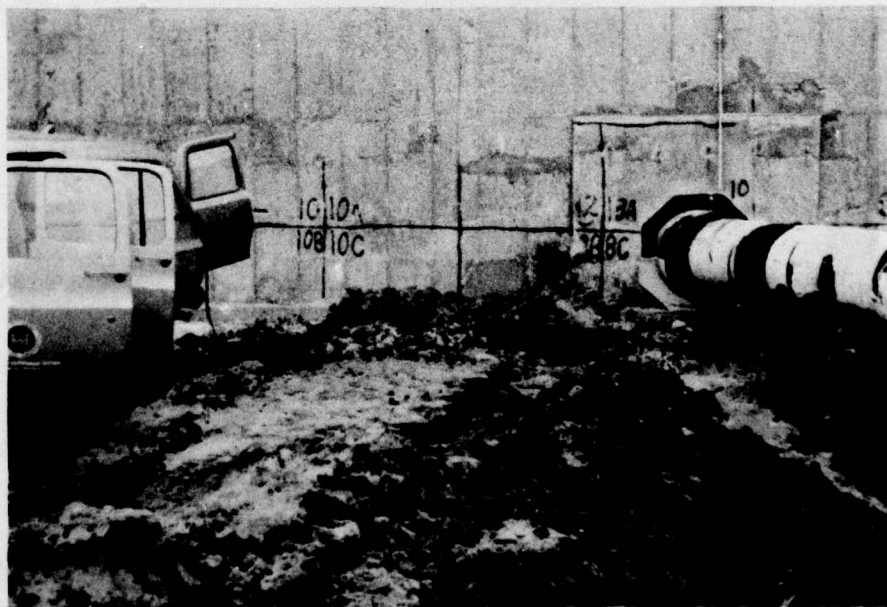
Photo 2. T-wall, east levee; note station numbers and letters on wall

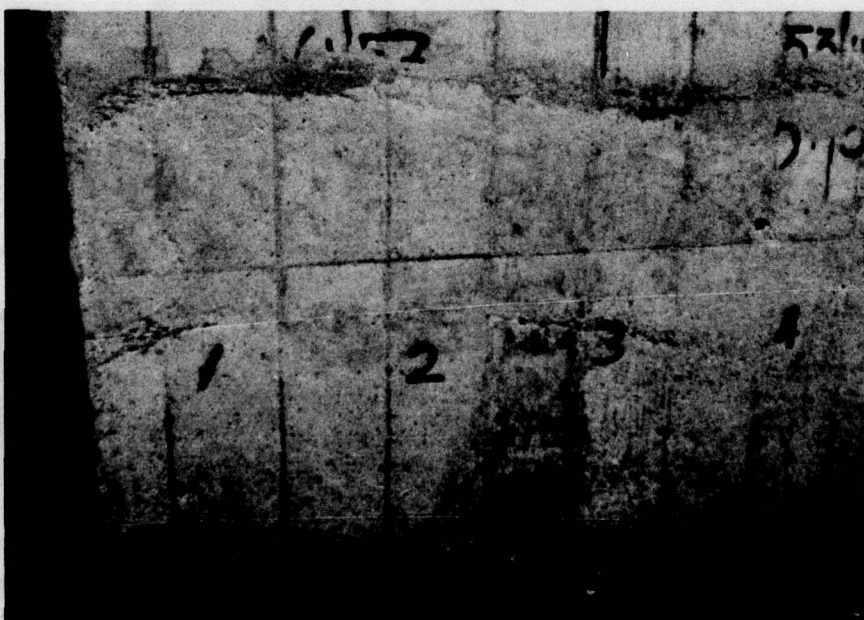
Photo 4. Flood side, west T-wall. Note seam
near station numbers

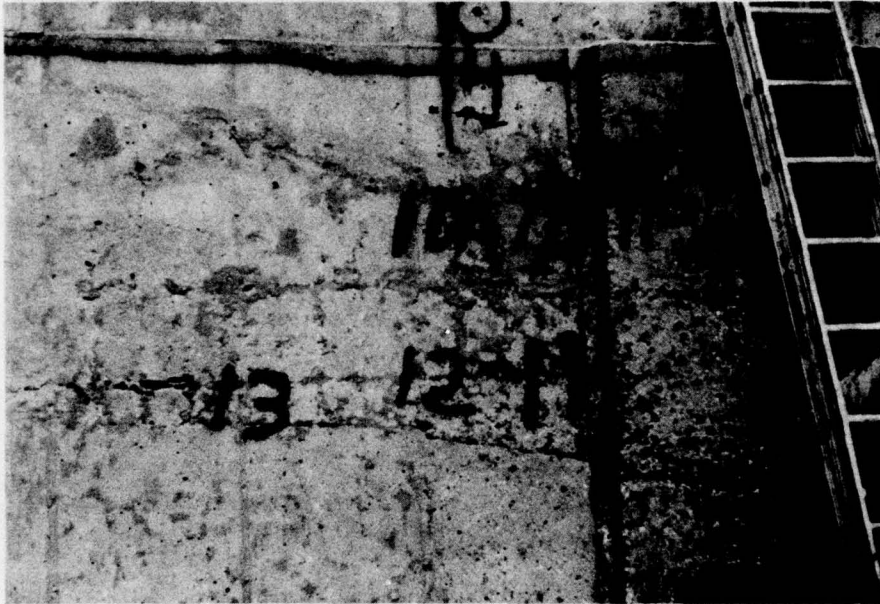
Photo 7. View showing the vertical section of concrete that houses the casing collar

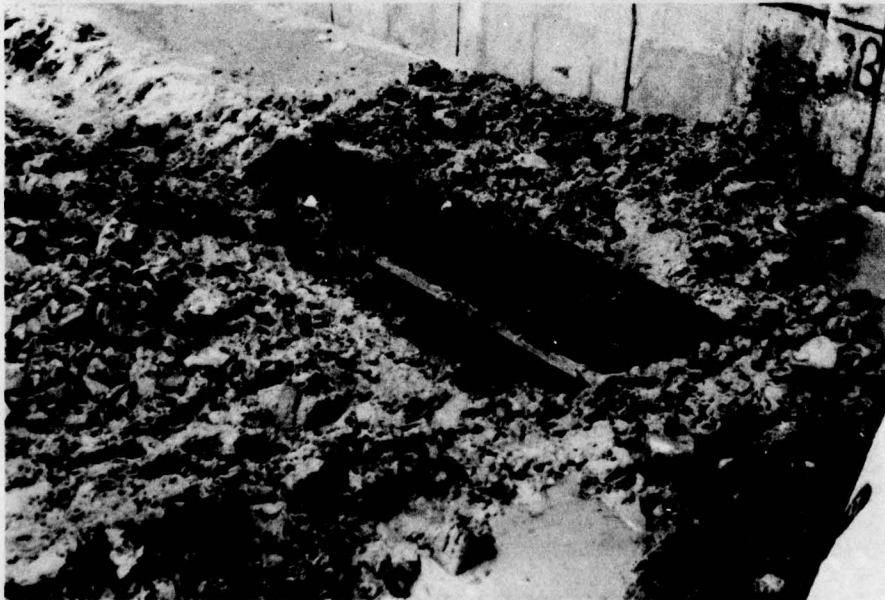
6. During the course of this investigation, the testing party learned that there was some concern on the part of NOD about the continuity of some of the prestressed concrete piles that were driven to serve as foundation for the T-wall structures. Two rows of piles were driven on 4-ft centers to depths of approximately 80 ft under each wall; 34 piles (14 by 14 in.) under the east wall and 40 piles (12 by 12 in.) under the west wall. Figure 3 shows a typical section through a wall. On 16 January 1979, with verbal authority from NOD, Messrs. Henry Thornton and Dan Wilson returned to the east protection wall and attempted to make determinations concerning the continuity of the foundation piles using the pulse-echo technique. This technique is in the developmental stage. It entails the introduction of an excitation pulse at the surface of a structure and receiving at the same surface reflections, or echoes, returning from boundaries within the structure. In this case the boundaries would be the end of the pile or cracks if any were present. Attempts to excite the piles through the 2.5-ft base slab were unsuccessful. Through the efforts of Messrs. Herb Juneau and Carl Rebouche, NOD, a small portion of a pile was exposed by excavating adjacent to the base slab (see Photo 8). This was done to facilitate actual contact with the pile in the hope that a shear mode measurement in direct contact with the pile would produce better results than the previous indirect (through the slab) longitudinal test. This was not the case. Although the efforts made in the excavation, and in the testing, were good, the small portion of pile exposed and the very close and undesirable working conditions made it very difficult to perform the test properly. Little confidence, if any, was generated for this method of testing in this particular application, and an oral report was made, as such, to NOD. The desire for information on the condition of the piles and the fact that the shear mode pulse-echo tests had been made under undesirable conditions prompted a request by NOD to reevaluate the applicability of the shear mode test if it could be done under more favorable conditions, i.e., more extensive excavation with more pile area exposed. On receiving this request, a decision was made to do calibration tests

Photo 8. Portion of pile exposed by excavation

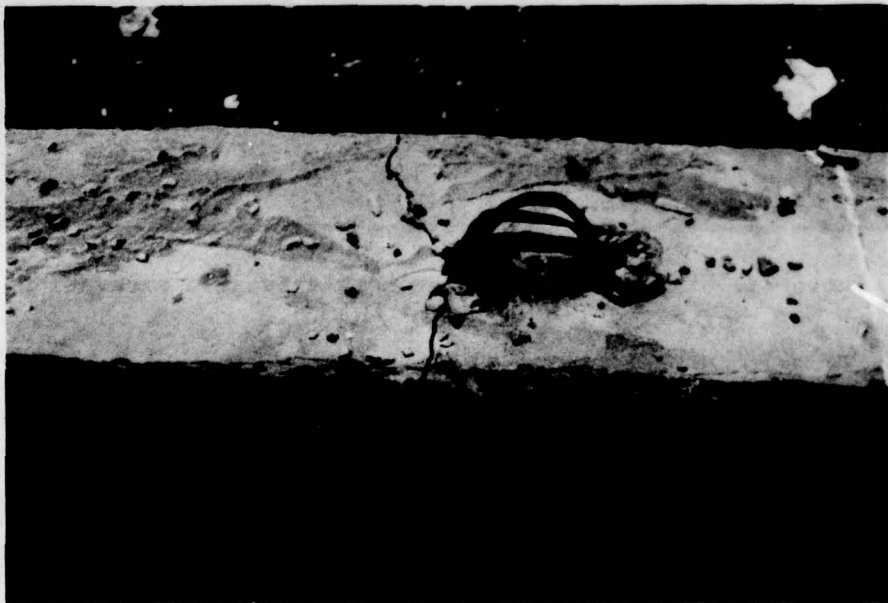
on companion piles which had not been driven. On 23 January 1979 Messrs. Henry Thornton and Michel Alexander travelled to the precast pile yard of Marine Concrete Structures, Inc., Metairie, La. Both shear mode and longitudinal mode pulse-echo measurements were made on cracked and uncracked piles. No difficulty was encountered in the measurements. Both shear and longitudinal echoes were received from the ends of the piles, and from the crack in the pile (see Photos 9 and 10). The results of these tests were considered to be excellent. With these results, and with expectations of having better access to the driven piles at the site, it was decided that there was at least an even chance for success. On 21 February 1979 Messrs. Thornton and Alexander returned to the east wall. More extensive excavation had been performed, but the exposed portions of the piles were still small (see Photo 11). After 2 days of intensive, exhaustive testing with no success the work was terminated. It was concluded that the damping factors of the surrounding soil and the 2.5-ft concrete cap were so high that the pile could not respond to the exciting impulse in either mode of test. An impulse of much higher energy than that available at the time would be required to excite piles in such an environment.

Photo 10. View showing cracked pile

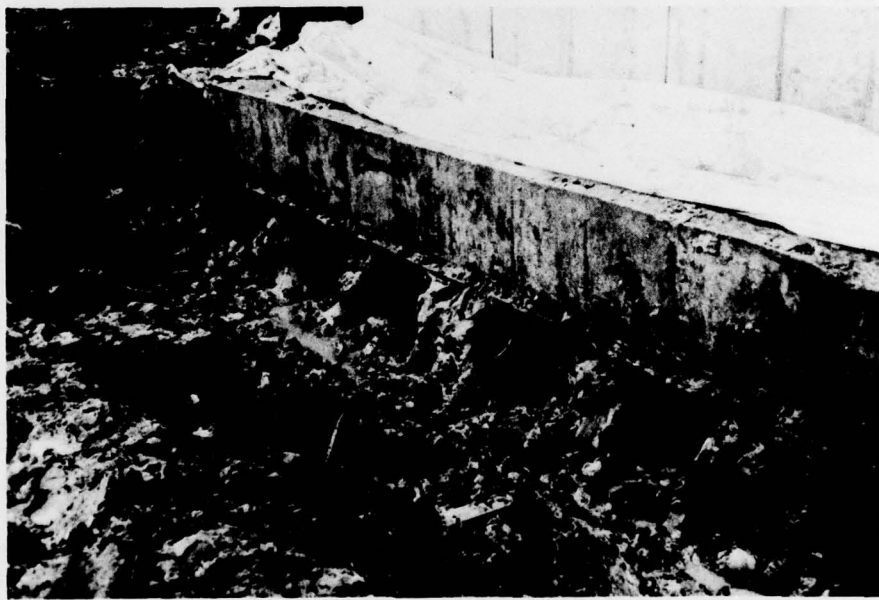
Photo 11. Exposed piles after more extensive excavation
