RARITAN RIVER BASIN
MANALAPAN BROOK, MONMOUTH COUNTY
NEW JERSEY

MILLHURST LAKE DAM NJ 00296

PHASE 1 INSPECTION REPORT NATIONAL DAM SAFETY PROGRAM.

Millhurst Lake Dam, NJ-00296.
Raritan River Basin, Manalapan Brook,
Monmouth County, New Jersey.
Phase I Inspection Report.

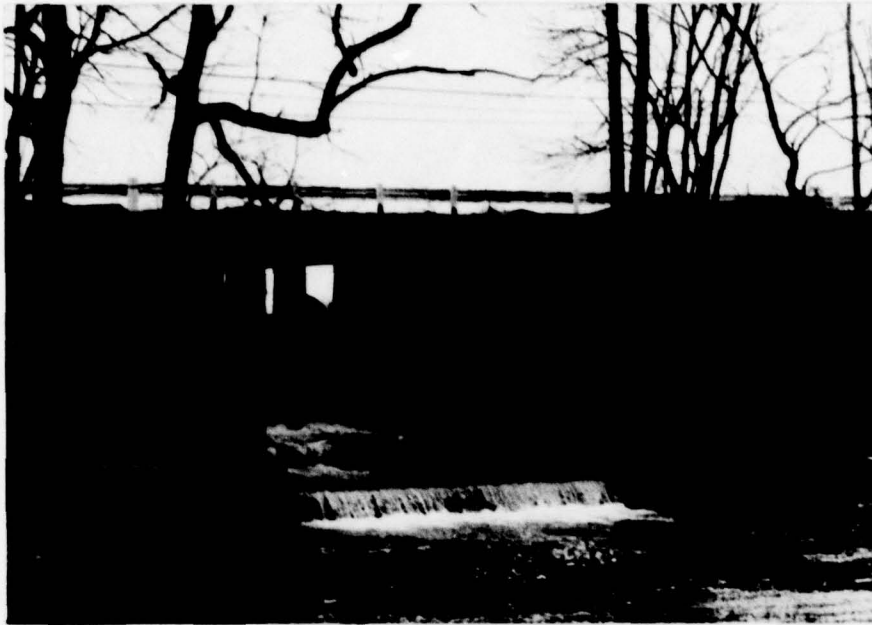
Settlement cracks in the wingwalls, the steepness of the embankment slopes, surface cracks in the road and tilting of the timber bulkhead would all indicate that a slow progressive failure is taking place.

Photo No. 1 - Overall view of spillway, apron and bridge structure from downstream. Note the cracking and undermining of the wingwalls.

3. Provide concrete underpinning at the toe of the wingwalls, and replace the missing masonry wall with concrete. This work to be commenced within six months.

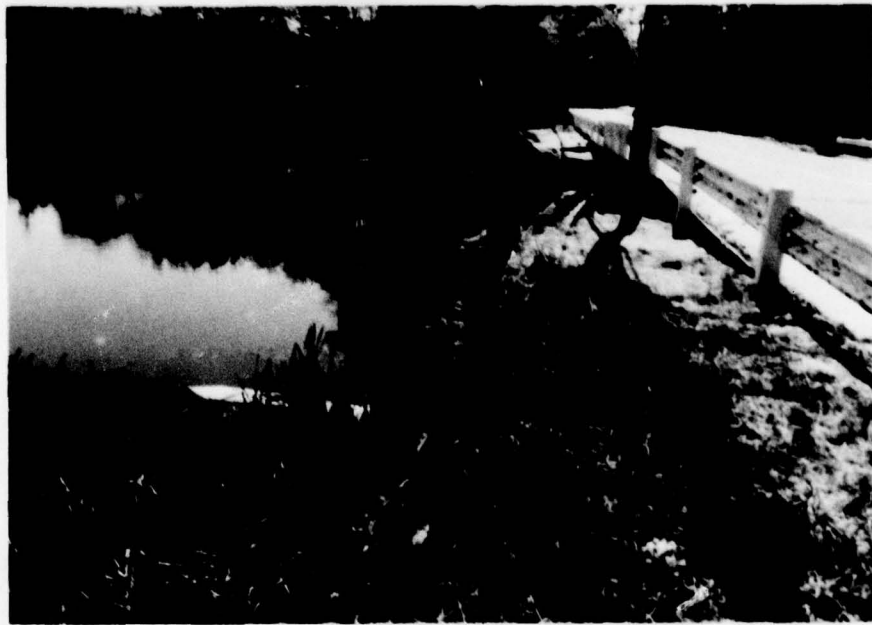
The debris interceptor of timber piles is functioning adequately. Some of the bracing between piles has been lost. The interceptor is necessary to keep floating trees and other large debris from blocking the spillway. Since the debris are forced to the side of the channel, leaving the interceptor clear, it appears reasonable to ignore any impedance of flow caused by it.

Photo No. 2 - Overall view of upstream face of dam. Note the debris interceptor upstream of the spillway.

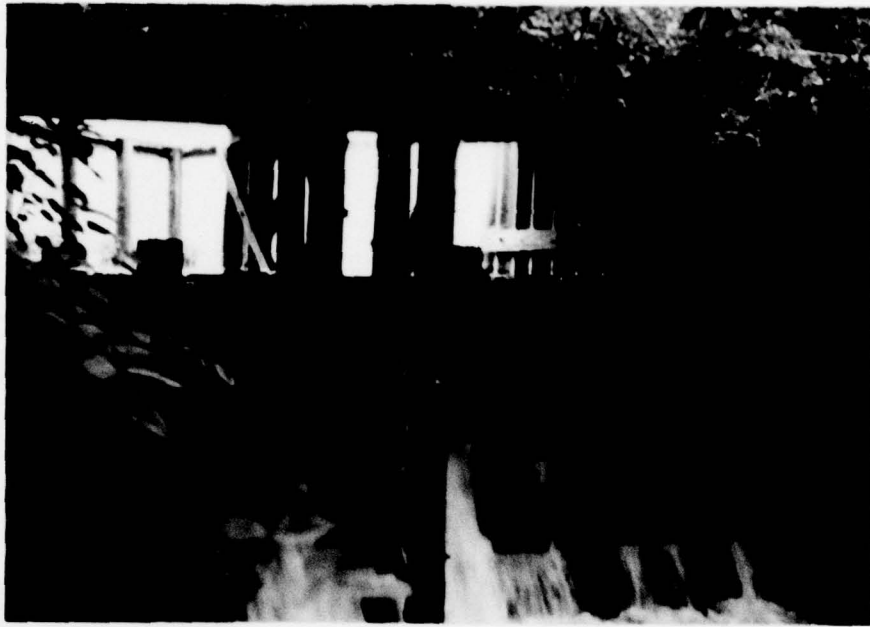
The stop-plank structure also serves as a low-level outlet. Removal of planks would be difficult and dangerous with the existing flow of water over the spillway. The structure appears sound and no leaks were noted between planks.

Photo No. 3 - View of concrete ogee weirs with a double stop-plank gate in the center. Note the timber bridge support and the timber bridge deck.

2. A safe means of lowering the lake should be provided. This would involve restoring the existing penstock to operable condition or providing suitable apparatus for safely removing the stop-planks. This work should commence within 12 months.

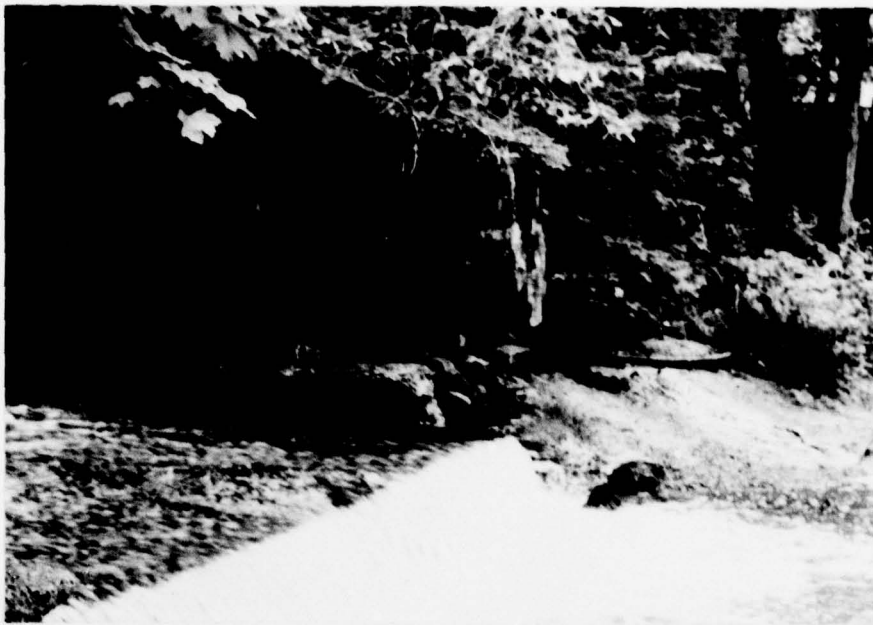
The only notable seepage from the downstream face was from the embankment toe within 5 feet of the left abutment. Tree and brush growth on this face is heavy and the root system appears to be stabilizing the fill. Settlement of the embankment is evident. The horizontal alignment of the road indicates that it now slopes away from the bridge deck on both sides: it is assumed that when the road was realigned, its elevation was the same as the bridge deck. It was not possible to determine visually if the embankment has been built with a corewall. No evidence of burrowing by animals was found.

Photo No. 5 - View of left wingwall, showing seepage at the toe of the embankment. The wingwall has been undermined and the concrete repair is also deteriorated. Tree roots are promoting deterioration.

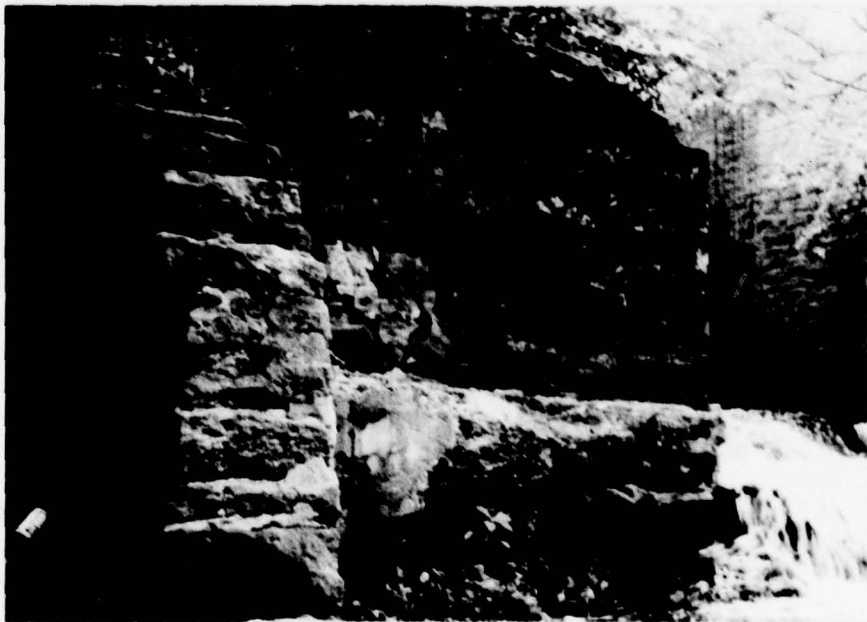
Photo No. 6 - Detail of toe of right wingwall showing severe settlement cracks and undermining.

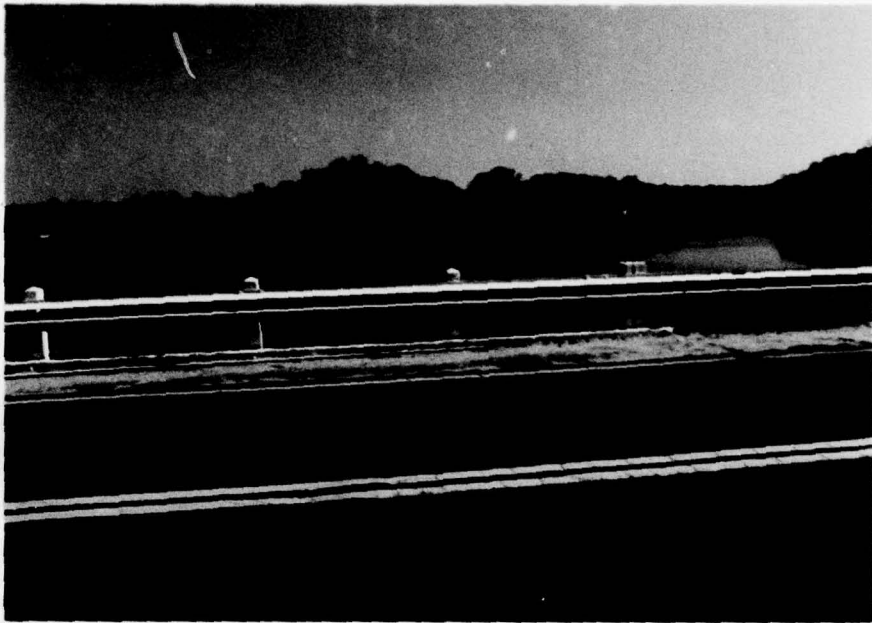
Photo No. 9 - General view of Millhurst Lake looking upstream. Note the moderate, wooded slopes and the accumulation of silt and weed at the rim.
