TECHNICAL REPORT GL-79-14

SUSCEPTIBILITY OF DISPERSIVE CLAY AT GRENADA DAM, MISSISSIPPI, TO PIPING AND RAINFALL EROSION

Edward B. Perry

September 1979

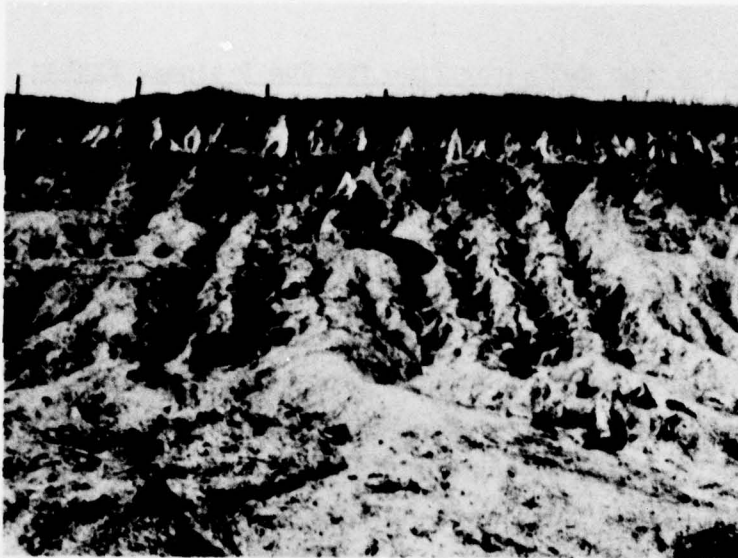
10. In May 1960, about 11 years after the completion of the main portion of the embankment, erosion patterns were documented in the excavated slope of borrow area DS (Figure 6). This erosion pattern has been reported subsequently in excavated slopes of dispersive clay in Mississippi (see Reference 14, Figure 7).

a. General view of slope showing rills

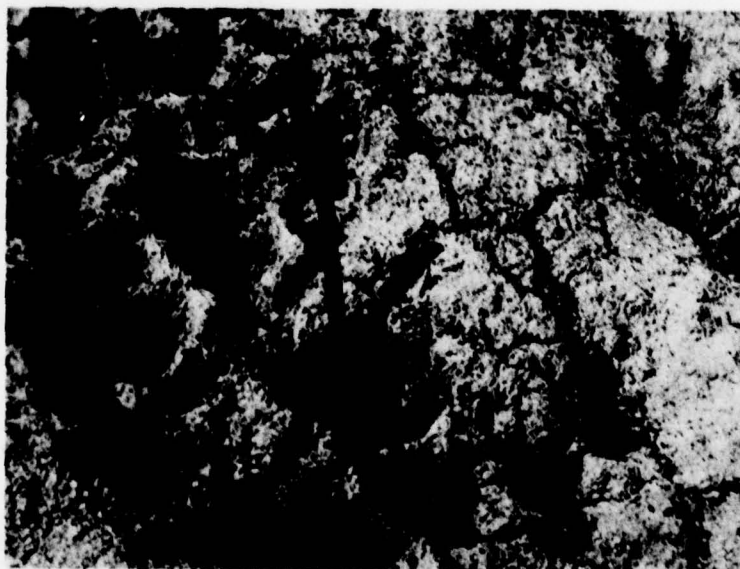
b. Close-up view of slope showing vertical erosion tunnels and surface cracking resembling a karst topography

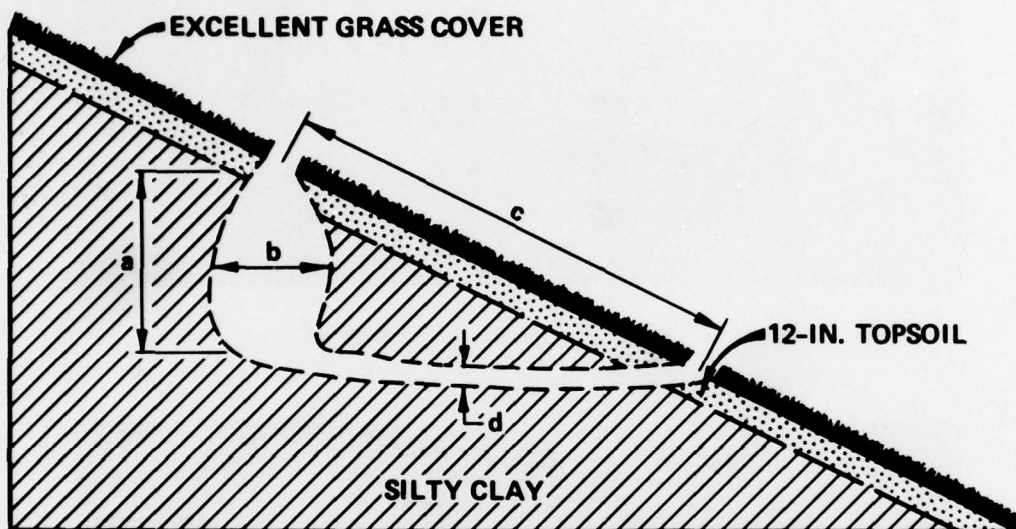
Figure 10. Schematic details of rainfall erosion tunnel in downstream slope (after References 13 and 18)

DIMENSIONS, FT		
	MINIMUM	AVERAGE	MAXIMUM
a.	1	4	7
b.	1	3	5
c.	2	6	25
d.	0.5	1	3

18. The rainfall erosion tunnels are initiated when shrinkage cracks, as much as 1 in. wide at the ground surface and tapering to zero at a maximum depth of 7 ft, are formed during periods of low rainfall and high evaporation. At Grenada, Mississippi, from May through October the mean precipitation is about 19 in. while the mean pan evaporation is about 39 in.²⁰ The type and amount of vegetation influence the amount of water lost through evapotranspiration, size and number of shrinkage cracks, and rainfall infiltration. Surface water from rainfall runoff enters the cracks and erodes the soil (carries away the dispersed fines) before the cracks can swell and close. The cracks generally run together on the surface of the slope in a dendritic pattern, like the branches of a tree, to form progressively larger cracks as the surface water moves down the slope. Eventually the vertical portion of the rainfall erosion tunnel becomes so large that the overlying soil collapses into the cavity. Although the development of the rainfall erosion tunnels with time was not investigated, it has been suggested that the cave-ins develop over a period of several years.²¹ During the excavation of rainfall erosion tunnels in 1954, a rather large and unusual surface crack pattern was found. A similar erosion pattern was discovered about six years later (about 11 years after completion of the main portion of the embankment) in the excavated slope of borrow area DS (Figure 6). Although the dam was not damaged structurally by the rainfall erosion tunnels, which were limited to a depth of about 7 ft, the cave-ins were unsightly, some man-holes along the collector pipe (prior to its replacement in 1961) were

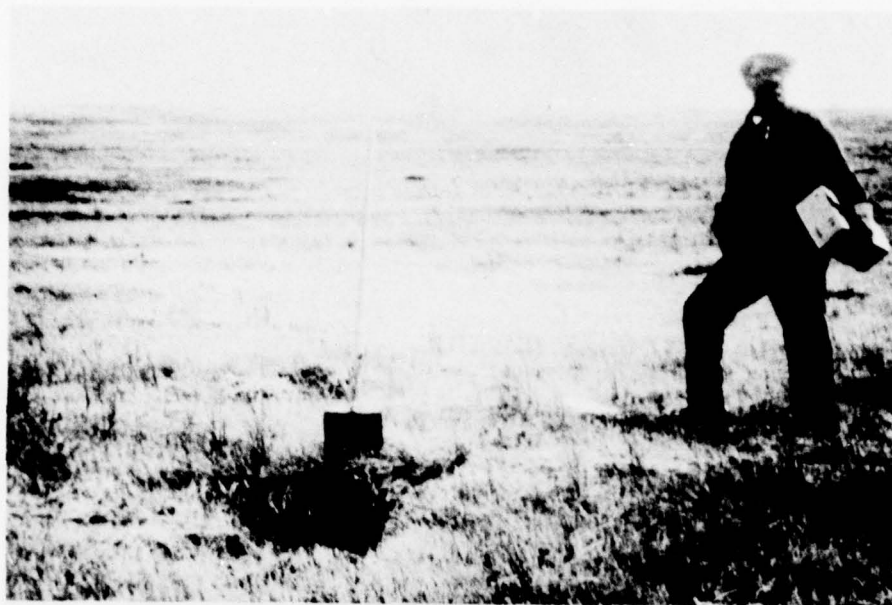
a. View upstream toward crest

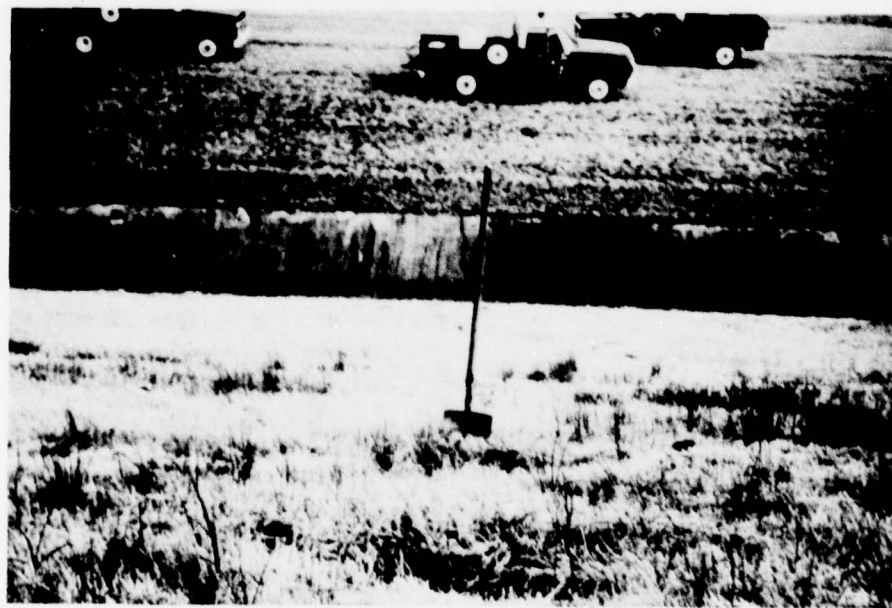
b. View downstream toward collector ditch

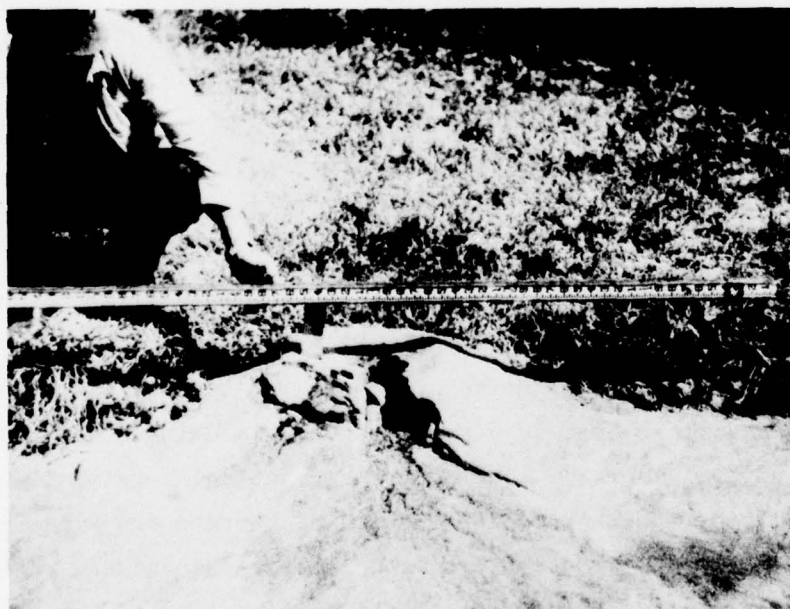
b. View upstream showing mound of eroded soil at tunnel exit

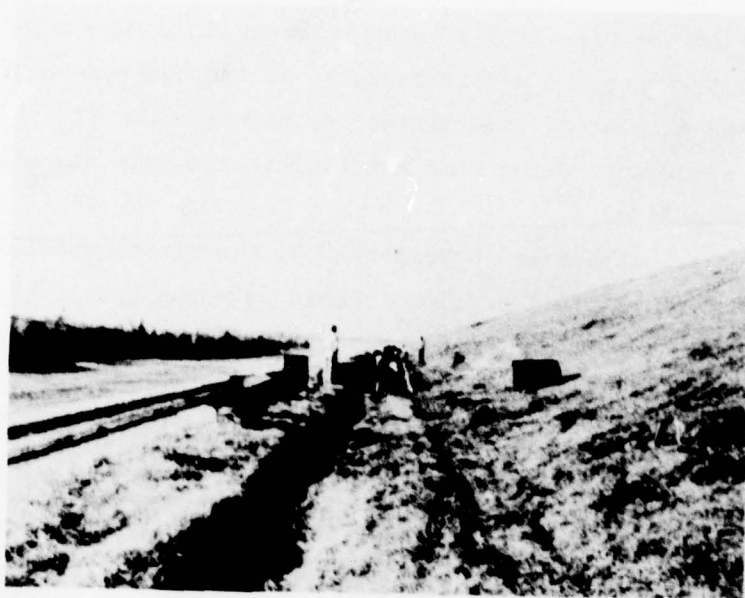
a. Excavation and forming work on berm ditch

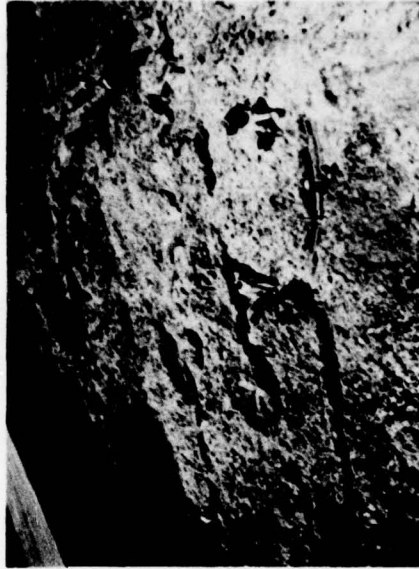
d. Excavating rainfall erosion tunnels sta 107+00, 20 March 1956

undermined, and the stability of some concrete drop inlets located on the berm was threatened. Repair measures to the downstream slopes consisted of hand excavating the rainfall erosion tunnels (later bulldozers were used), recompacting the same material in the channels with power tampers, and sodding.^{3,18}

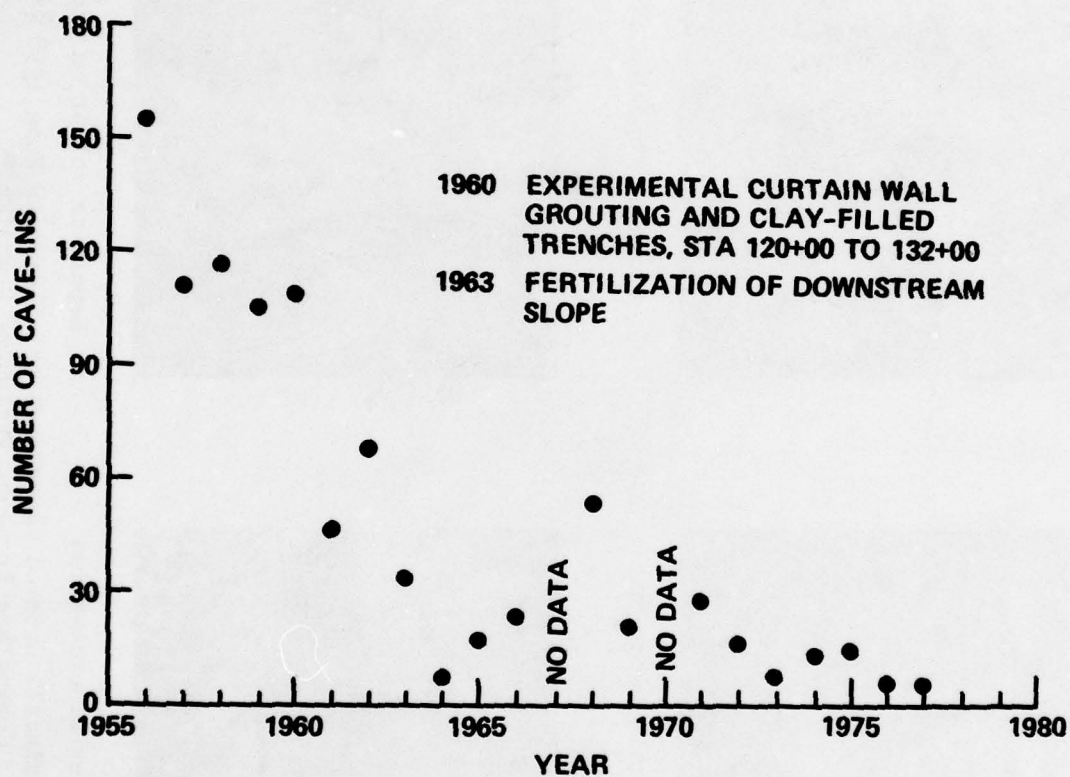
Figure 19. Number of cave-ins, 1956-1977 (from References 13, 36-44)

22. Beginning with the year 1956 records are available, as indicated in Table 3 and shown in Figure 19, for the number and locations of cave-ins on the downstream slopes of the dam. The cave-ins were about equally distributed over the upper, middle, and lower downstream slopes with the greatest intensity occurring in the valley section between sta 105+00 and 145+00. Over 100 cave-ins per year are recorded for the period 1956 to 1960. Figures 20 and 21 show repair of rainfall erosion tunnels in the vicinity of concrete slope drain pipes and drop inlets in June 1958 and March 1960, respectively. Figure 22 shows excavated rainfall erosion tunnels prior to backfilling.

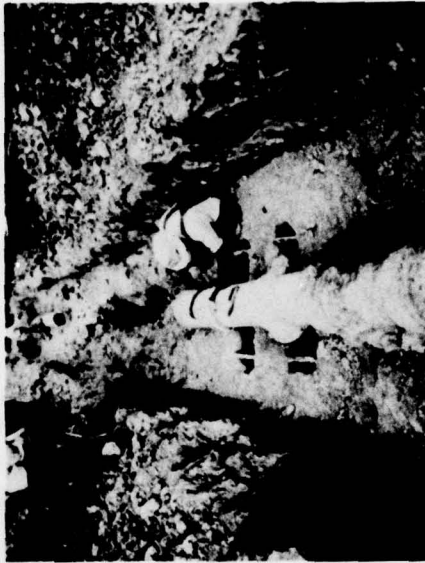
d. Repairing collar on slope drain pipe
 Figure 20. Repairing rainfall erosion tunnels at sta 118+00, 9 June 1958 (from File 1514-02
 Subsurface Erosion, Vicksburg District)
