ULTRASONIC DETECTION OF SURFACE FLAWS IN GAS TURBINE CERAMICS.(U)

4. TITLE (and Subtitle) ULTRASONIC DETECTION OF SURFACE FLAWS IN GAS TURBINE CERAMICS		5. TYPE OF REPORT & PERIOD COVERED Final Technical Report	13. Sep 77-12 hlc 76

6. AUTHOR(s) Thomas/Derkacs Istvan M. Matay		7. PERFORMING ORG. REPORT NUMBER TRW-ER-7986-F	
8. PERFORMING ORGANIZATION NAME AND ADDRESS TRW Inc. 23555 Euclid Avenue Cleveland, OH 44117		9. CONTRACT OR GRANT NUMBER(s) (15) N62269-77-C-0136

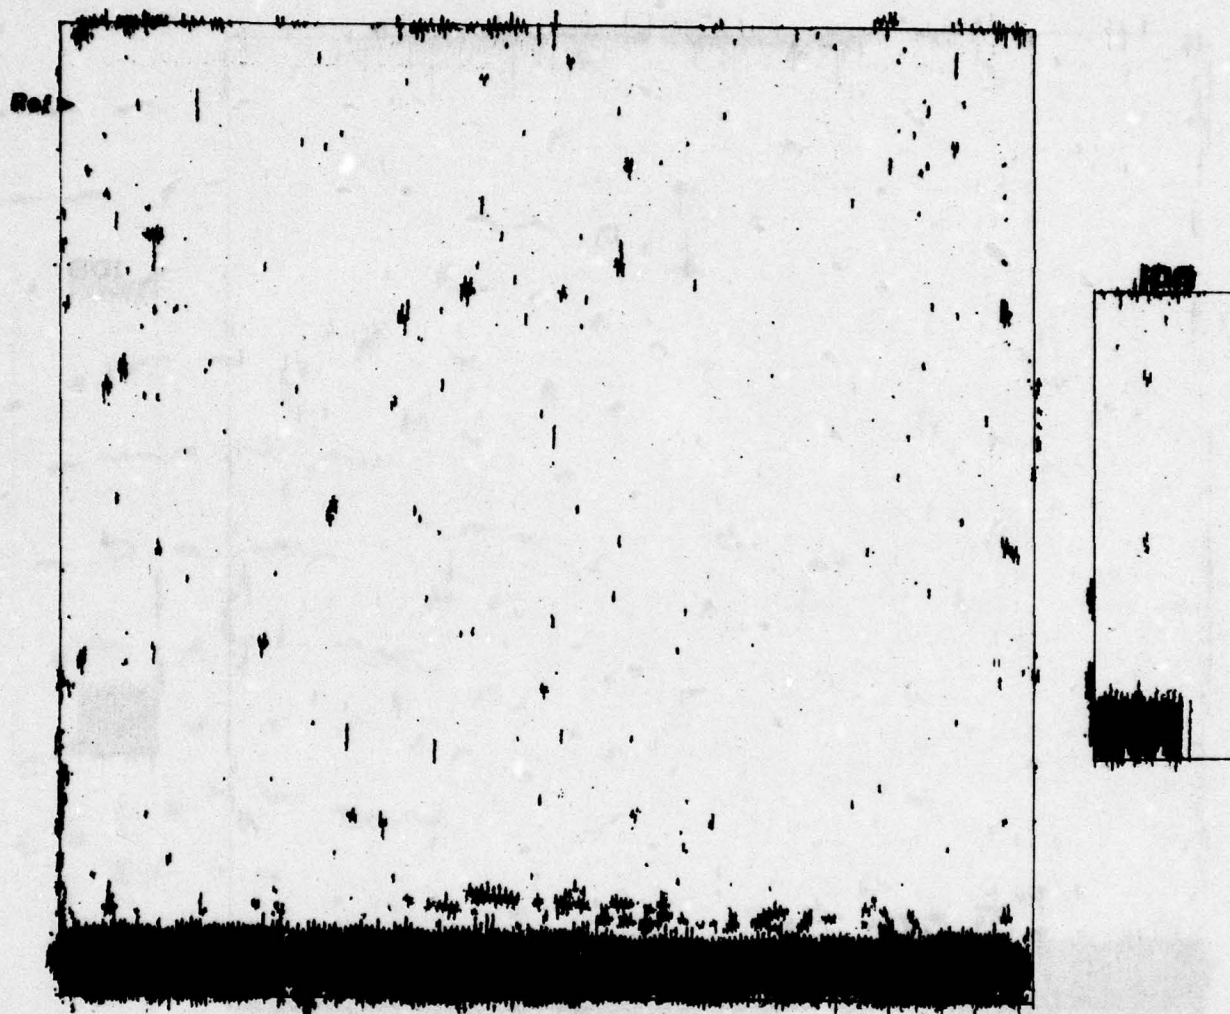
The C-scan recordings of the 45 MHz shear wave inspections of the billet of Ceralloy 147A are shown in Figures 12 through 15. As with previous samples of this material, these scans show a large number of defect indications. Figures 16 through 19 show the corresponding surface wave inspections. These scans also show large numbers of indications. The two types of scans were compared by means of transparencies. Since the shear wave inspection is performed from the opposite side of the surface than the surface wave inspection, the transparency of the shear wave C-scan is turned over on the surface wave C-scan so that the reference notches coincide. This type of comparison revealed that only a few of the defect indications correspond between the two types of scans. Most of the defects detected by the surface wave technique were not detected by the shear wave technique.

Figure 12. C-scan Recording of 45 MHz, 11° Shear Wave Inspection of Billet of Ceralloy 147A Hot Pressed Silicon Nitride (Notch Down).

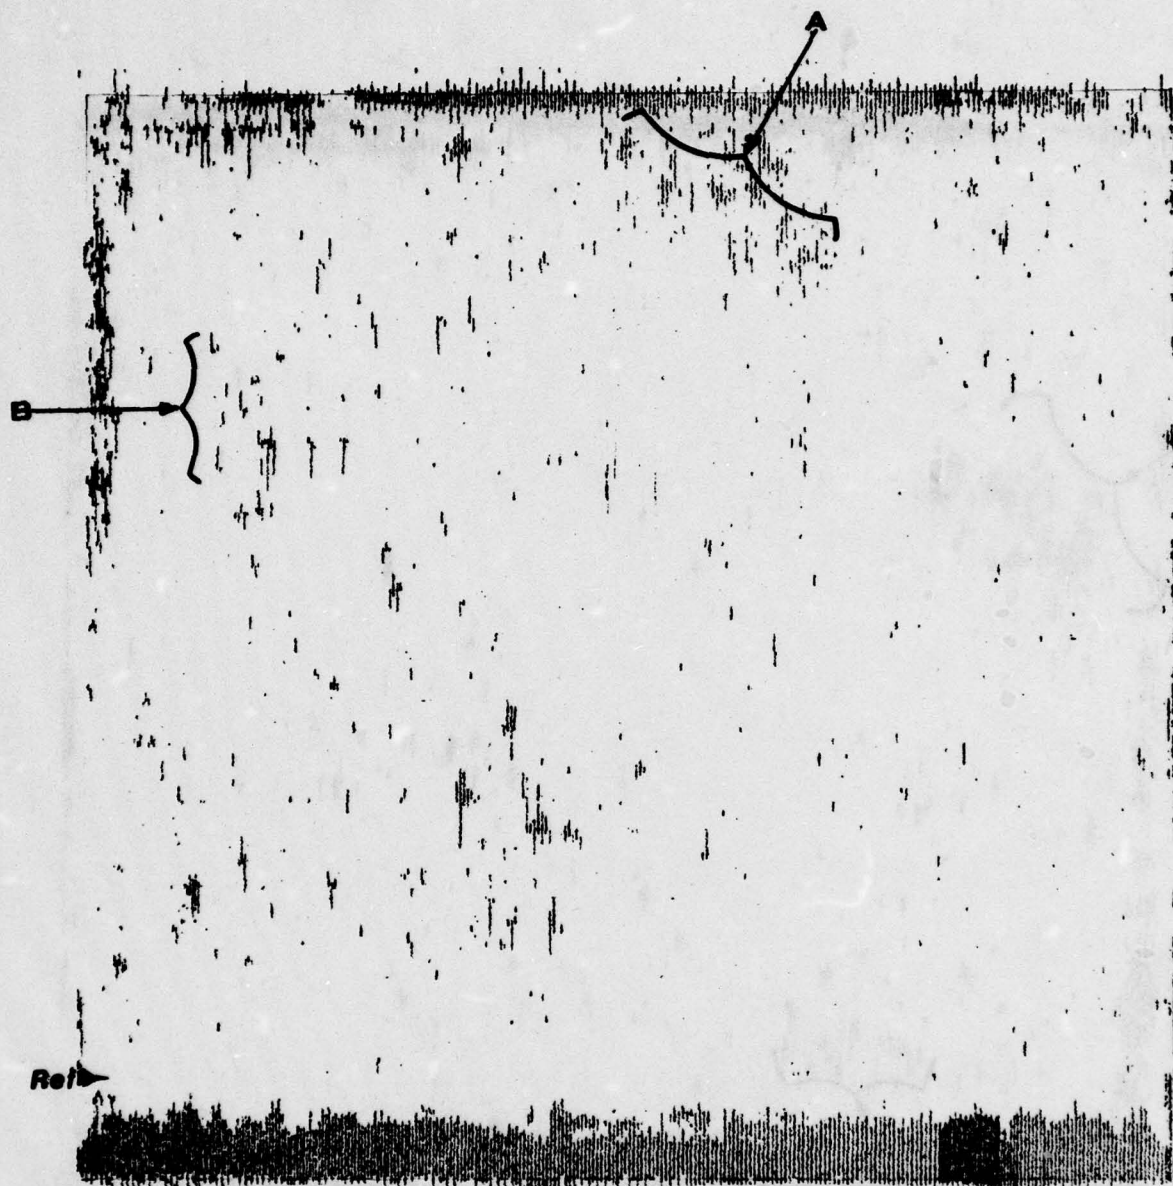
Figure 16. C-scan Recording of 45 MHz, 18° Surface Wave Inspection of Billet of Ceralloy 147A Hot Pressed Silicon Nitride (Notch Up).

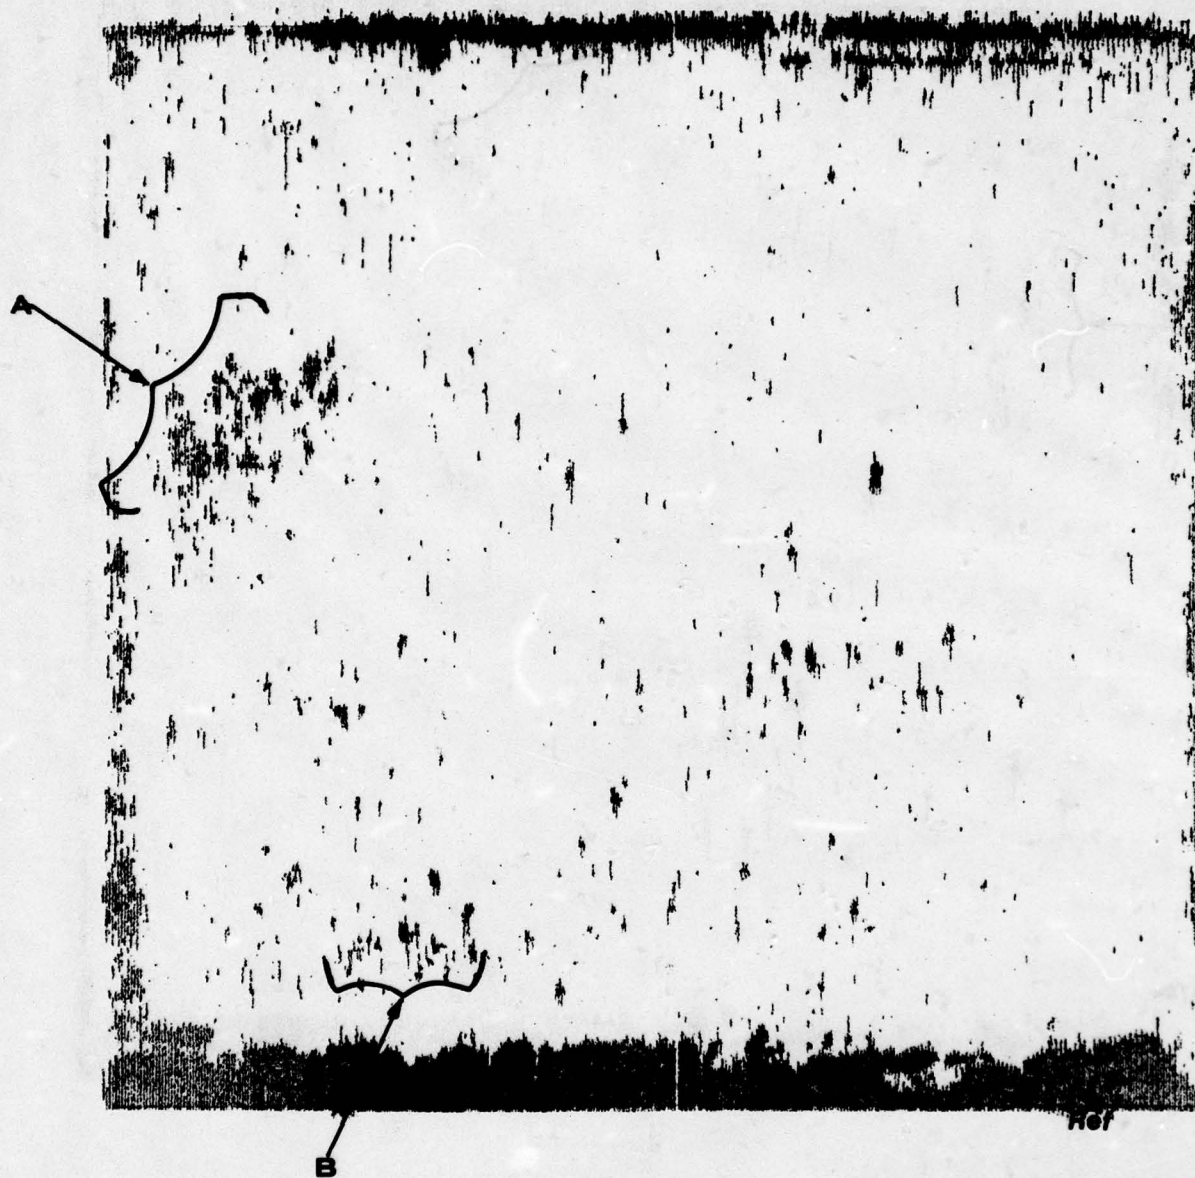
Figure 17. C-scan Recording of 45 MHz, 18° Surface Wave Inspection of Billet of Ceralloy 147A Hot Pressed Silicon Nitride (Rotated 90° , Notch Up).

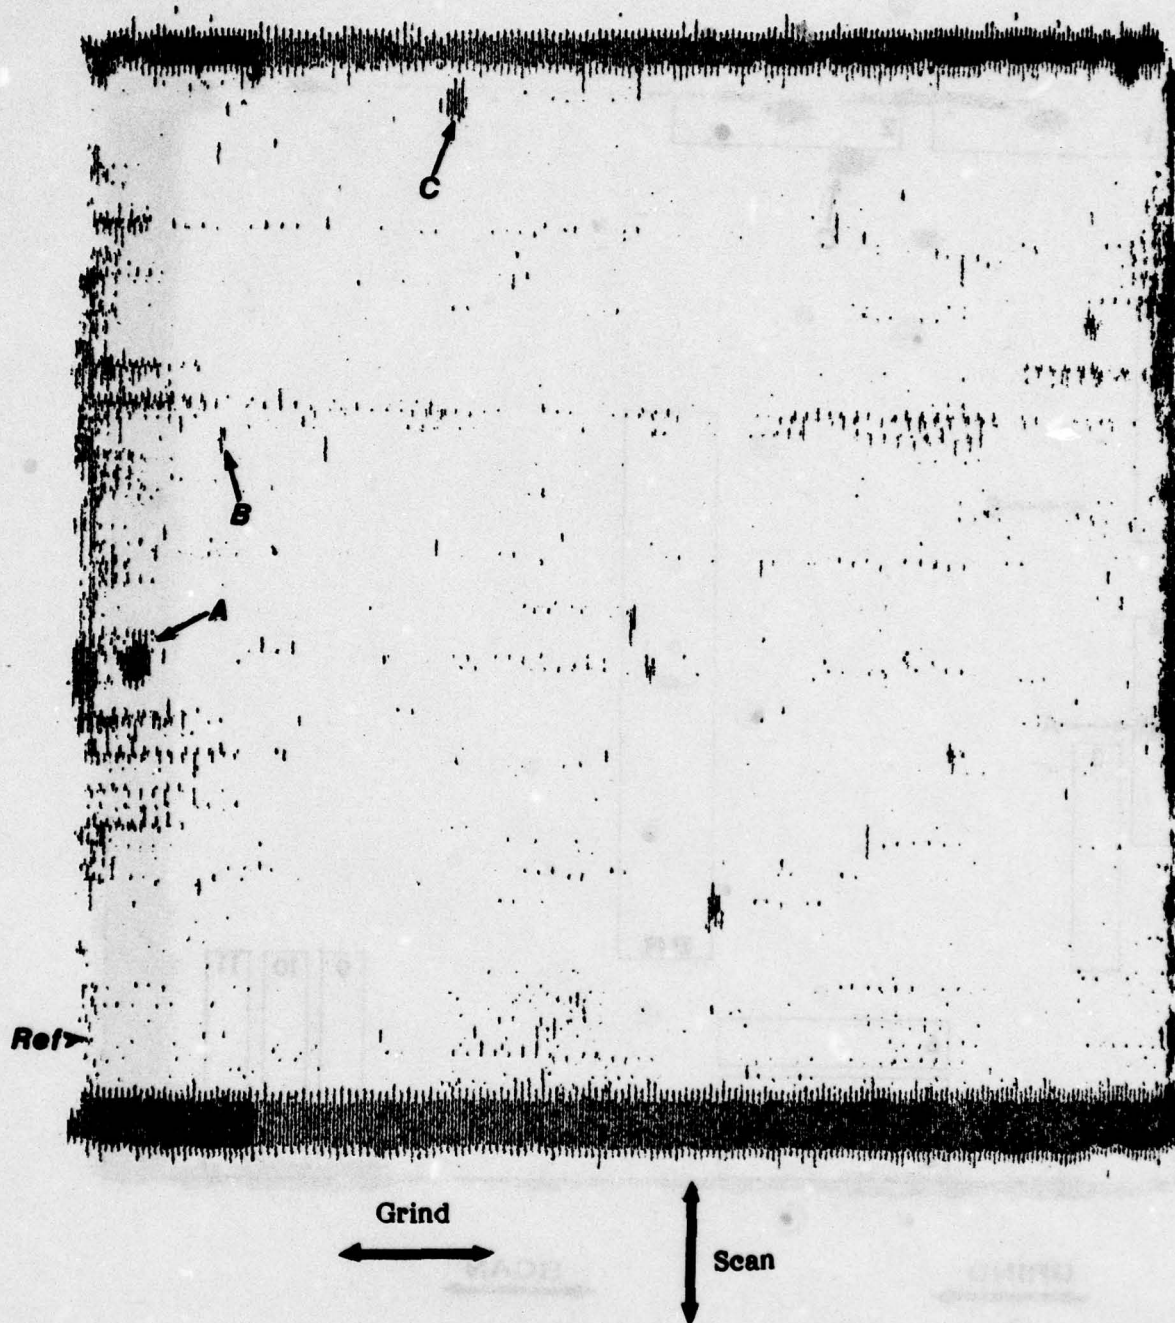
This billet was subsequently machined to a 20 microinch surface using a 320 grit diamond wheel running perpendicular to the side containing the reference notch. Approximately 1000 μm (0.040 inches) were removed from the total billet thickness to provide a smooth surface on both sides. Figures 21 through 24 show C-scan recordings of 45 MHz surface wave inspections made on both sides at two orientations 90° apart after machining. These inspection results show a few scattered surface defects, as well as some sensitivity to the surface texture left by machining, only on those scans made perpendicular to the machining direction. Arrows in the figures indicate both the grinding and scanning directions. The sensitivity could have been increased so that Figures 21 and 24, which were scanned perpendicular to the direction of machining, would have shown the surface texture due to grinding. However, in order to allow larger defects to be detected, the sensitivity was reduced so that only a few indications were detected from the most severe grinding damage.

Figure 21. C-scan Recording of 45 MHz, 18° Surface Wave Inspection of Top Surface of Billet of Ceralloy 147A HPSN After Machining (Scan Perpendicular to Grinding Direction).

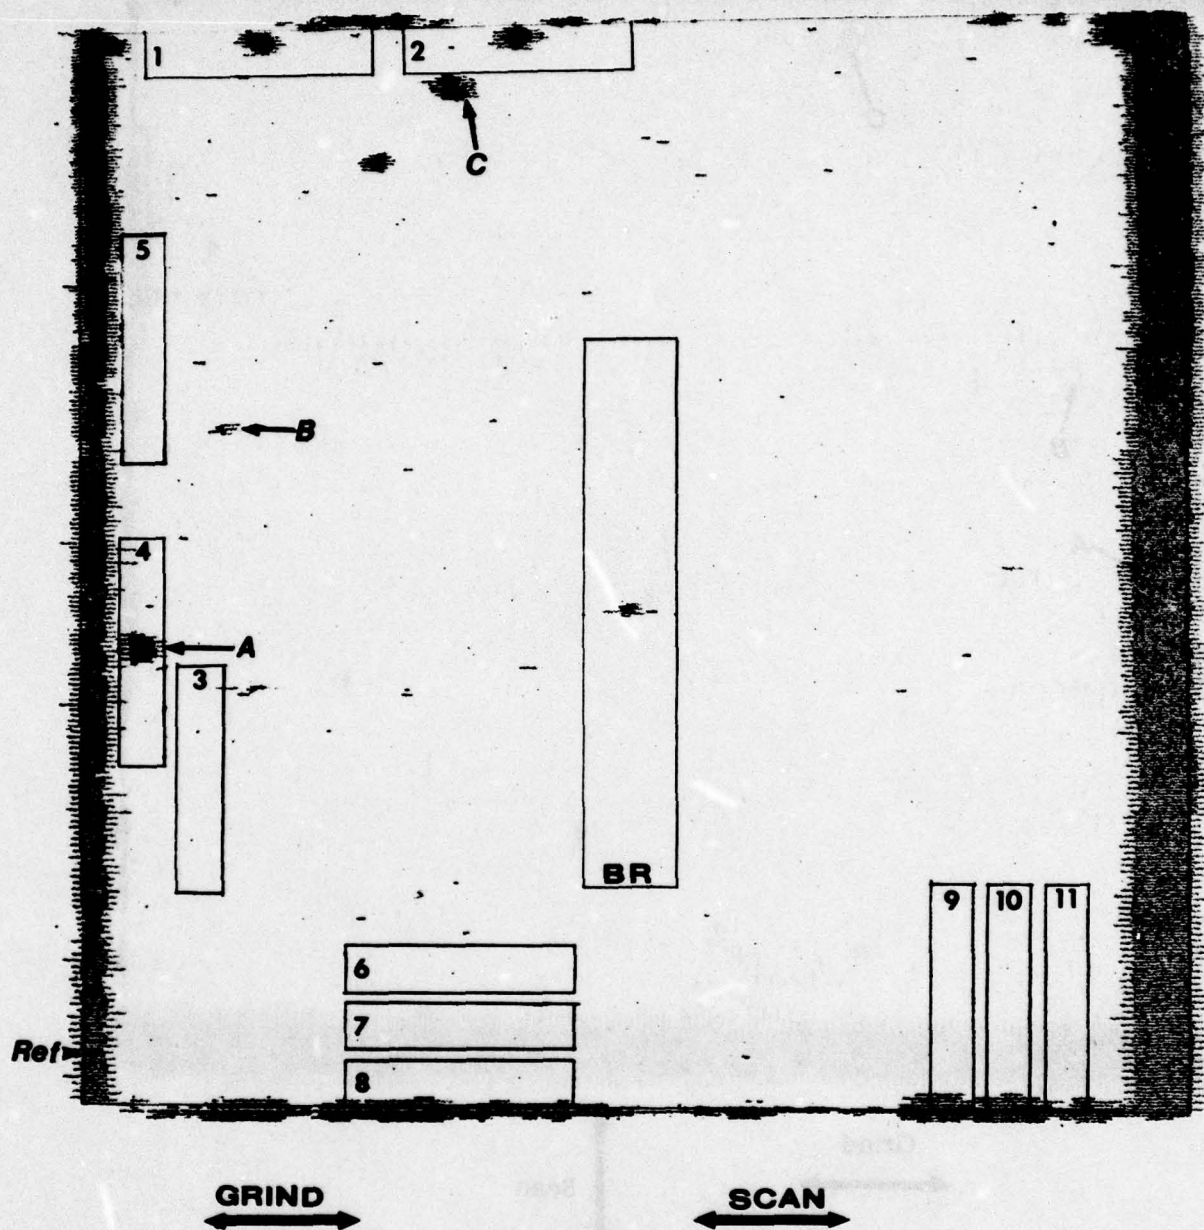
Based on the surface wave inspection results after machining, areas of the billet were selected for burner rig testing and for four-point-bend testing. Figures 22 and 24 show how these specimens relate to the inspection results on the two sides of the billet. In Figure 22 it can be seen that four-point-bend specimens were machined

Figure 22. C-scan Recording of 45 MHz, 18° Surface Wave Inspection of Top Surface of Billet of Ceralloy 147A HPSN After Machining (Scan Parallel to Grinding Direction).

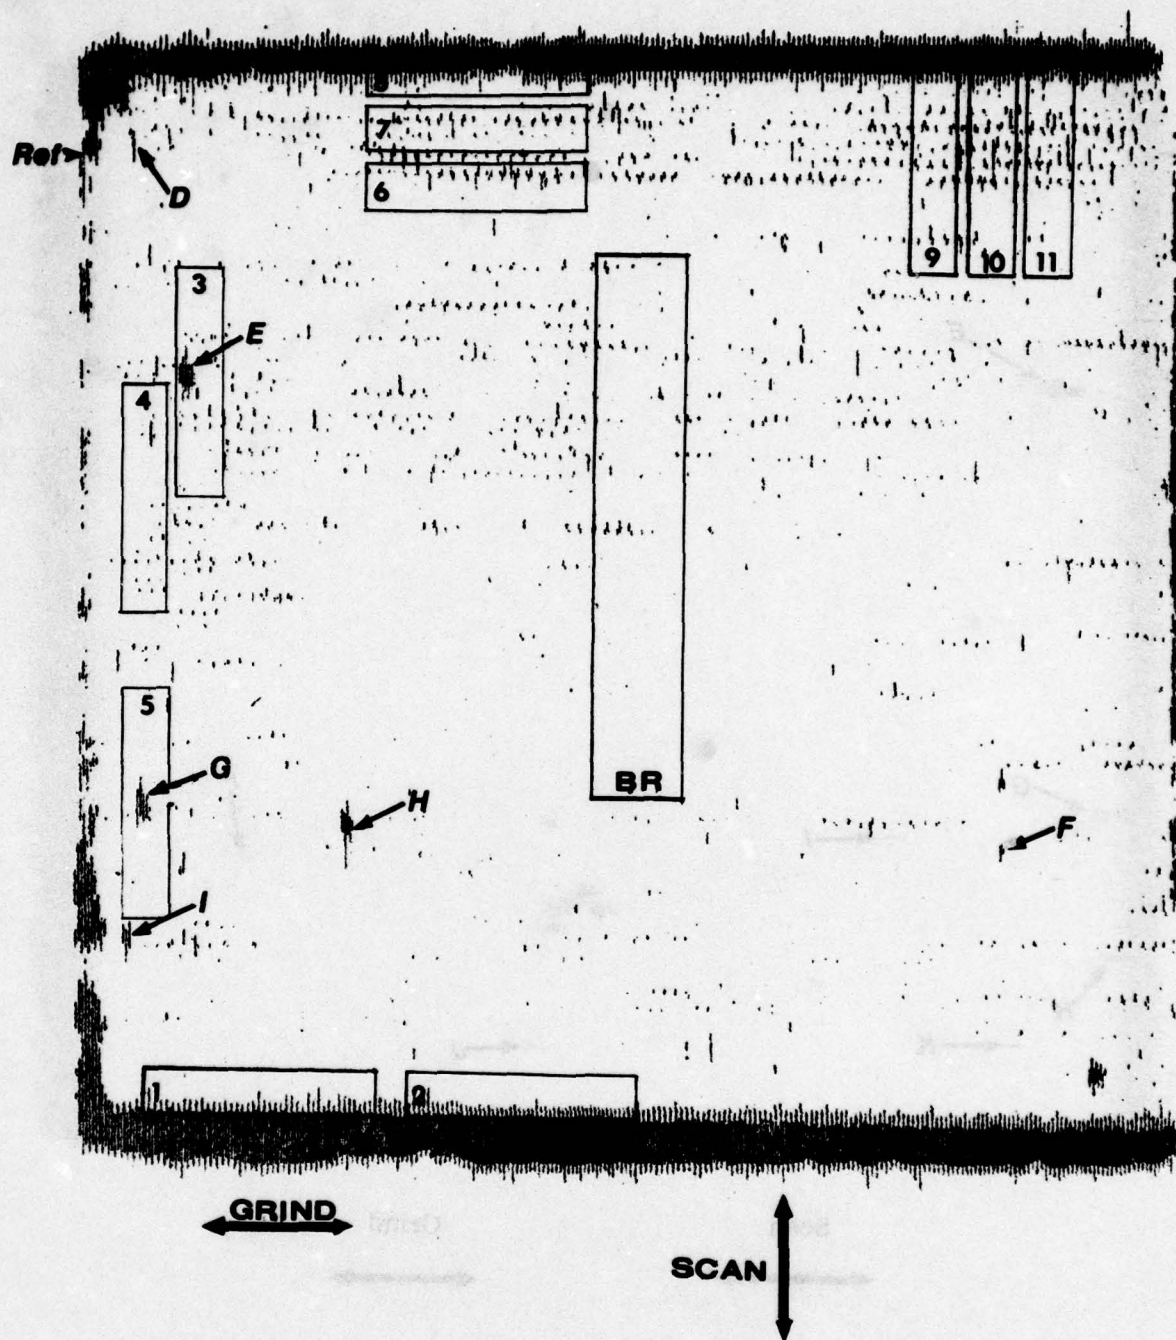
Figure 24. C-scan Recording of 45 MHz, 18° Surface Wave Inspection of Bottom Surface of Billet of Ceralloy 147A HPSN After Machining (Scan Perpendicular to Grinding Direction).

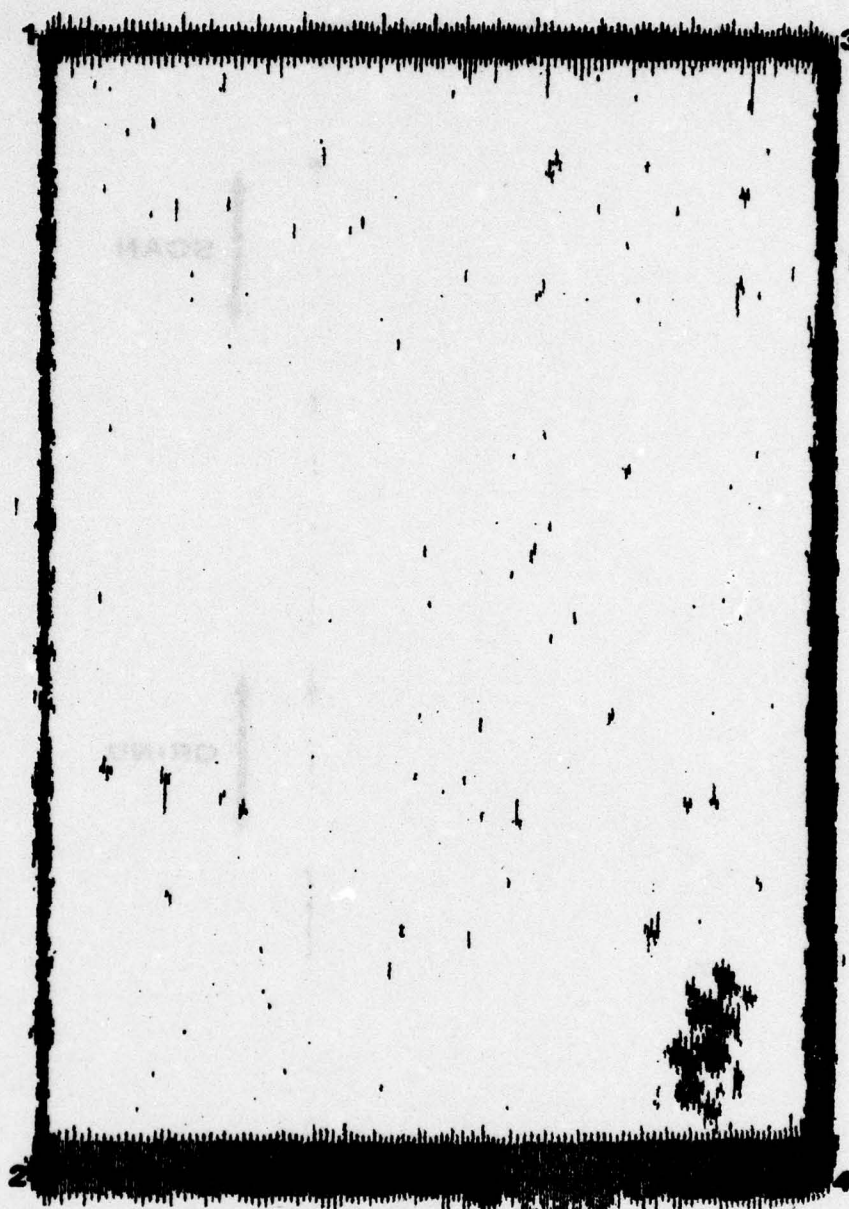
Figure 26 shows a C-scan recordings of a surface wave inspection of the billet of NC-132 HPSN. The cluster of defects in corner No. 4 are shallow surface pits. This corner was cut off and used as a burner rig specimen. Figures 27 through 30 show C-scan recordings of surface wave inspections of both sides of the remainder of the billet from two orientations each. Other than of few small indications in Figure 29, the only defects detected were the grinding marks. The location of four-point-bend specimens made from this billet are indicated in Figures 29 and 30. Specimens 1, 2 and 3 were centered around very small defect indications, as shown in Figure 29. Specimens 4, 5, and 6 run parallel to the grinding damage and specimens 7, 8 and 9 run perpendicular to the grinding damage, as is shown in Figure 30. The C-scan recording of the surface wave inspection of the tensile surface of the individual specimens is shown in Figure 31 prior to machining to final thickness.

Figure 26. C-scan Recording of 45 MHz, 18° Surface Wave Inspection of Top Surface of Billet of NC-132 Hot Pressed Silicon Nitride.

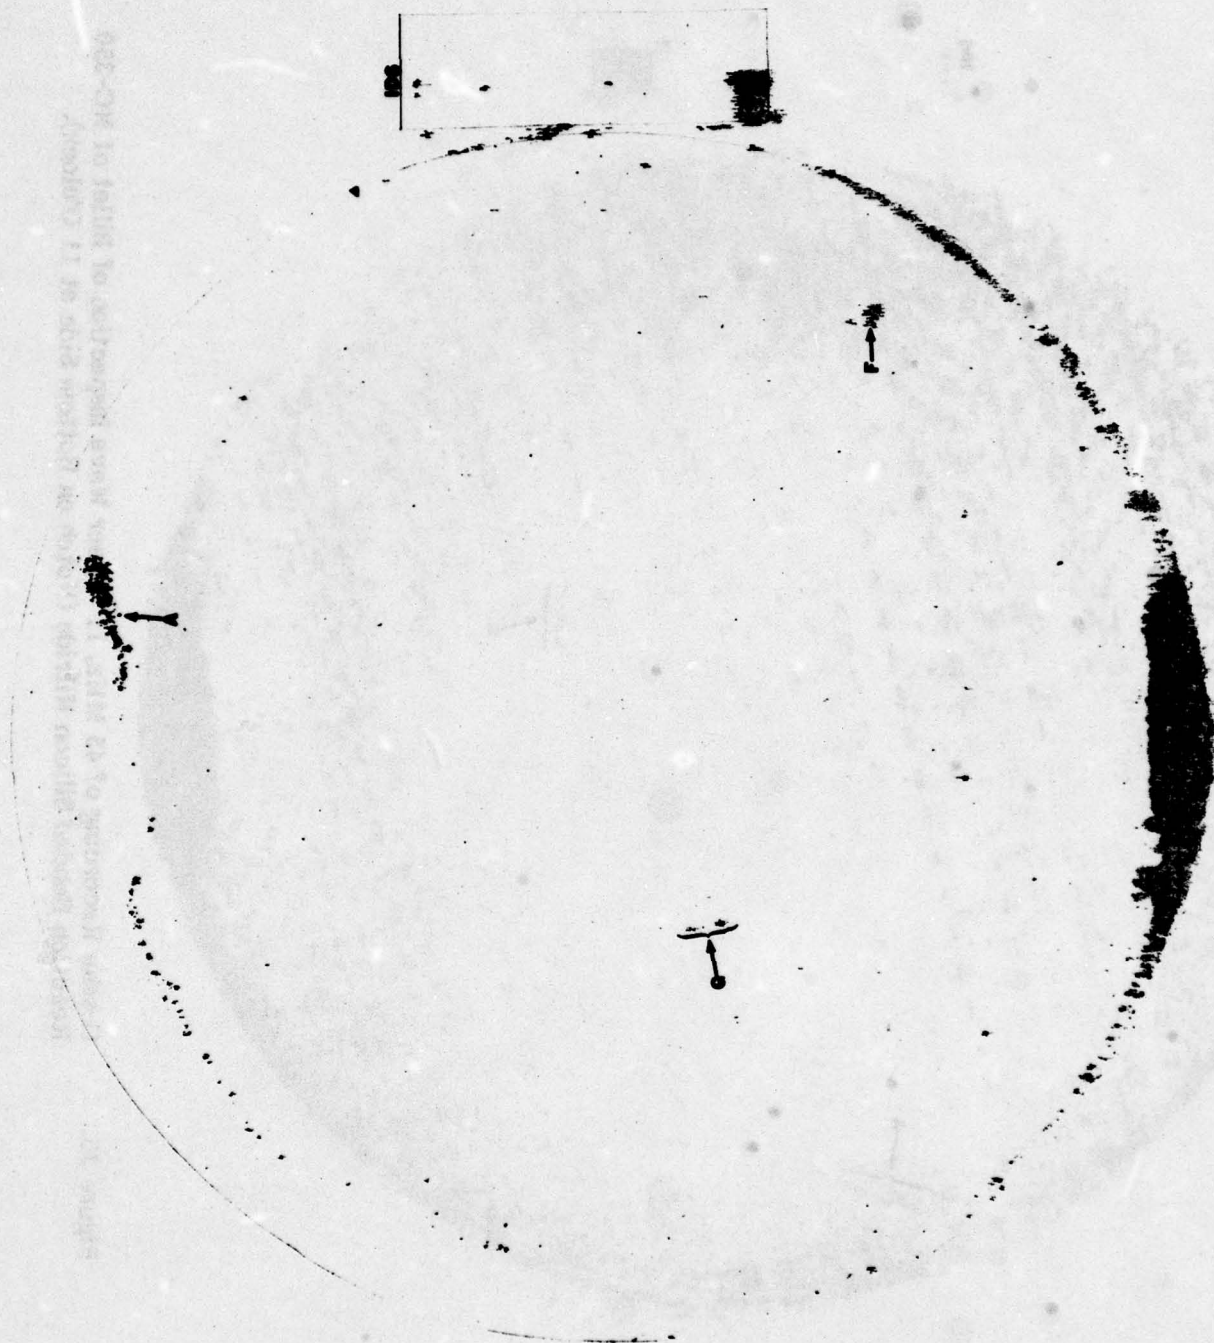
Figure 34. C-scan Recording of 45 MHz, 11° Shear Wave Inspection of Billet of NC-350 Reaction Bonded Silicon Nitride (Notch on Bottom Side at 2 O'clock).

part. These indications are extremely sensitive to beam orientation as can be seen by comparison with Figure 34, where the billet is rotated 90° . Visually, the billet shows three areas, approximately 2.5 cm square, near the edge where the material is lighter grey. These areas correspond to the groups of indications marked A, B and C on Figures 32 through 35. These are apparently areas of larger porosity since the defects associated with these areas are internal. The indications labeled E, F and G are associated with defects that are visible on the surface.

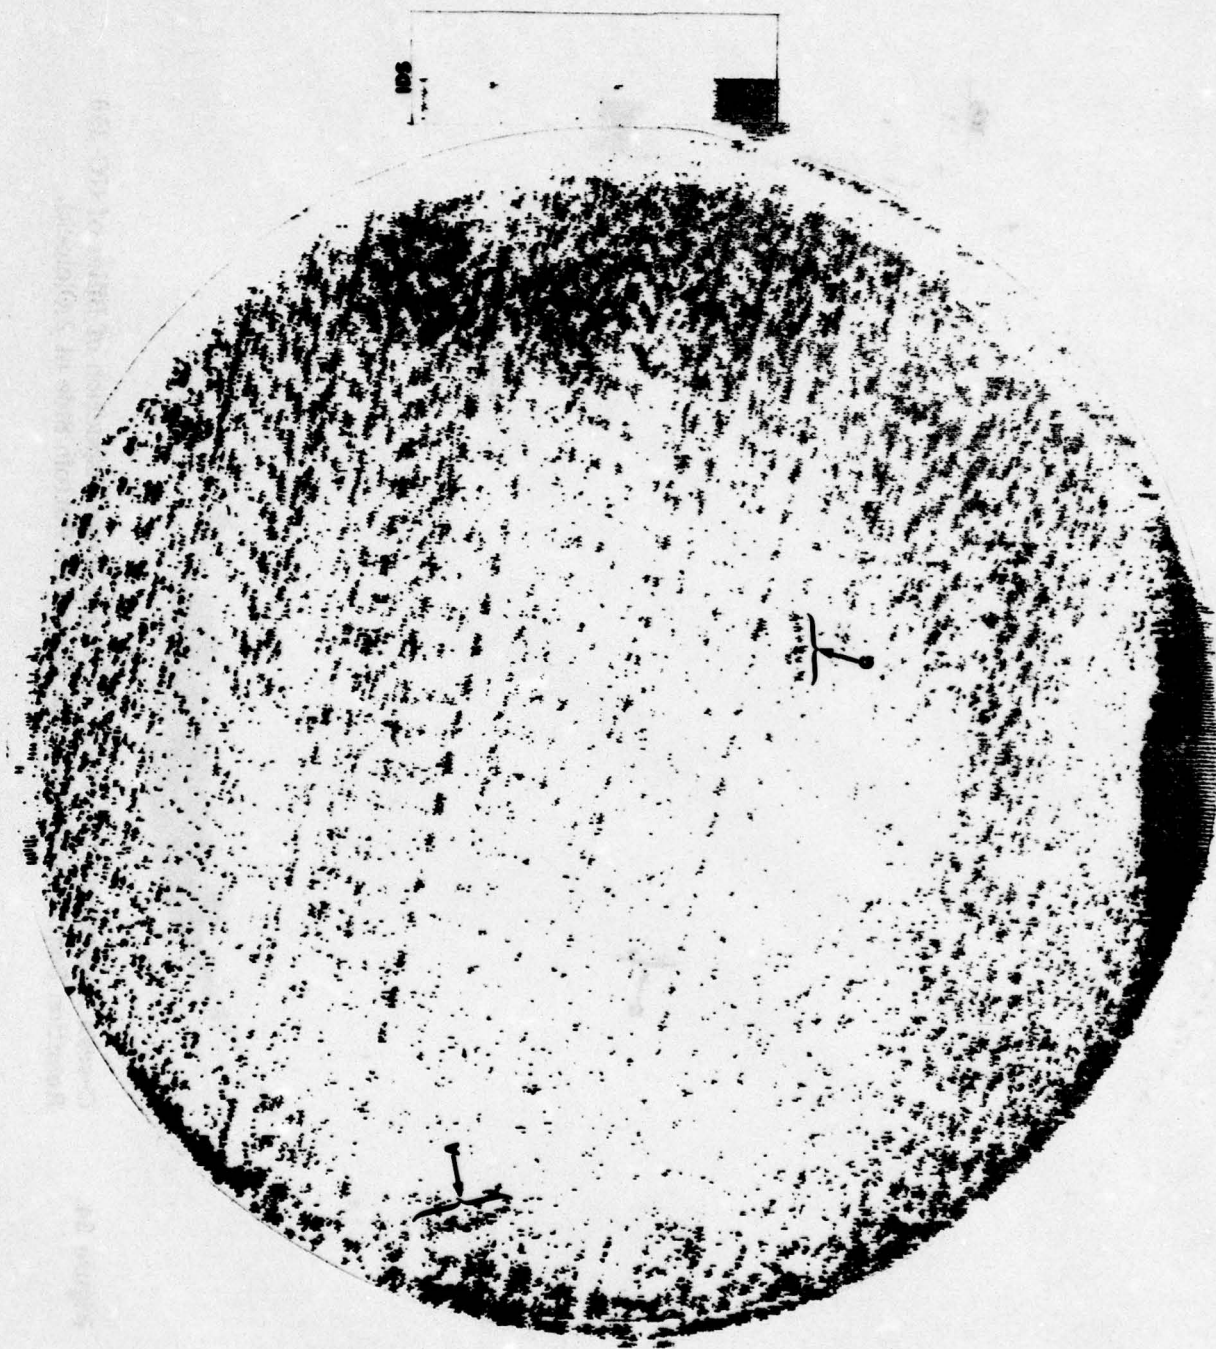
Figure 35. C-scan Recording of 45 MHz, 11° Shear Wave Inspection of Billet of NC-350 Reaction Bonded Silicon Nitride (Notch on Bottom Side at 11 O'clock).

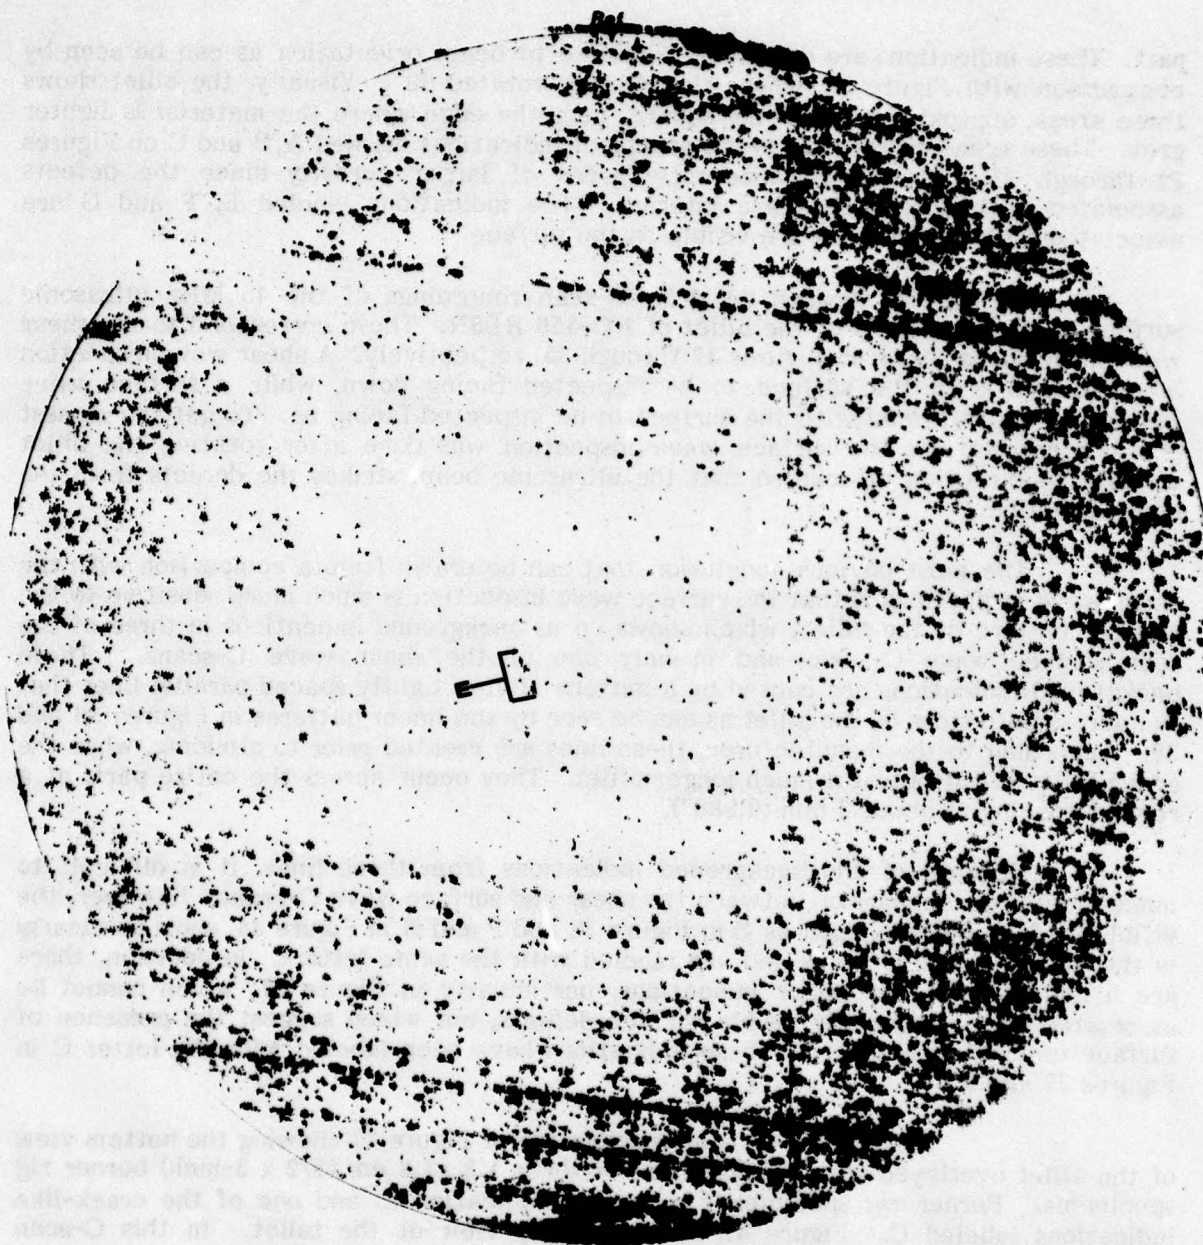
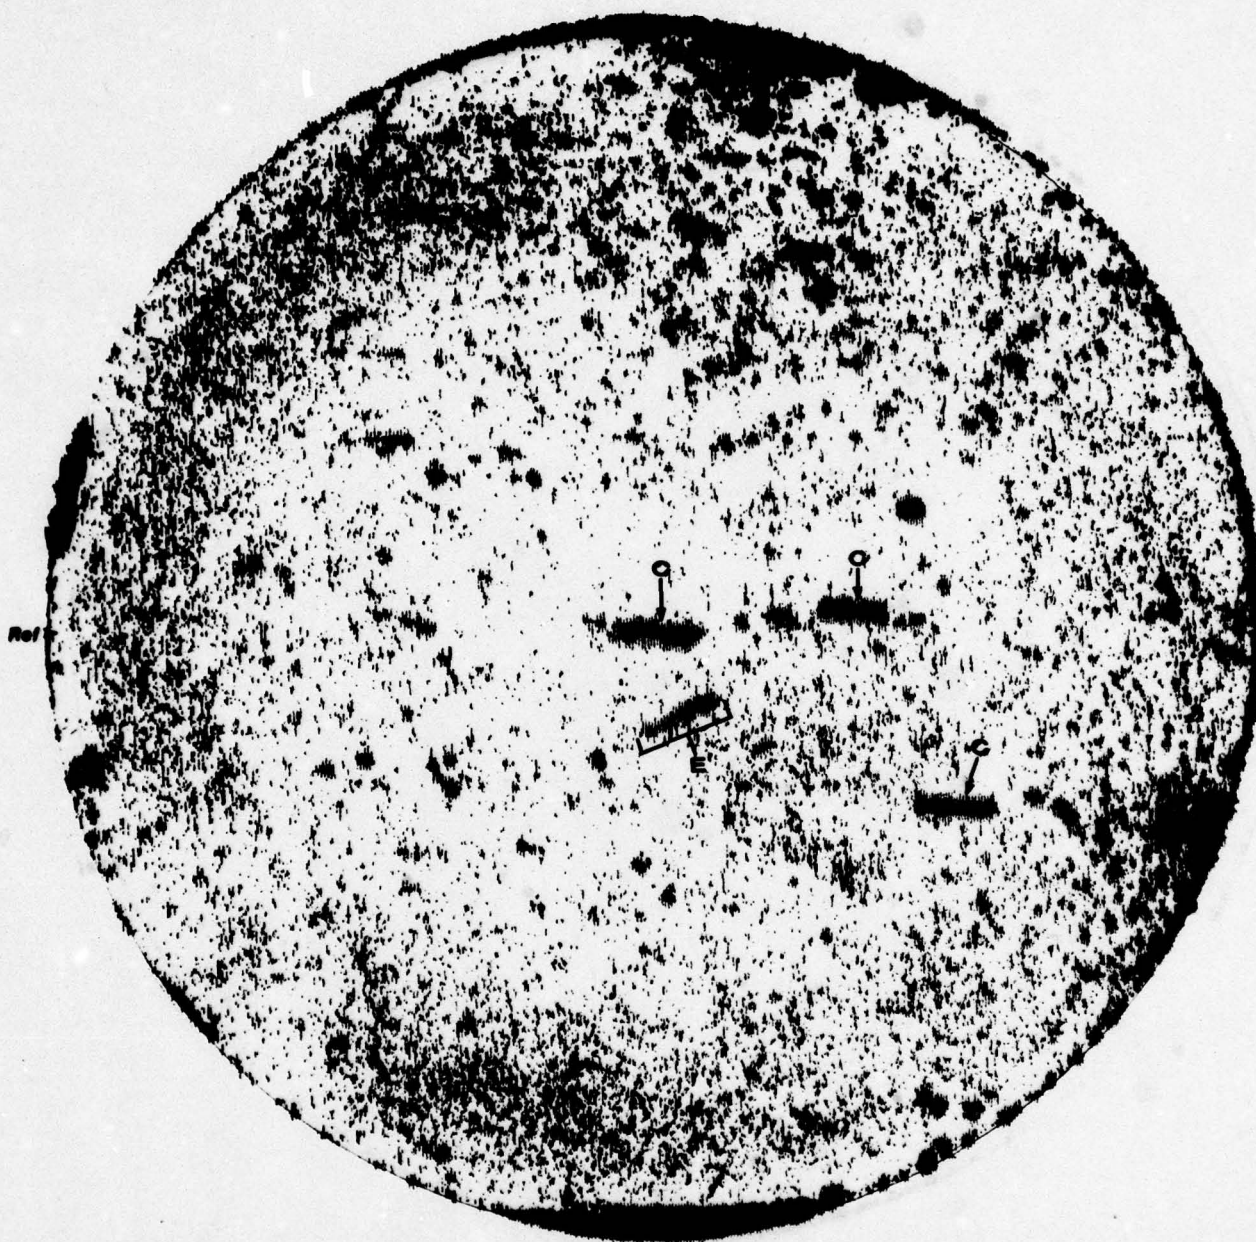
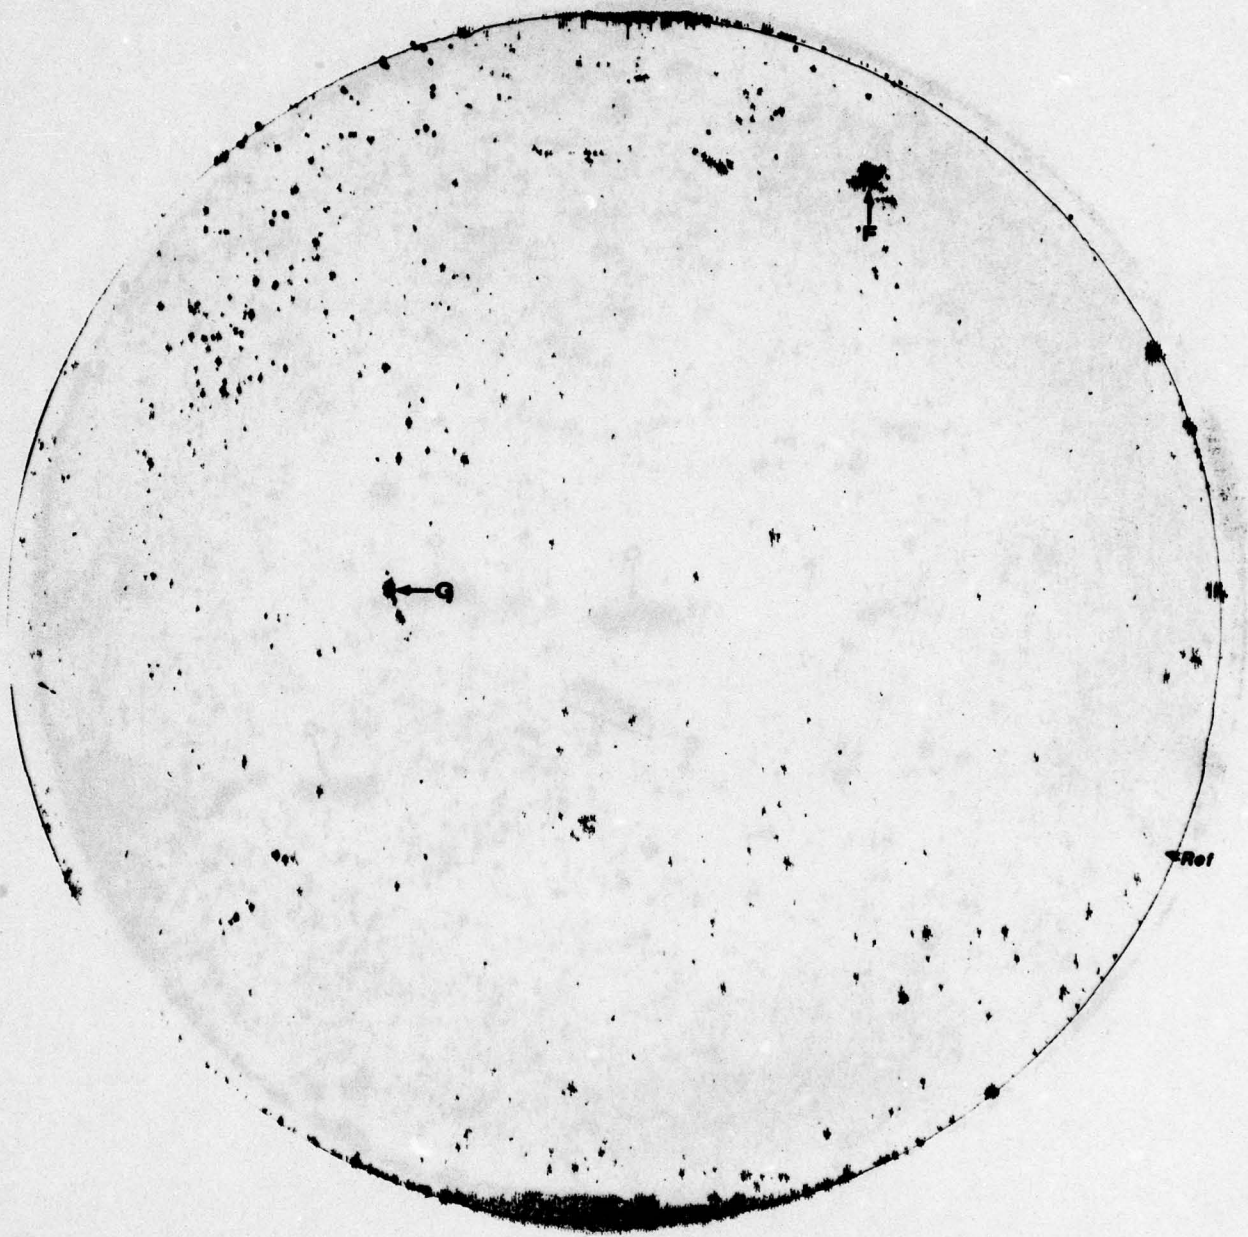
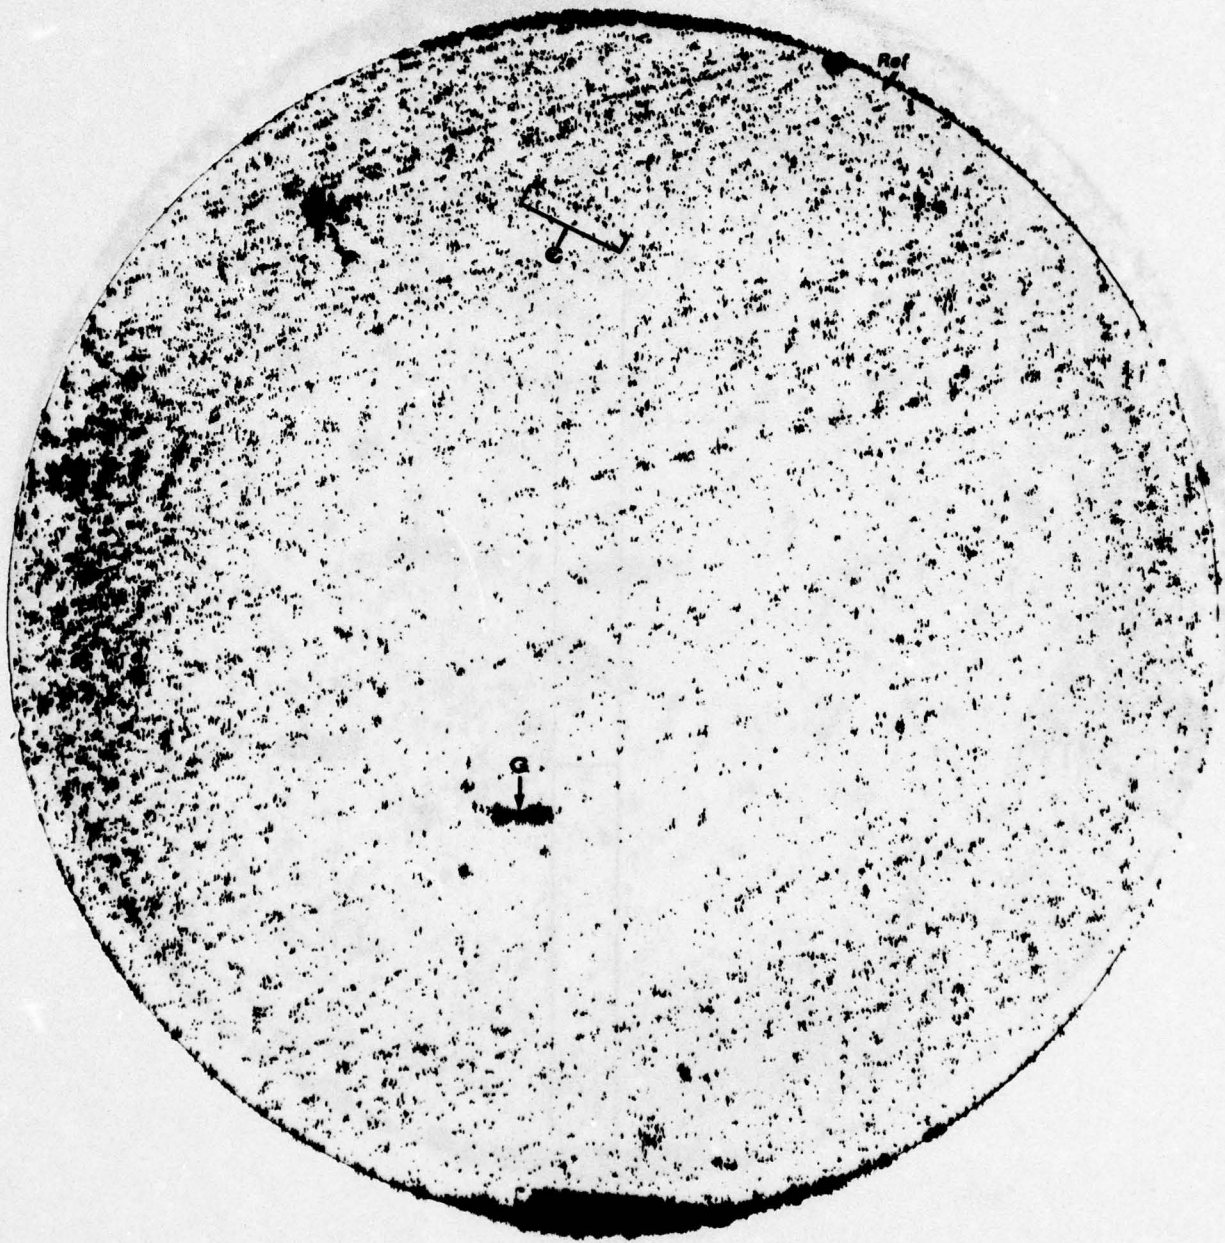
Figures 36 through 39 show C-scan recordings of the 45 MHz ultrasonic surface wave inspections of the billet of NC-350 RBSN. These correspond to the shear wave inspections shown in Figures 32 through 35, respectively. A shear wave inspection is performed with the surface to be inspected facing down, while a surface wave inspection is performed with the surface to be inspected facing up. To get the closest possible correlation, the surface wave inspection was done after rotating the billet around the direction of scan so that the ultrasonic beam strikes the defects from the same direction.

The most obvious conclusion that can be drawn from a comparison with the shear wave inspections is that the surface wave inspection is much more sensitive to the surface texture of the billet, which shows up as background indications in three of the four surface wave C-scans and in only one of the shear wave C-scans. These background indications are caused by a pattern of fine tightly spaced parallel lines that run across both sides of the billet as can be seen by the linear patterns in Figures 36 and 39. According to the manufacturer, these lines are created prior to nitriding, when the green billet is cut out of a much longer billet. They occur across the entire part, at a regular spacing of about 2 mm (0.080").
