ULTRASONIC DETECTION OF SURFACE FLAWS IN GAS TURBINE CERAMICS.(U)

4. TITLE (and Subtitle) ULTRASONIC DETECTION OF SURFACE FLAWS IN GAS TURBINE CERAMICS		5. TYPE OF REPORT & PERIOD COVERED Final Technical Report	13. Sep 77-12 hlc 76

6. AUTHOR(s) Thomas/Derkacs Istvan M. Matay		7. PERFORMING ORG. REPORT NUMBER TRW-ER-7986-F	
8. PERFORMING ORGANIZATION NAME AND ADDRESS TRW Inc. 23555 Euclid Avenue Cleveland, OH 44117		9. CONTRACT OR GRANT NUMBER(s) (15) N62269-77-C-0136

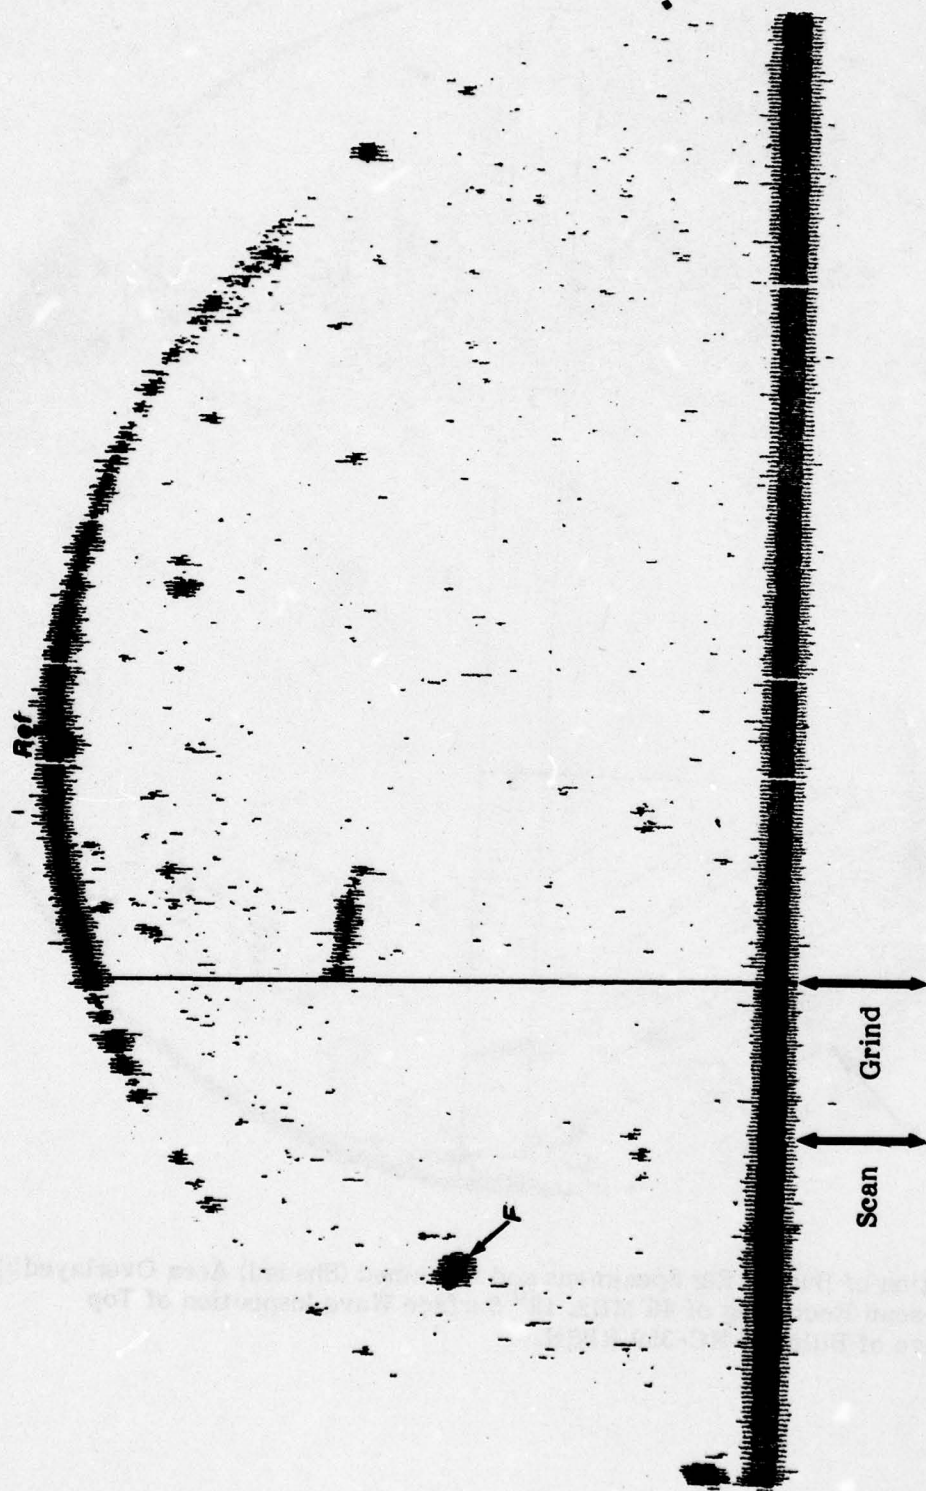
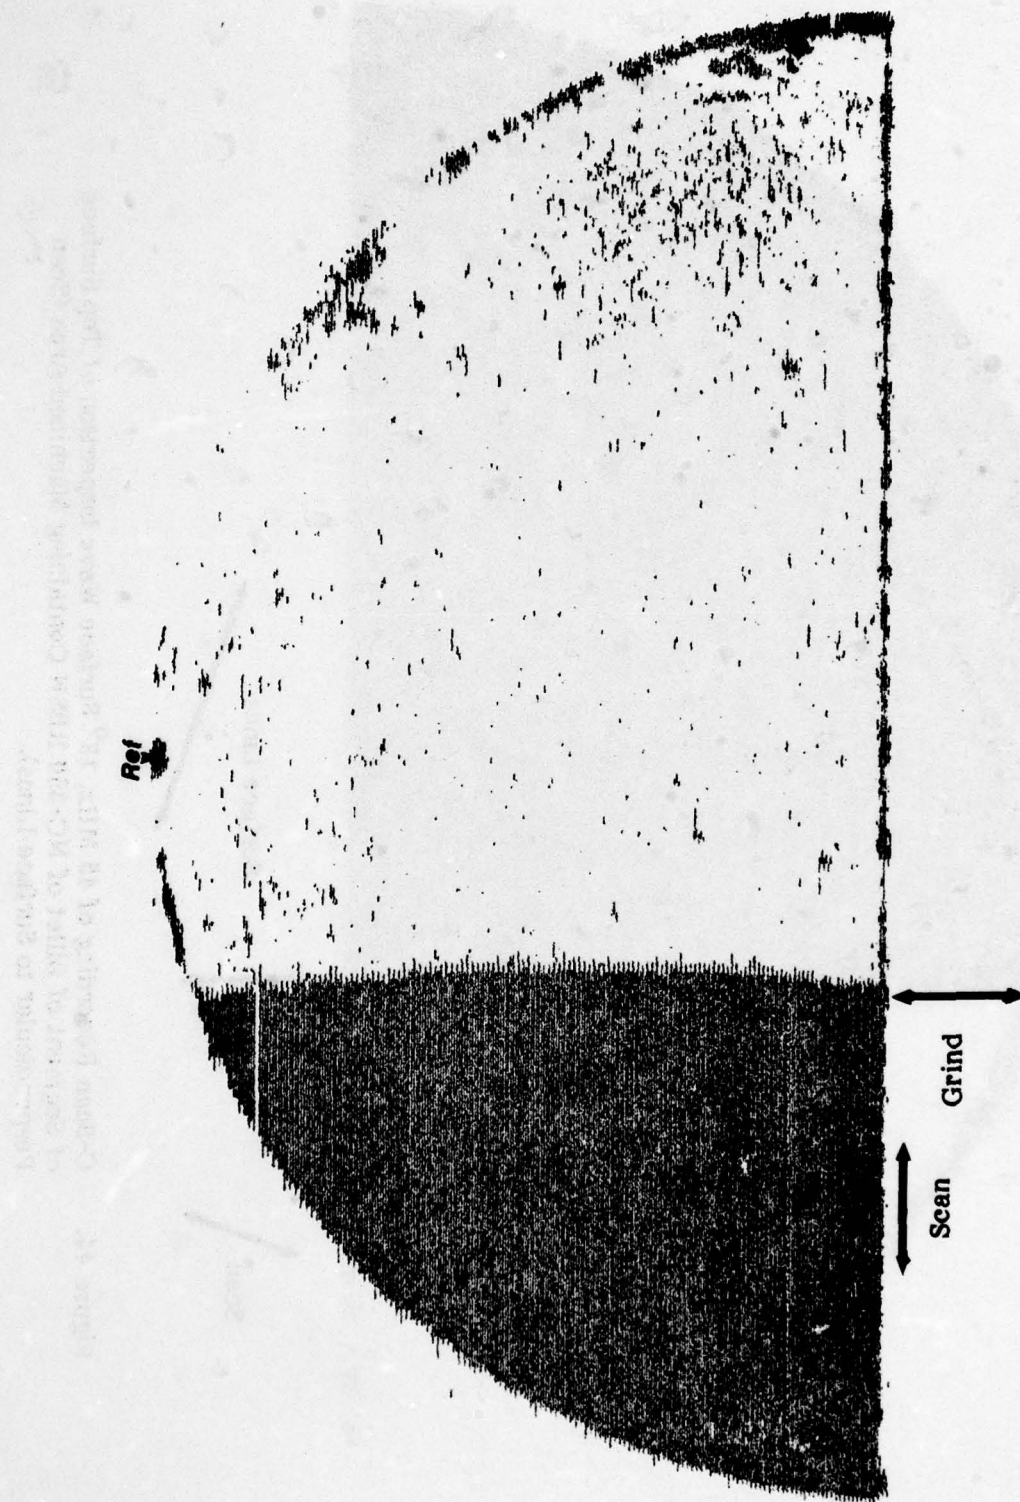
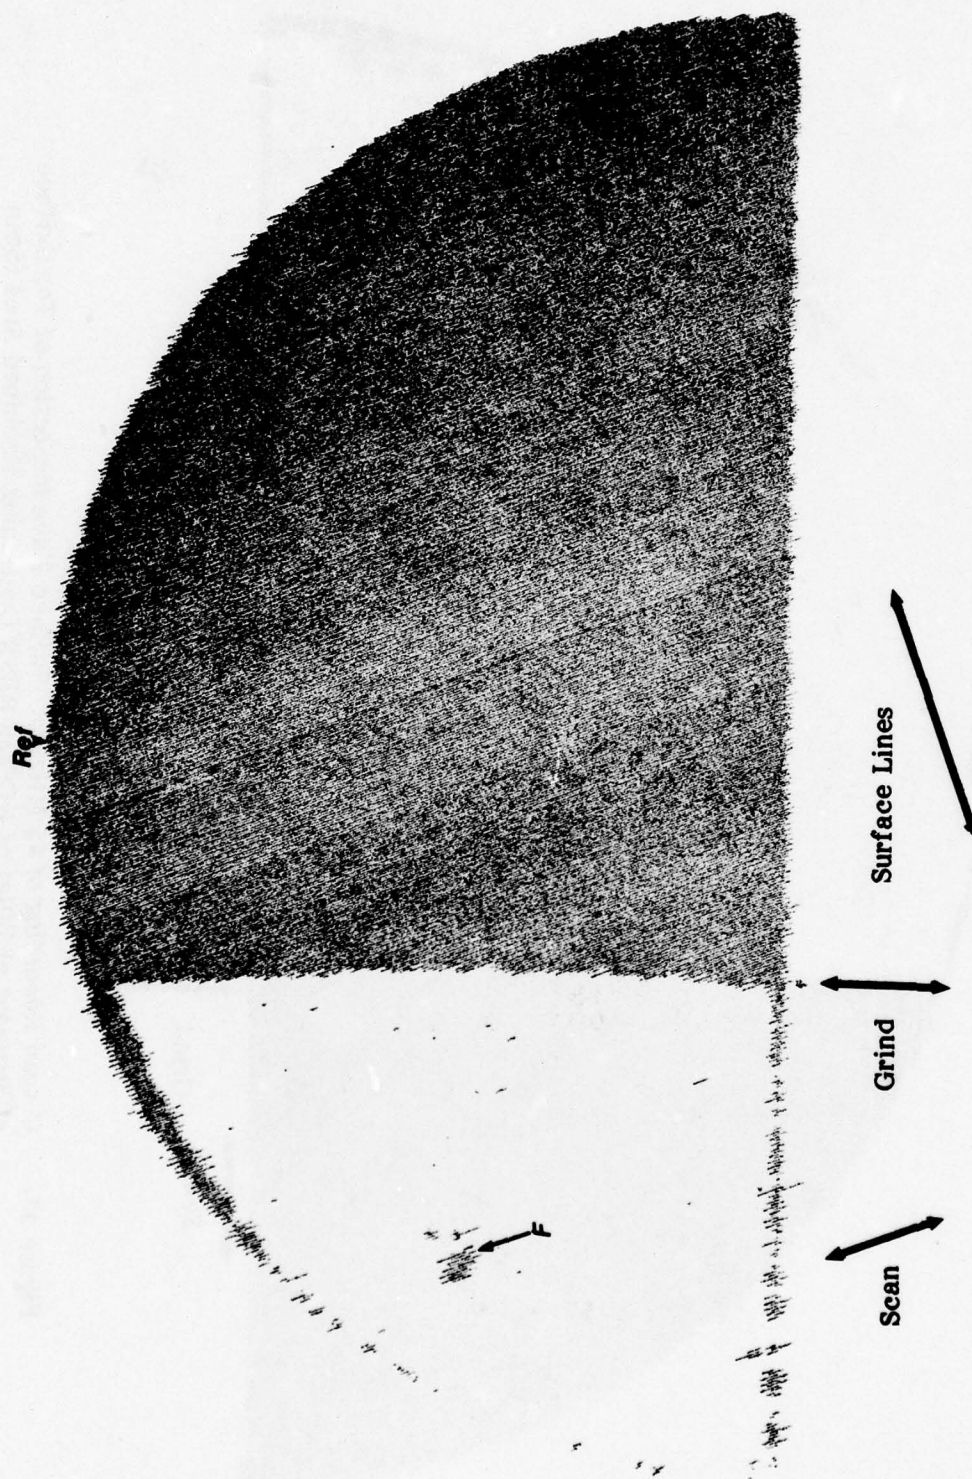
Figures 42, 43, and 44 are C-scan recordings of 45 MHz, 18° surface wave inspections of the top side of the segment of the billet containing the machined area. The arrows in these figures illustrate the relationship between the scan direction, the

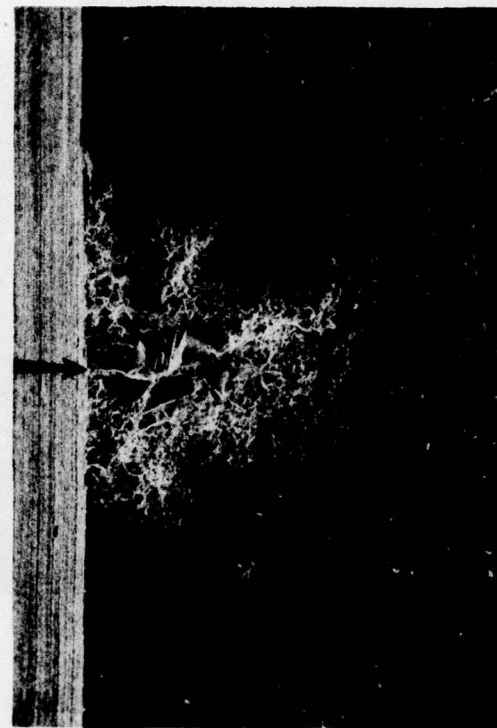
Figure 66. Fracture Surfaces of Ceralloy 147A HPSN Specimen No. 3, Showing Ultrasonically Detected Defect at Fracture Origin.

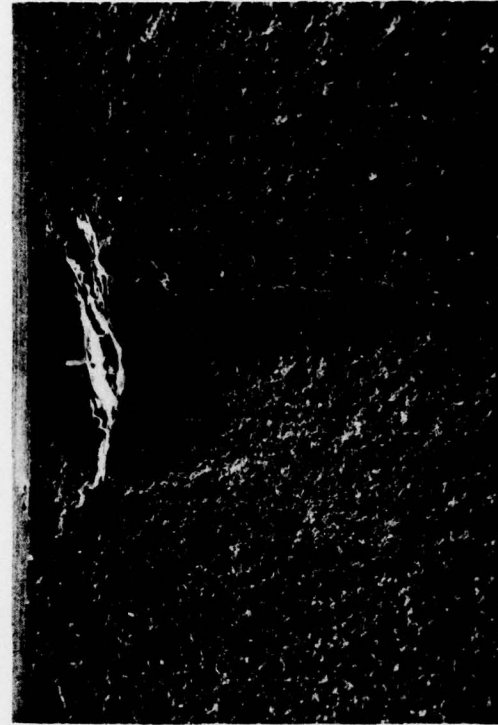
Figure 67. Fracture Surfaces of Ceralloy 147A HPSN Specimen No. 4, Showing Ultrasonically Detected Defect at Fracture Origin.

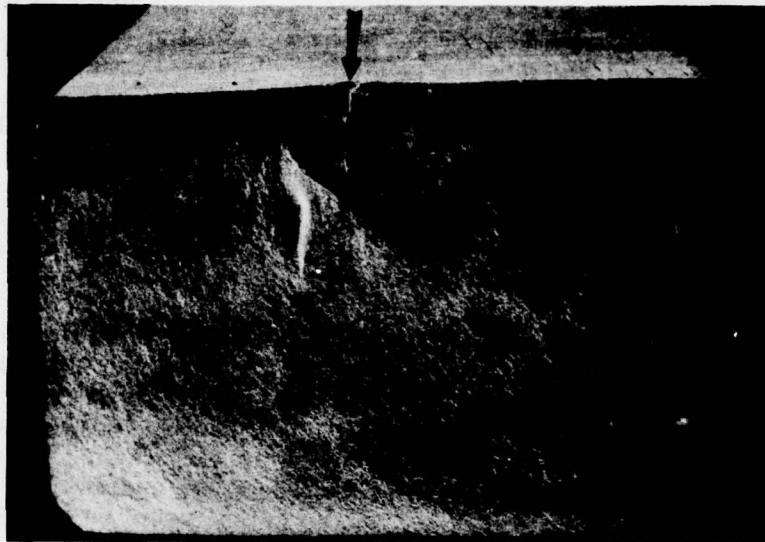
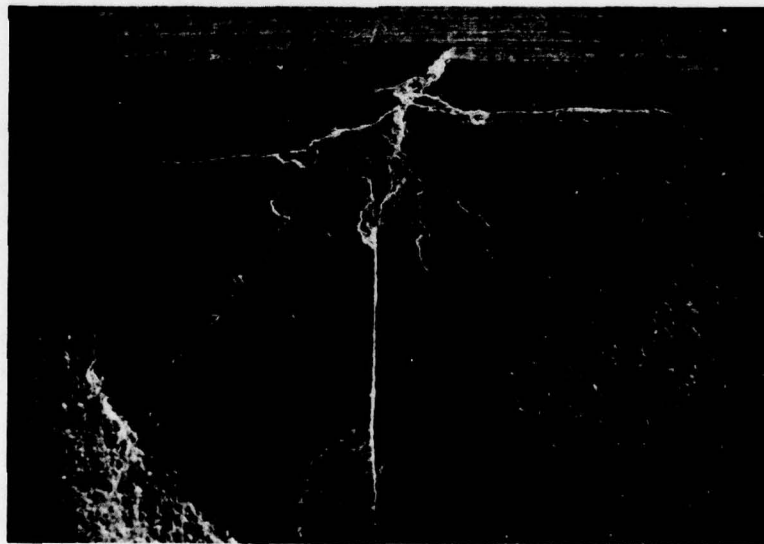
Figure 69. Fracture Surface of Ceralloy 147A HPSN Specimen No. 9, Showing 50 kg Vicker's Indentation at Fracture Origin.

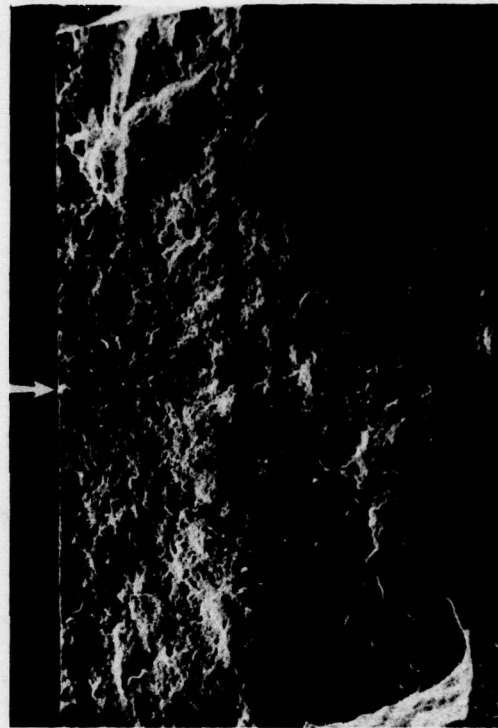
Figure 70. Fracture Surfaces of NC-132 HPSN Specimen No. 1, Showing Ultrasonically Detected Defect at Fracture Origin.

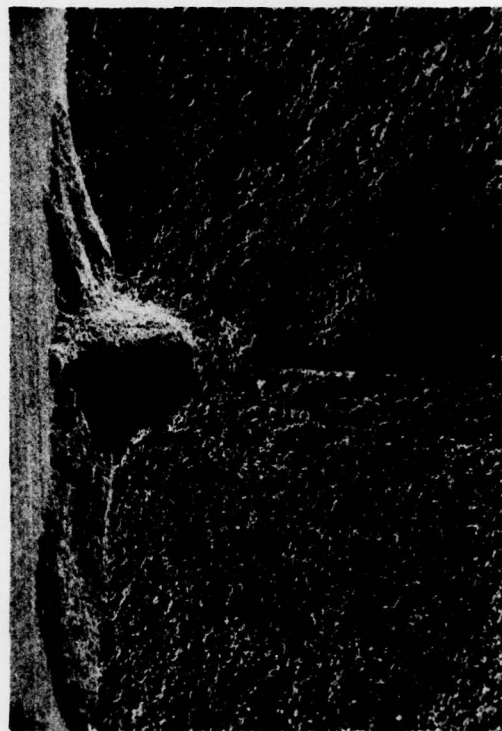
Figure 74. Fracture Surfaces of Ceralloy 146A HPSiC Specimen No. 1, Showing 50 kg Vicker's Indentation at Fracture Origin.

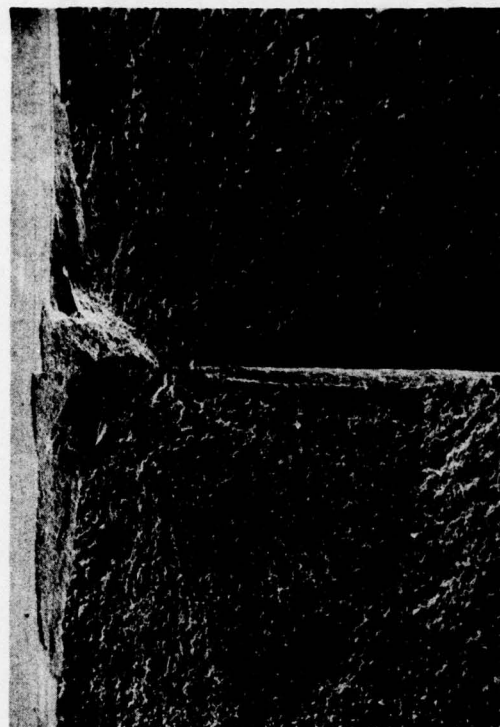
Specimens 1 and 4 of NC-230 also contain 50 kg and 1 kg Vicker's indentations, respectively. The fracture surfaces of these specimens are shown in Figures 76 and 77, respectively. In Figure 76 it can be seen that the 50 kg Vicker's indentation consists of a $200 \mu\text{m}$ (0.0008 inch) wide by $160 \mu\text{m}$ (0.0064 inch) deep pit with a $510 \mu\text{m}$ (0.0204 inch) deep crack. The 1 kg Vicker's indentation shown in Figure 77 consists of a $20 \mu\text{m}$ (0.0008 inch) wide by $5 \mu\text{m}$ (0.0002 inch) deep pit with a $35 \mu\text{m}$ (0.0014 inch) deep crack. Specimens 2 and 3 were machined in an area of heavier grinding damage while specimens 5 and 6 were machined in an area of lighter grinding damage, but all specimens were machined perpendicular to the damage. Specimen 2 was damaged during finish machining and was not tested. Specimen 3 had a strength of 412 MN/m^2 (59.8 ksi) compared to $504 \pm 13 \text{ MN/m}^2$ ($73.1 \pm 1.9 \text{ ksi}$) for specimens 5 and 6. Here again there is a considerable difference in strengths which corresponds with the ultrasonic results, but the data is insufficient to draw a statistically valid conclusion. Specimens 7, 8 and 9 were from an area that showed extensive ultrasonic indications, not only by the surface wave technique, but also by shear and longitudinal wave techniques. The average strength of these specimens was $187 \pm 21 \text{ MN/m}^2$ ($27.2 \pm 3.1 \text{ ksi}$). This is significantly lower than the average of specimens 3, 5 and 6, 473 ± 54

Figure 76. Fracture Surfaces of NC-230A HPSiC Specimen No. 1, Showing 50 kg Vicker's Indentation at Fracture Origin.

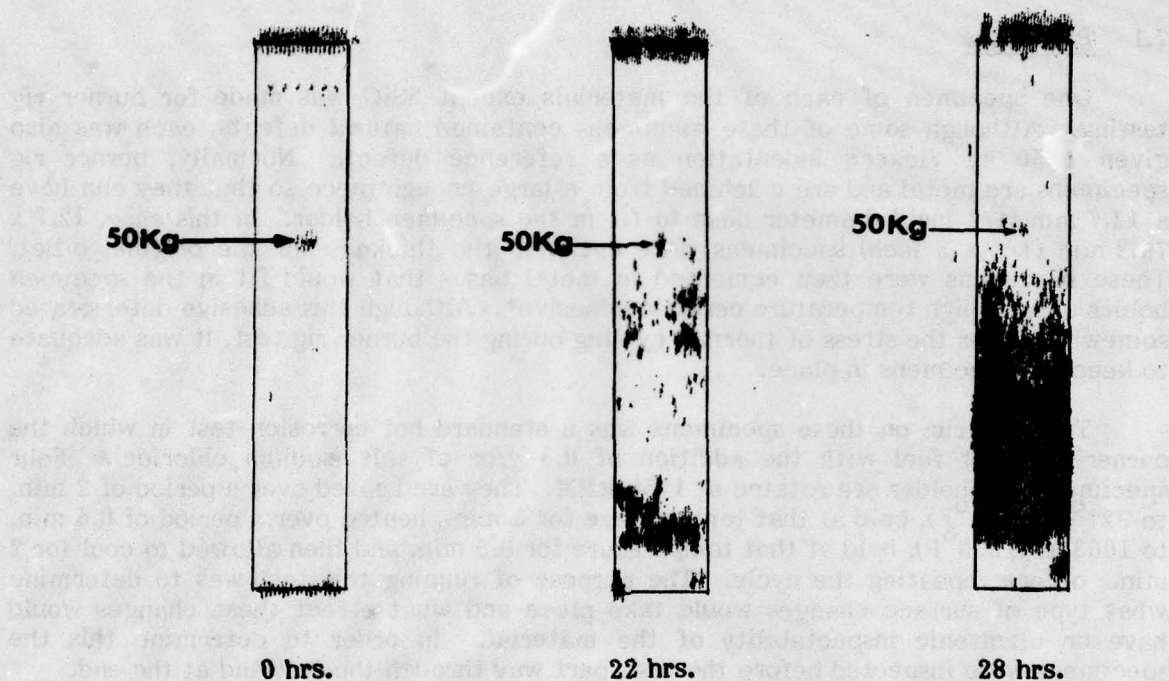
Figure 82. C-scan Recordings of 45 MHz, 18° Surface Wave Inspections of Specimen of Ceralloy 147A HPSN After 0, 22 and 28 Hours Exposure in Burner Rig.

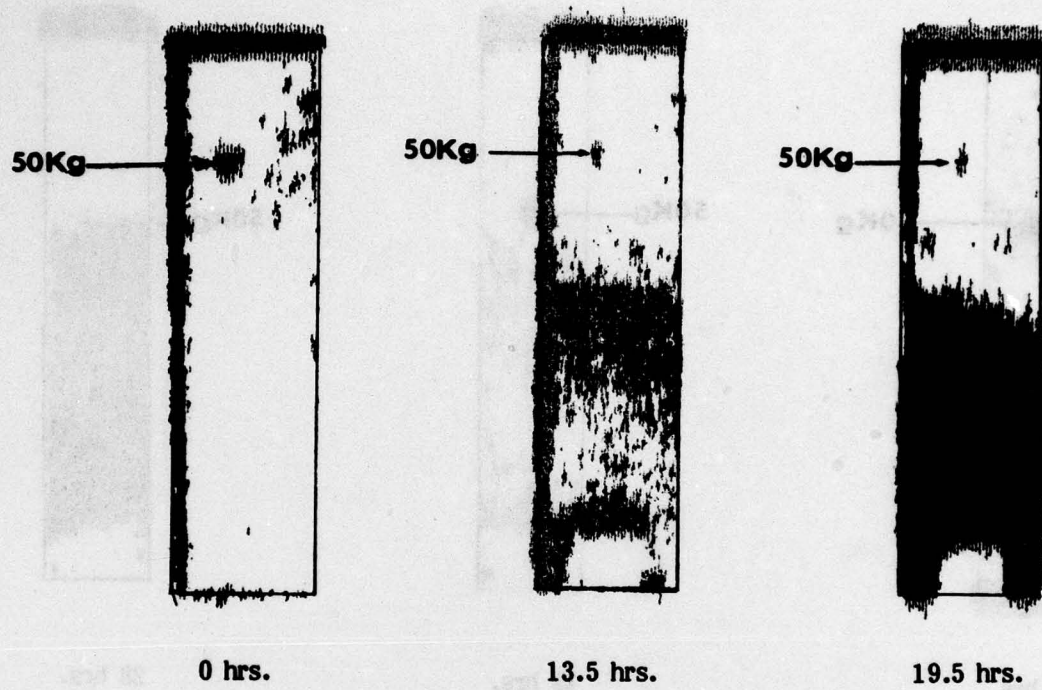
Figure 83. C-scan Recordings of 45 MHz, 18° Surface Wave Inspections of Specimen of NC-132 HPSN After 0, 13.5 and 19.5 Hours Exposure in the Burner Rig.

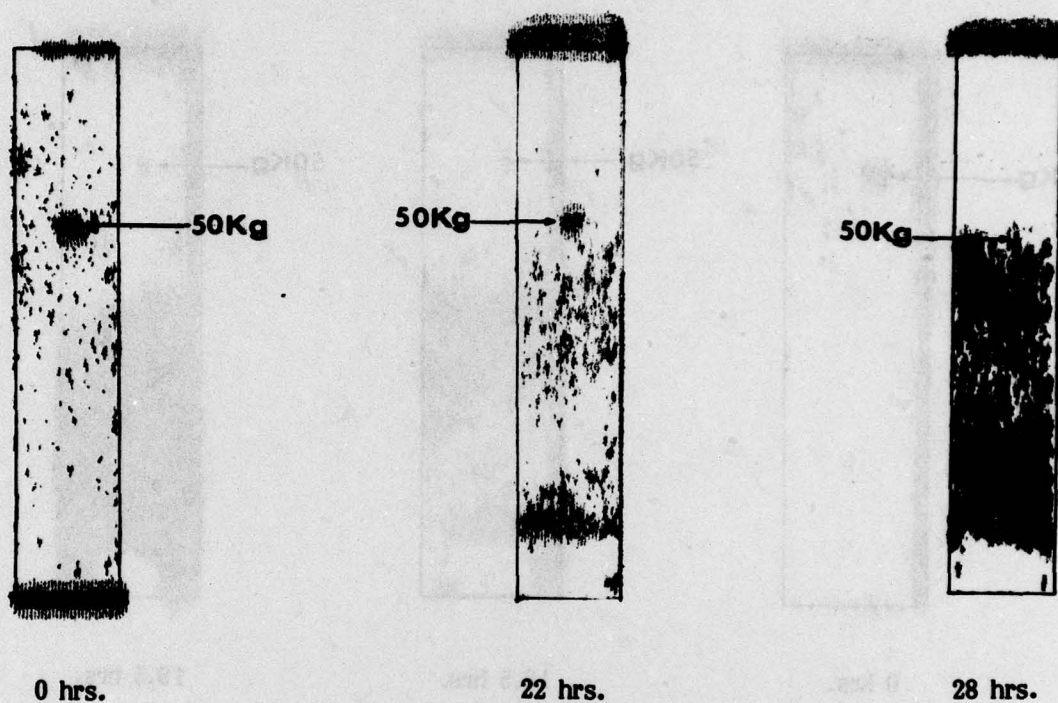
Figure 84. C-scan Recordings of 45 MHz, 18° Surface Wave Inspections of Specimen of NC-350 RBSN After 0, 22 and 28 Hours Exposure in the Burner Rig.

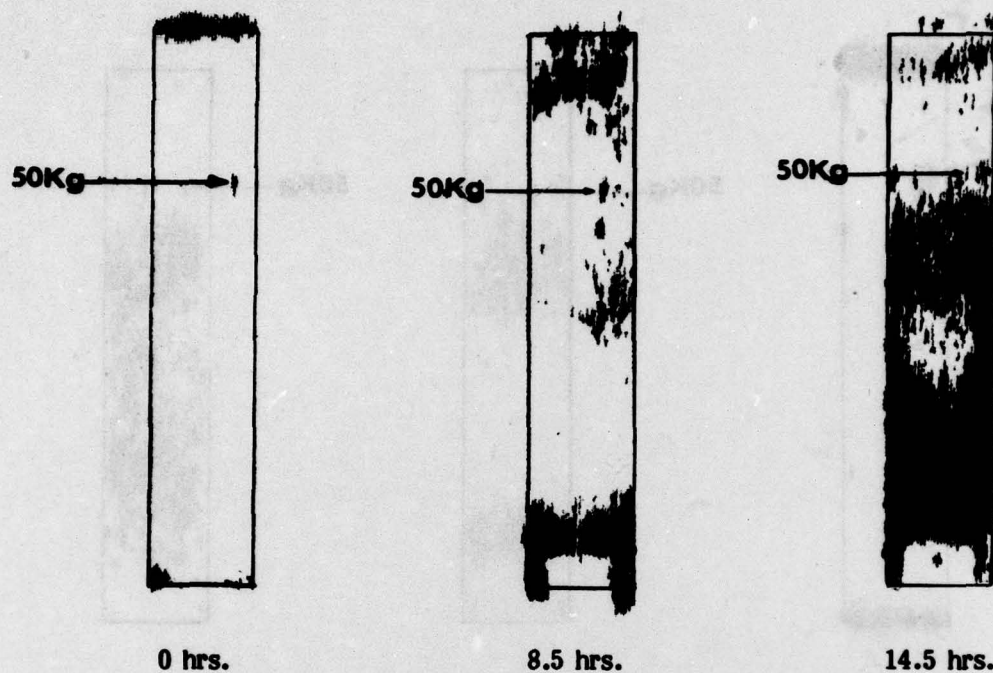
Figure 85. C-scan Recordings of 45 MHz, 18° Surface Wave Inspections of Specimen of Ceralloy 146 HPSiC After 0, 8.5 and 14.5 Hours Exposure in the Burner Rig.

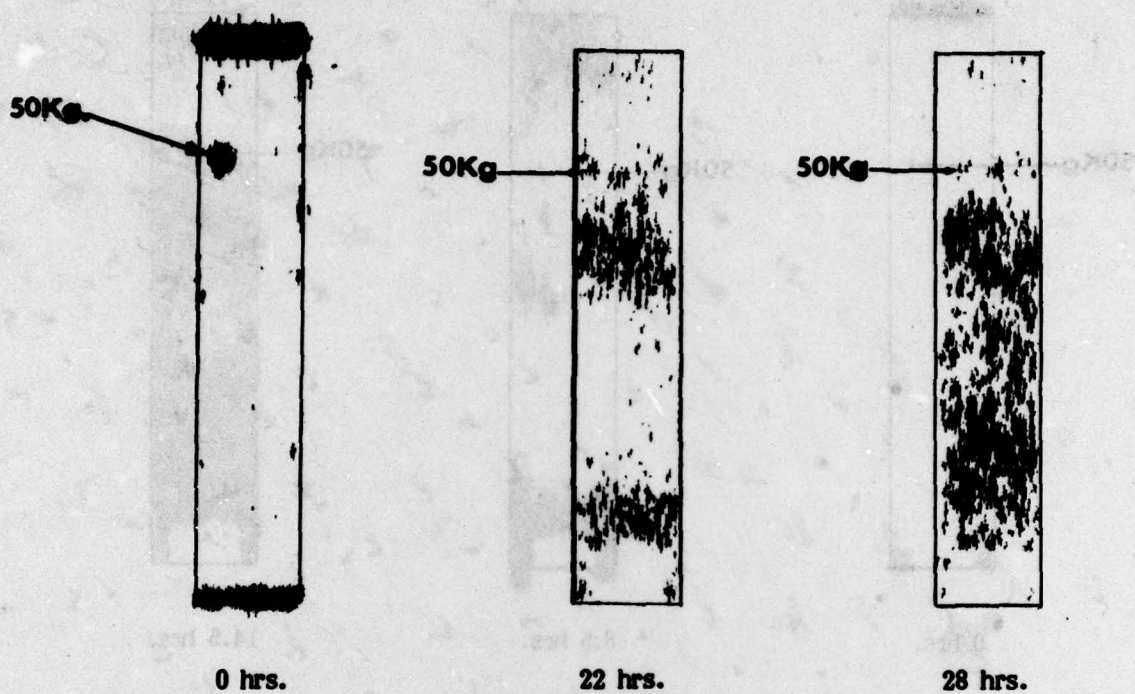
Figure 86. C-scan Recordings of 45 MHz, 18° Surface Wave Inspections of Specimen of NC-230A HPSiC After 0, 22 and 28 Hours Exposure in the Burner Rig.
