SERIAL NUMBER: WADC-TR-52-68

DATE: April 1952

PHASE V (ALL WEATHER) TESTING OF T-29A AIRCRAFT

All Weather Section
Flight Test Division
Project No. S207-20

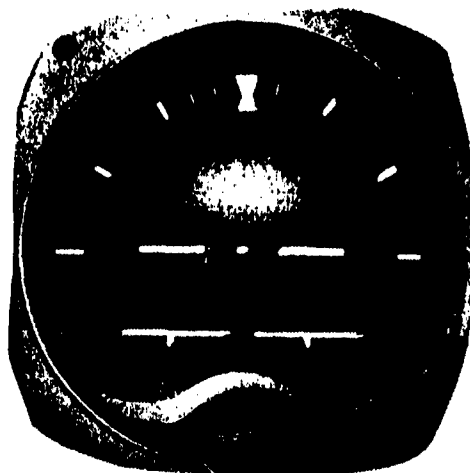
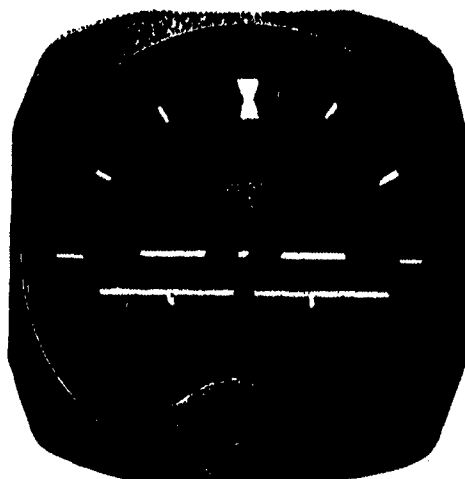
The attitude of the aircraft at recommended VFR climbing speed (122K) is $22\frac{1}{2}^{\circ}$ nose up; however, the presentation of the A-2 Vertical Gyro at this speed makes it difficult to maintain this attitude in instrument flight. For ease of operation, instrument climbs were made at 140K which gives a more flyable presentation on the attitude indicator, as noted in the following illustrations.

Attitude Gyro at climbing speed - 122K

Attitude Gyro at climbing speed - 140K

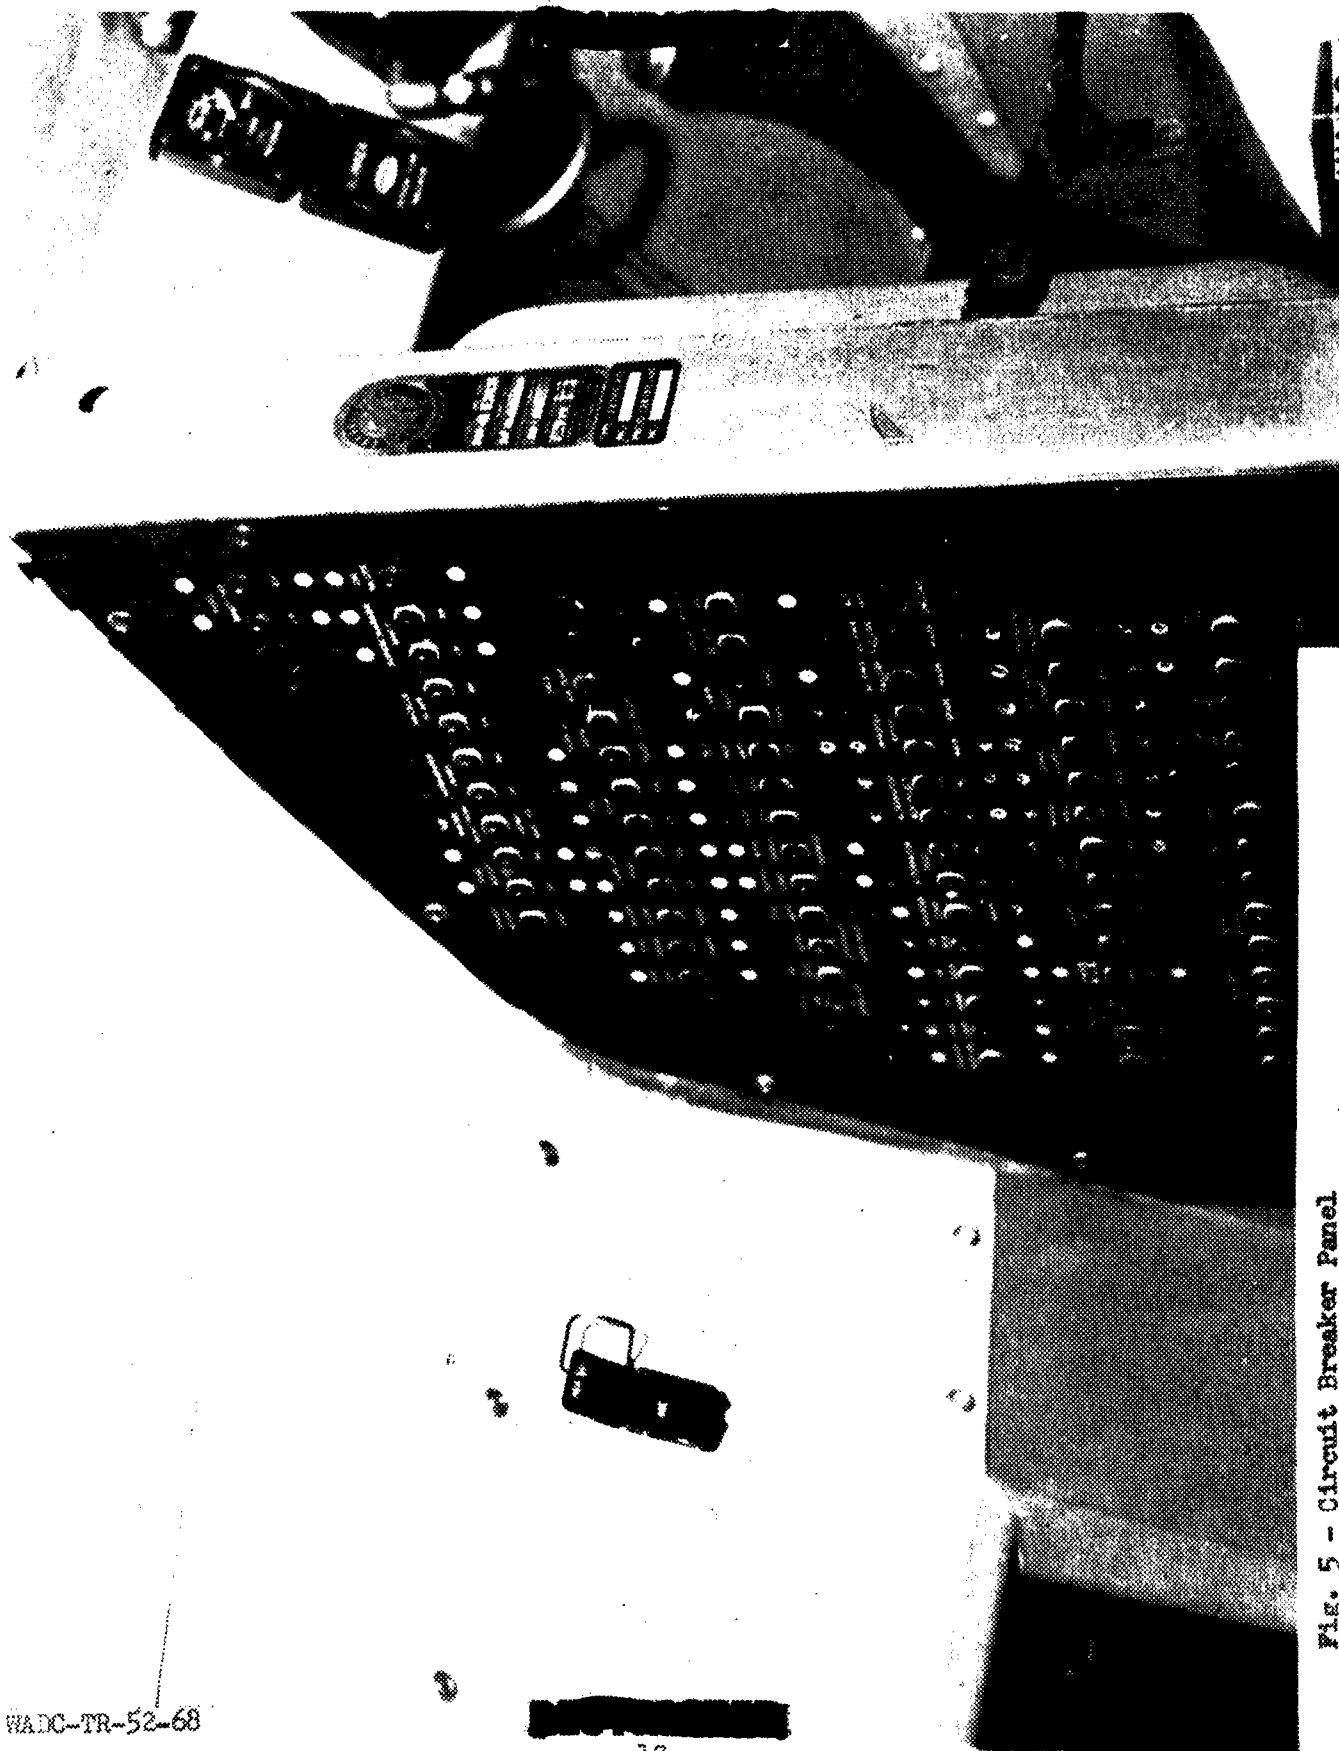
Fig. 5 - Circuit Breaker Panel

- (1) The circuit breaker panel behind the copilot is unlighted and, when flying at night, it is necessary to use either the dome light or a flashlight to check the circuit breakers. (See Fig 5).
- (2) The trim tab indicators are unlighted.
- (3) The white flood light, installed on the pilot's dome light panel and actuated by the switch on the pilot's and copilot's control wheel, satisfactorily floods the cockpit with light. However, by inadvertently touching the switch on the wheel, as has often been done, both the pilot and copilot are distracted. There is seldom, if any, occasion to momentarily use this light.

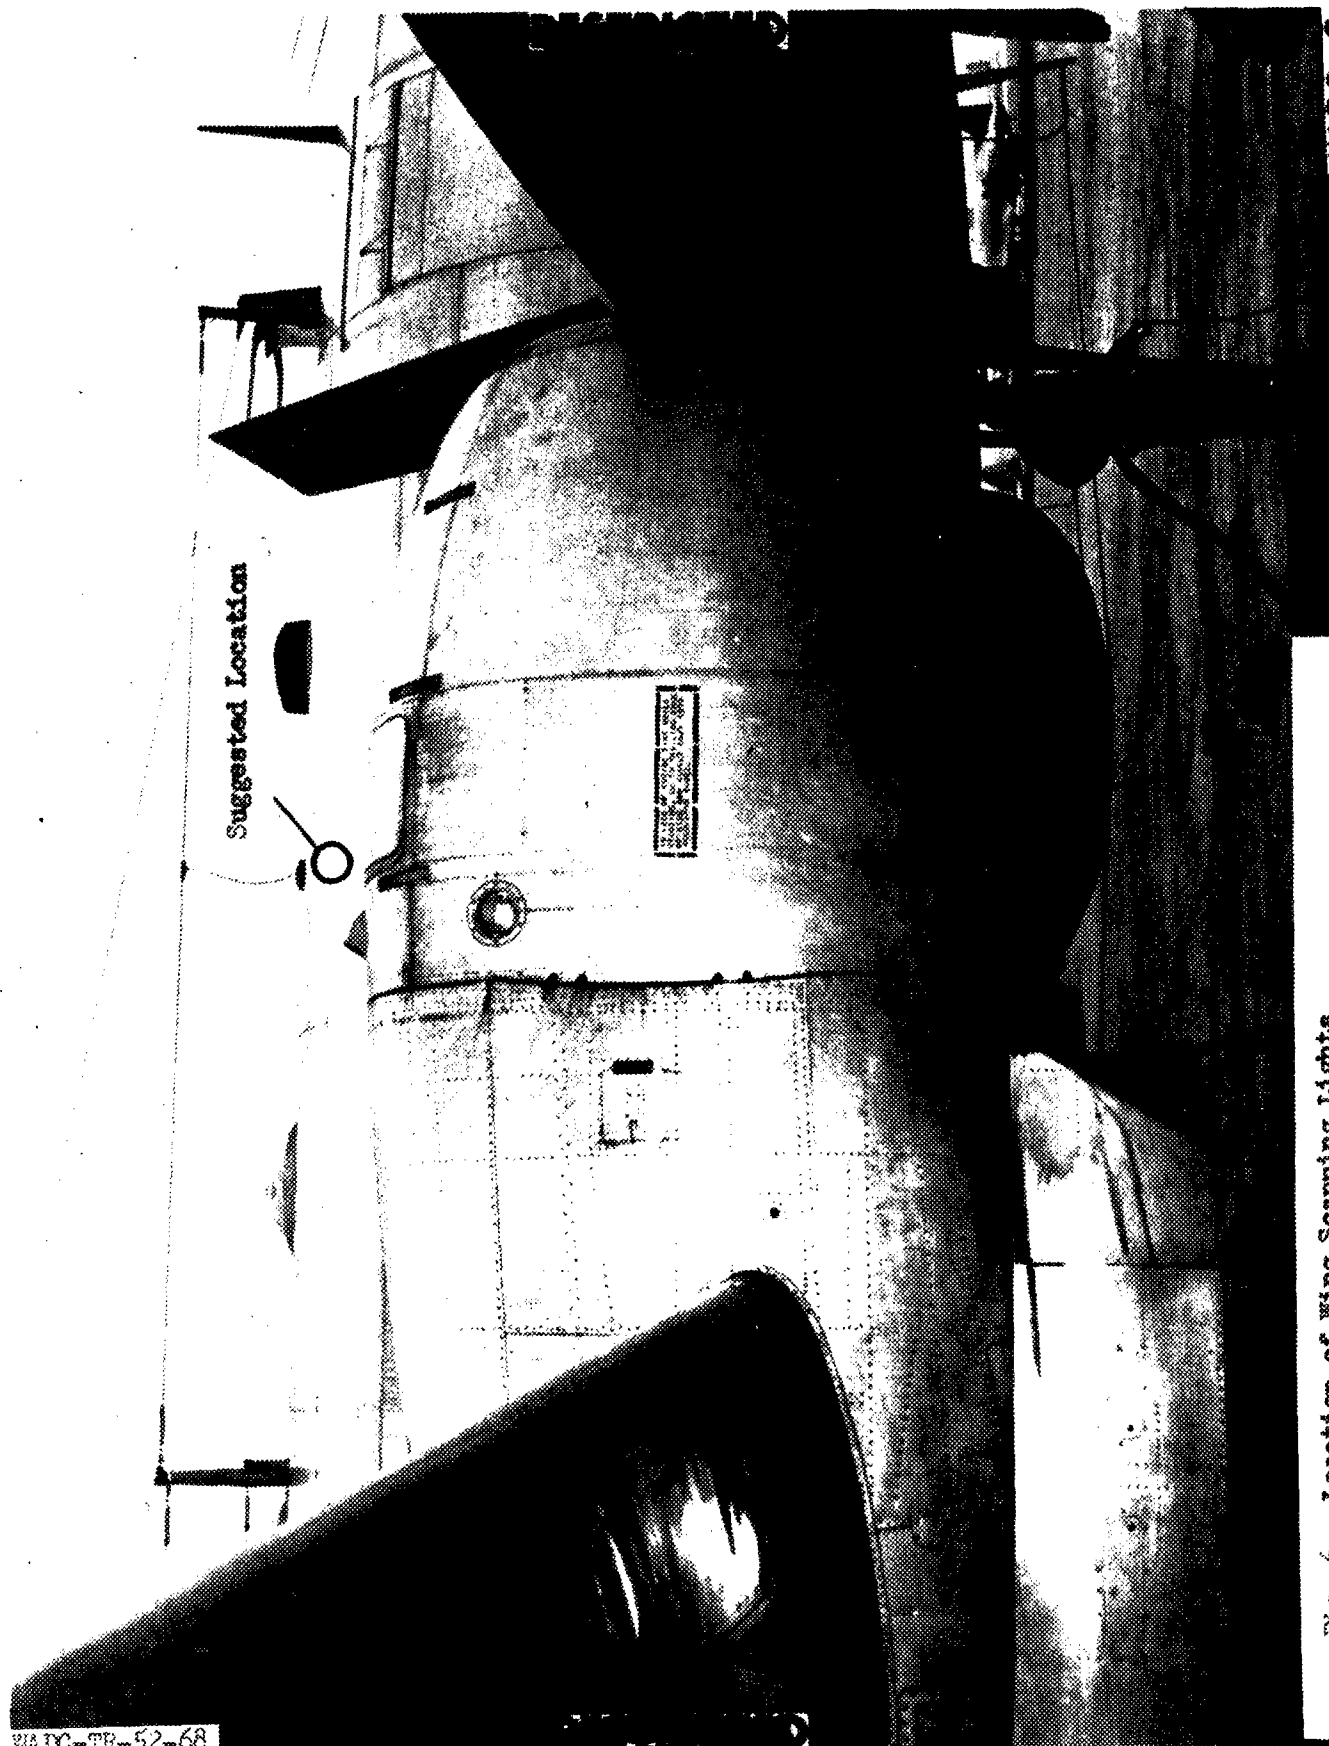
Fig. 6 - Location of Wing Scanning Lights

- (1) The exterior lighting is satisfactory.
- (2) The taxi light, mounted on the nose-wheel strut, is excellent for use during ground operation. It turns with the nose wheel and enables the pilot to locate the taxiways after landing. It also saves an immense drain on the battery which normally results when using the landing lights for taxiing.
- (3) The wing scanning lights, located outboard of each engine nacelle, are excellent for determining wing icing during flight at night. Their useful function could be enhanced by placing them in the upper portion of the fuselage. In this position it would enable the pilot to scan the engine nacelles for oil leaks as well as ice build-up on the wings. (See Fig 6).

19. Relocate the scanning lights from their present location to a position near the top of the fuselage.
