Name Of Dam: BENS BRANCH DAM
Location: WISE COUNTY, VIRGINIA
Inventory Number: VA. NO. 19509

PHASE I INSPECTION REPORT

NATIONAL DAM SAFETY PROGRAM

Name of Dam: Bens Branch Dam, Va. No. 19509
State: Virginia
County: Wise
Coordinates: Lat 36° - 54.1' Long 82° - 45.1'
USGS Quad Sheet: Appalachia
Stream: Bens Branch
Date of Inspection: May 23, 1979

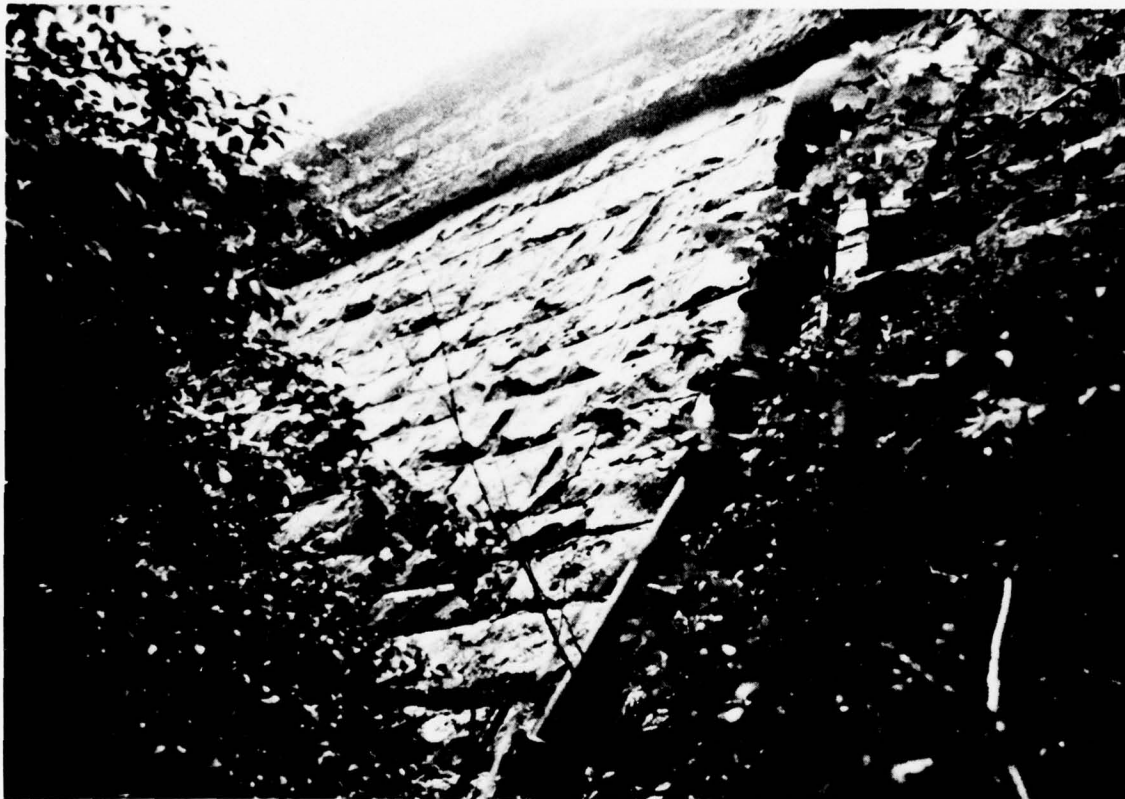
PHOTO OF FACE AND WATER INTAKE TO WATER TREATMENT PLANT
