MOSS NO. 2

RUSSELL COUNTY, VIRGINIA

Inventory Number: VA. NO. 16705

PHASE I INSPECTION REPORT

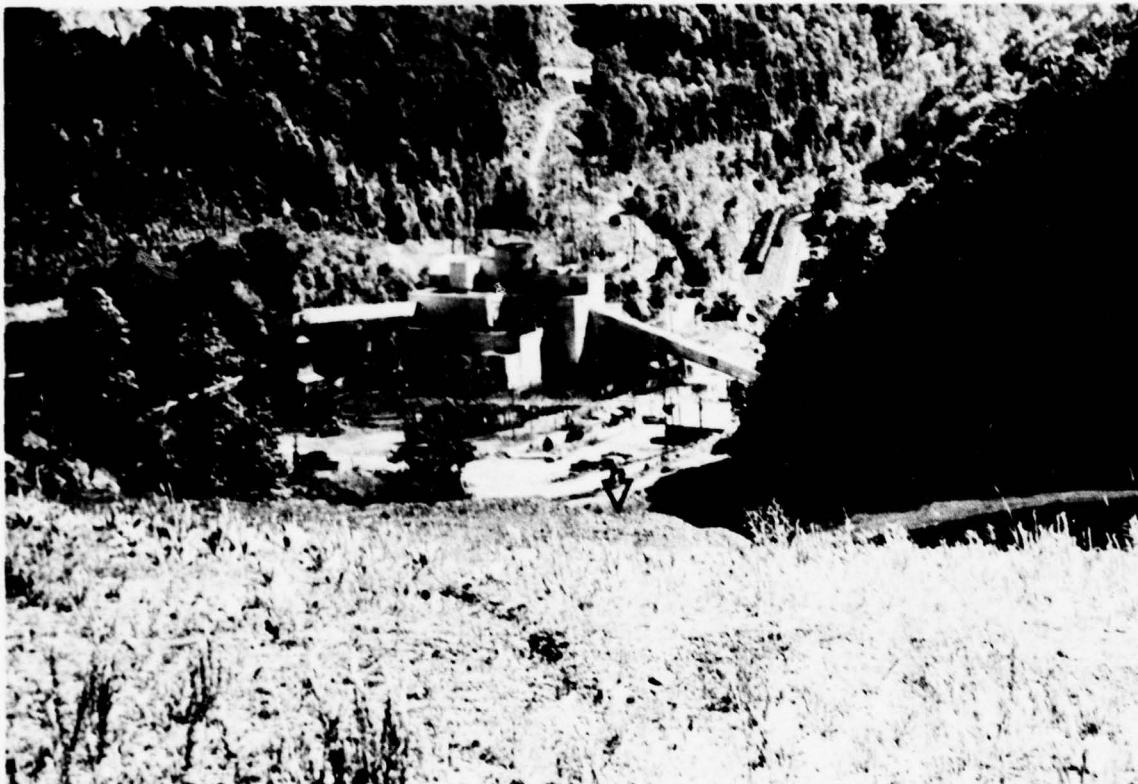
VIEW FROM TOP OF DAM LOOKING DOWNSTREAM AT TOE OF DAM AND MINING OPERATION IN VALLEY BELOW IMPOUNDMENT. (ARROWS DENOTE BOTH SPILLWAY LOCATIONS)

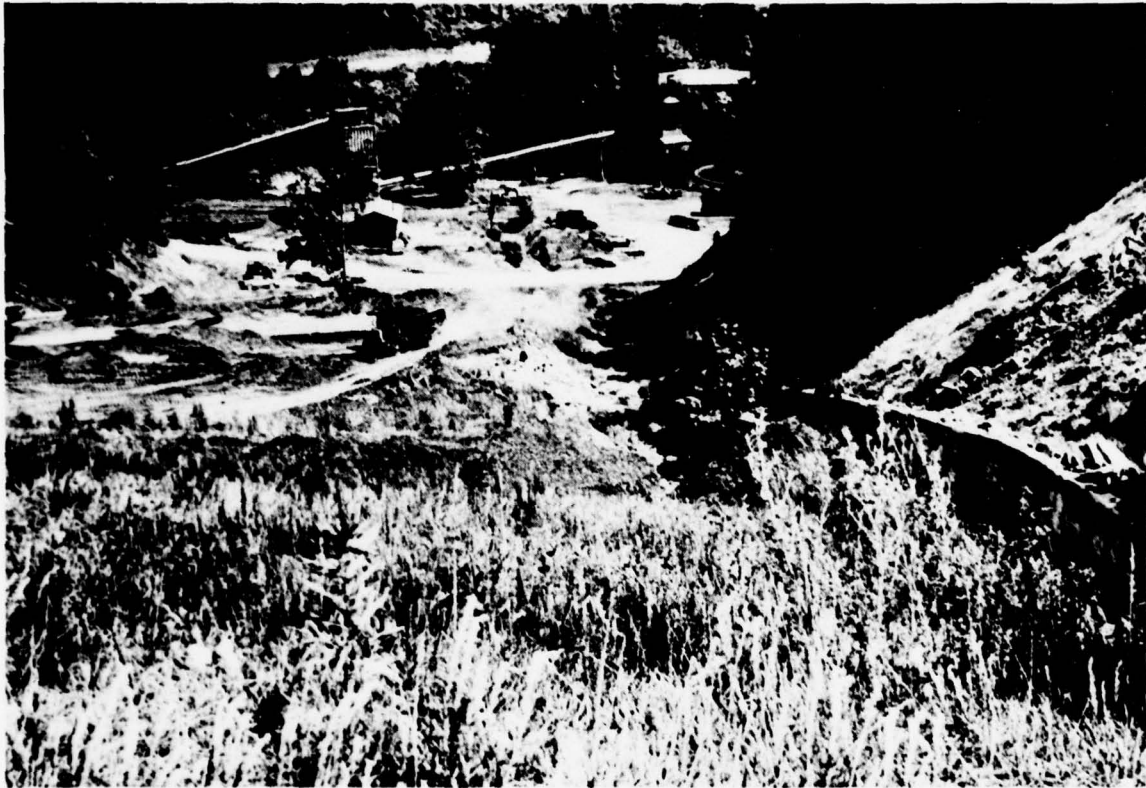
VIEW OF THE END OF CONCRETE SPILLWAY (ARROW)
AND DISCHARGE CHANNEL TO STILLING BASIN
