Name Of Dam: DIXIANA DAM
Location: WISE COUNTY, VIRGINIA
Inventory Number: VA. NO. 19505

PHASE I INSPECTION REPORT

NATIONAL DAM SAFETY PROGRAM

SCHNABEL ENGINEERING ASSOCIATES, P.C./
J. K. TIMMONS AND ASSOCIATES, INC.

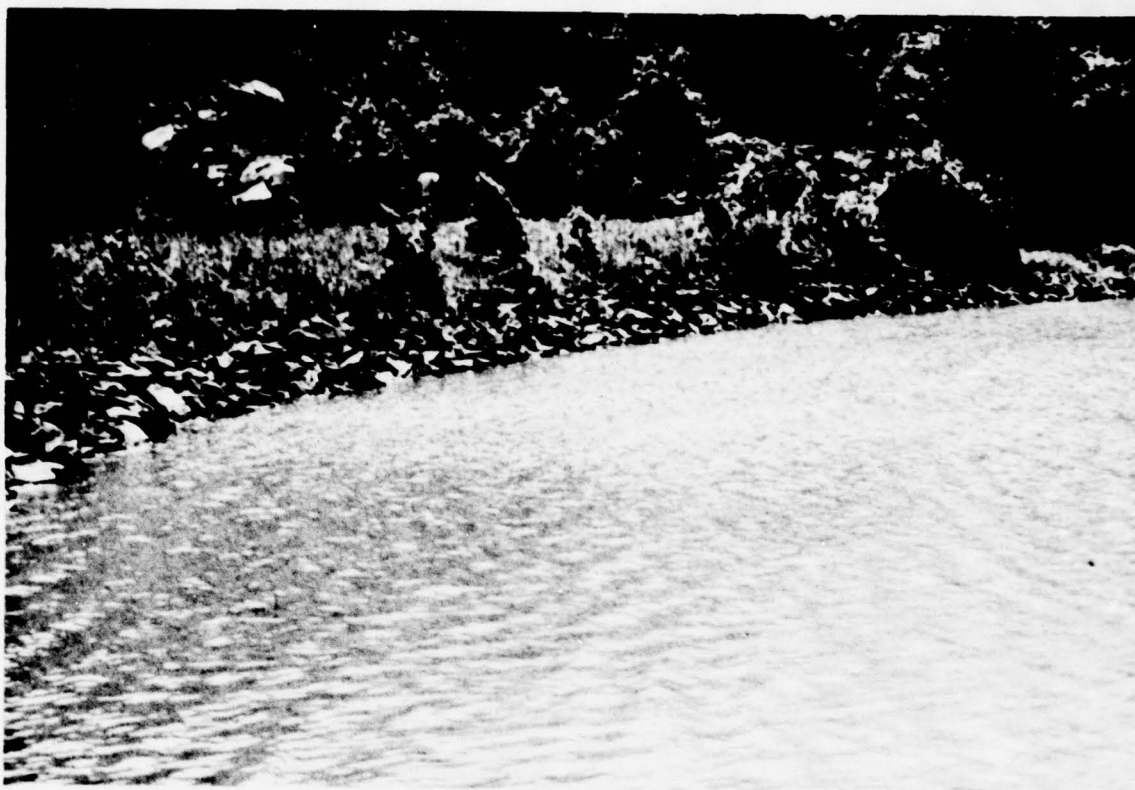
VIEW OF UPSTREAM FACE OF DAM AND RIP RAP

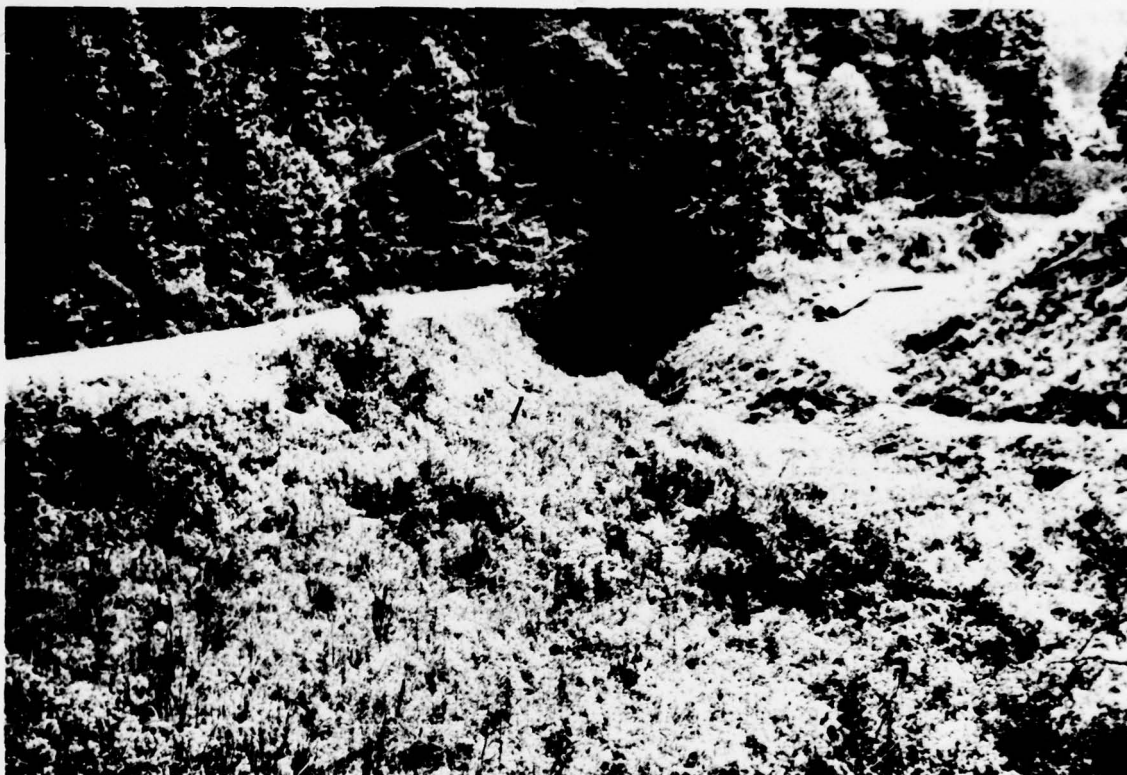
VIEW OF DOWNSTREAM CHANNEL AREA
(NOTE: STATE ROADWAY TO LEFT OF OUTLET CHANNEL)

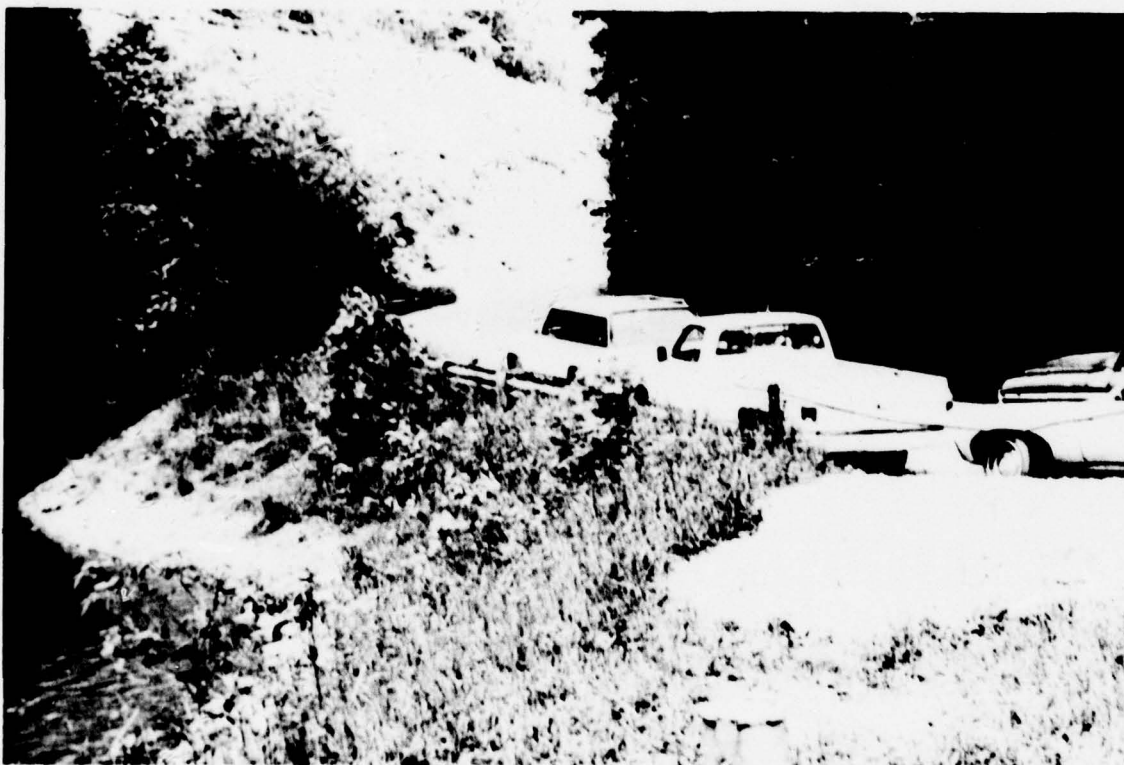
The abutment slopes were considered safe and stable at the time of the inspection. Only minor sloughing was observed, particularly in the basal 15 ft of the emergency spillway.

VIEW OF LEFT ABUTMENT

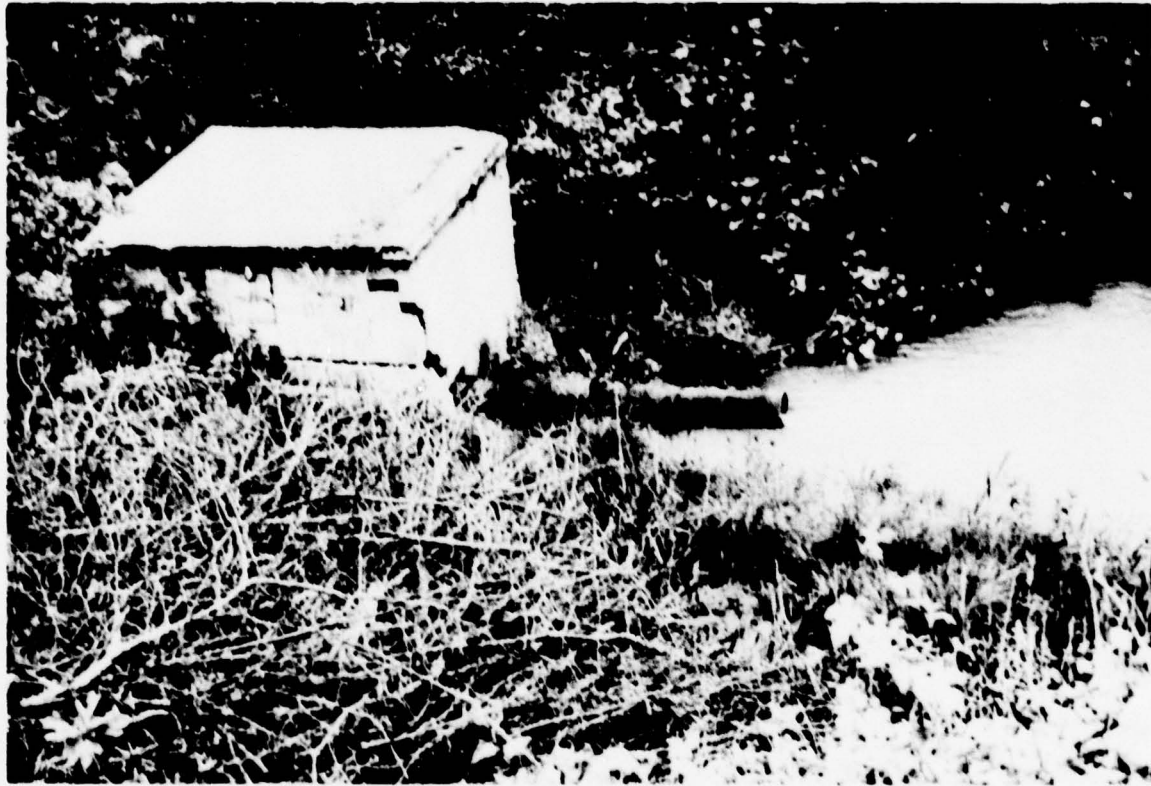
PRINCIPAL SPILLWAY DISCHARGE

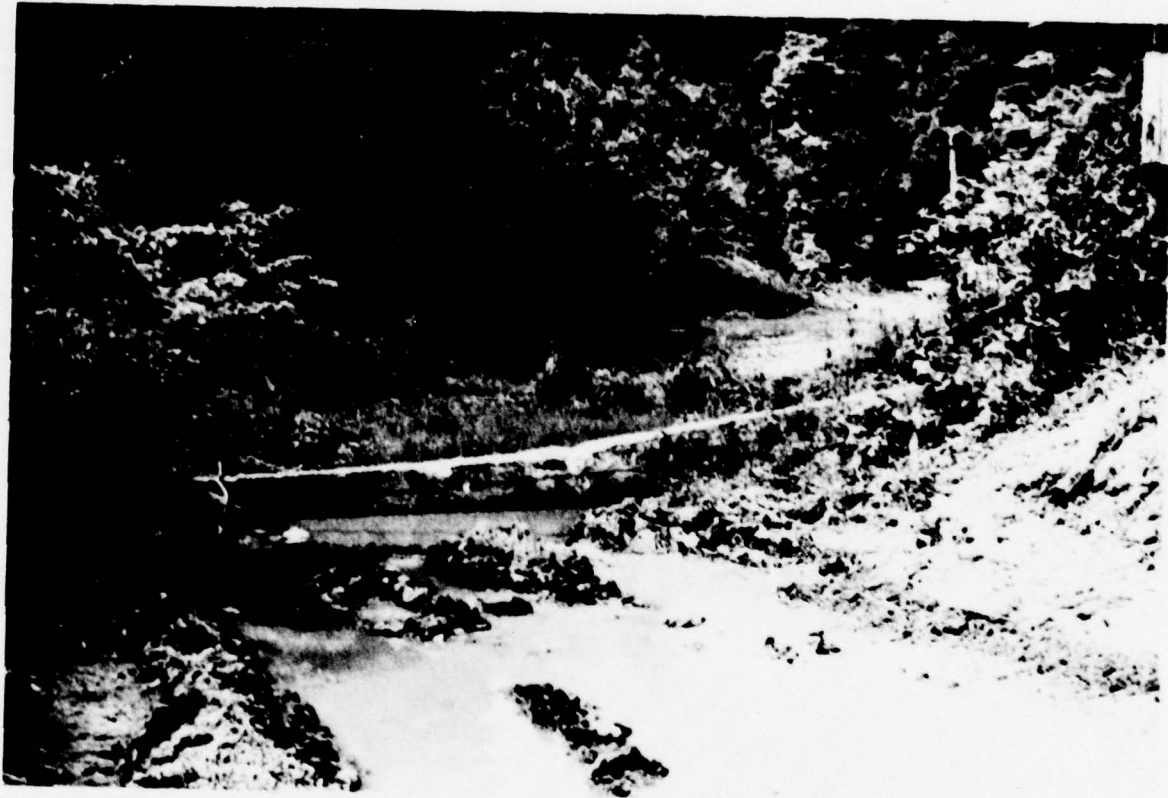
EMERGENCY SPILLWAY LOOKING UPSTREAM

1.3 Sloughing or Erosion: No sloughing or erosion was noted on the embankment. Some erosion was noted in the basal 15 ft of the emergency spillway.

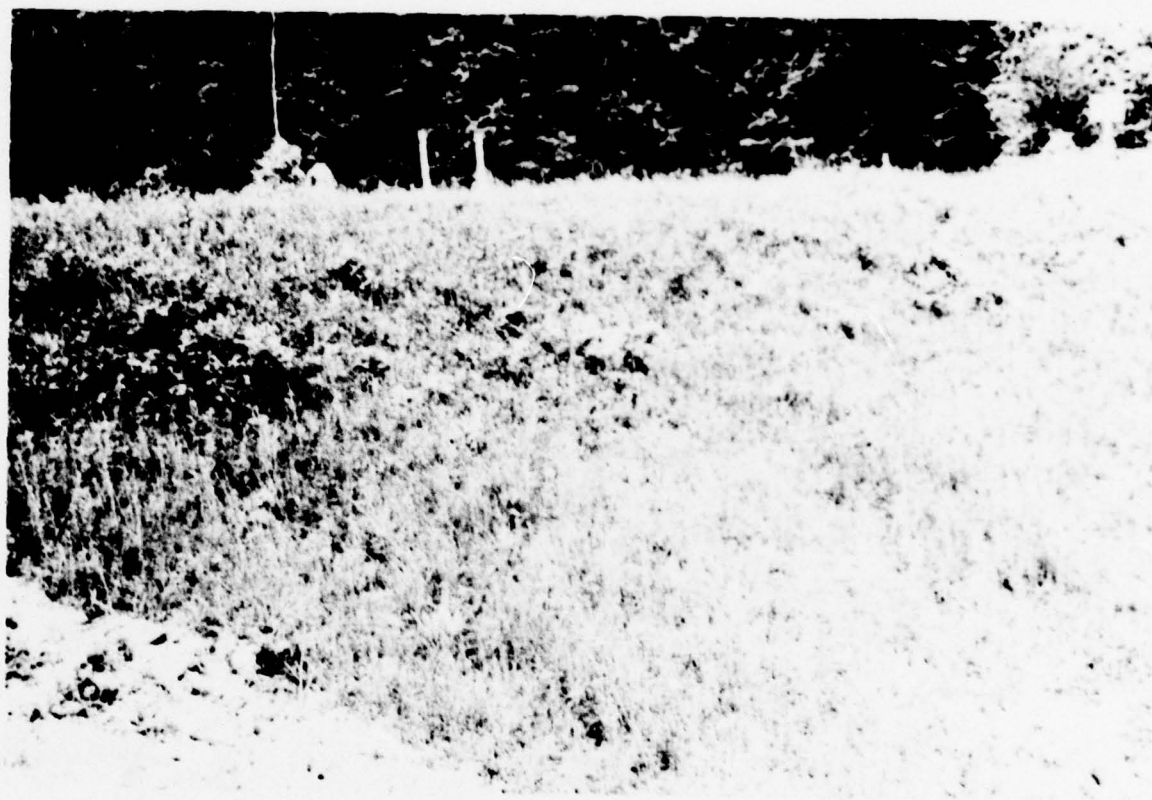
DOWNSTREAM FACE OF EARTH EMBANKMENT
(NOTE: **WATER** OBSERVATION WELLS SHOWN BY ARROWS)

1.7 Seepage: Iron-stained seepage estimated at about one gpm and 8-10 ft[±] below normal pool was encountered along the left and right downstream abutment embankment junctions in areas containing abundant cattails and marsh grass. The downstream toe of the structure was also saturated.
