Research
Note
FPL-0240

By
G.E. SHERWOOD
and
W.A. GATZ
Forest Products Laboratory,²
Forest Service
U.S. Department of Agriculture

Performance of Wood in a Do-It-Yourself Solar Collector¹

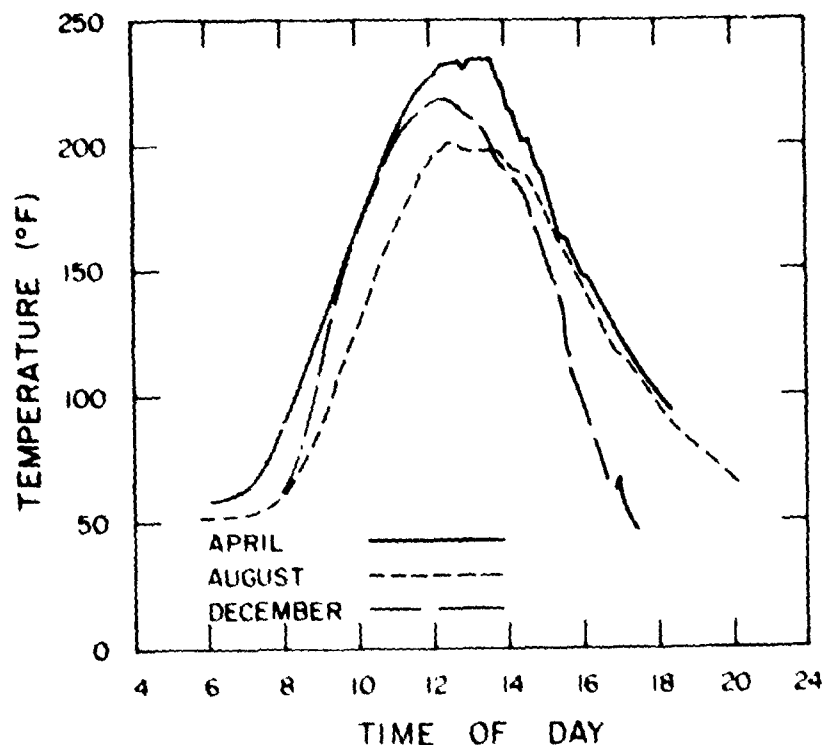
200° F on the selected sunny day in August, and only one panel (No. 3) had temperatures exceeding 200° F on the selected sunny day in December. The highest temperatures were in Panel 3, which had temperatures above 200° F on 123 days or about one-third of the days of a year.

Temperature cycles for Panel 3 on selected sunny days in early spring, late summer and winter are shown in figure 4.

Figure 4. Temperature cycles in Panel 3 for a selected sunny day of each of the three months.

Spontaneous ignition has occurred in wood heated above 212° F for long times, so the collector panels tested should not be maintained at stagnation conditions for long times. Under operating conditions, temperatures should be kept below 212° F.
