SAW CREEK CLUB DAM

NDI ID NO. PA-00764
DER ID NO. 52-7

PHASE I INSPECTION REPORT
NATIONAL DAM INSPECTION PROGRAM

FEBRUARY 1980

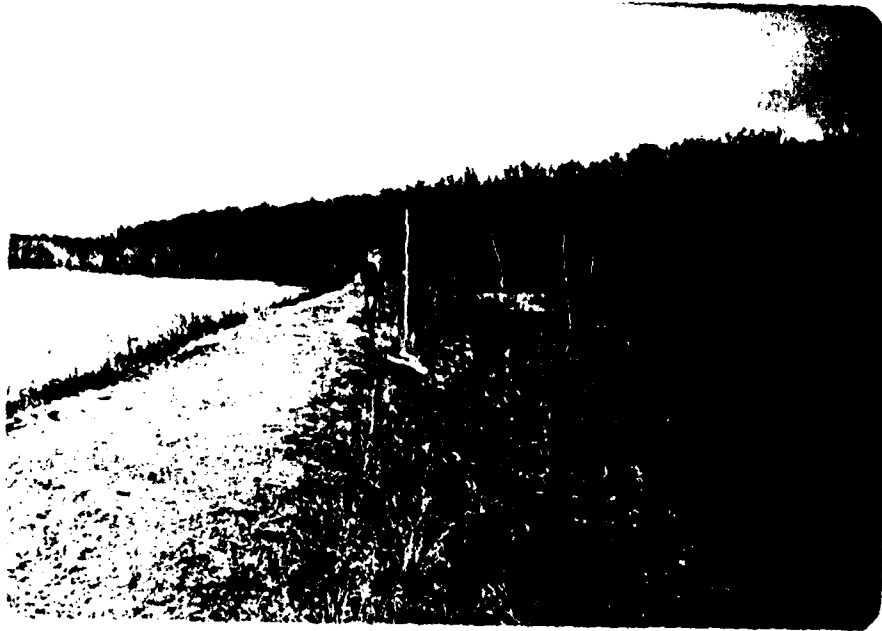
b. Embankment. The riprap on the upstream slope is in good condition. There is high grass and very low brush growing in the upstream slope (Photograph B). The downstream slope is slightly uneven. It has low brush and a few small trees growing on it (Photograph C). The brush is significantly thicker to the right of the outlet works, near the right abutment (Photograph I). To the left of the outlet works, the downstream toe is protected by large boulders. The boulders also act as the right bank of the spillway exit channel (Photograph A).

A. Downstream Slope

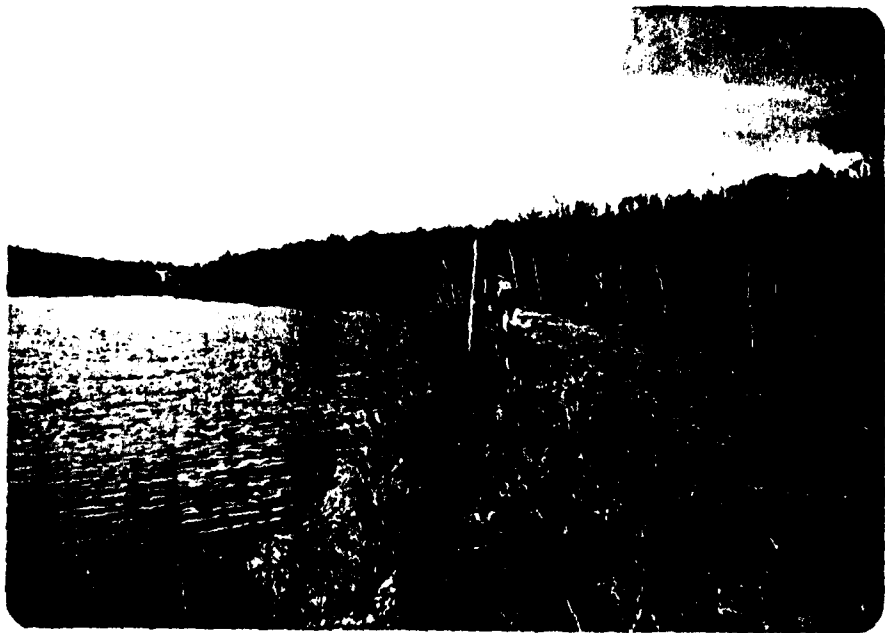
B. Upstream Slope

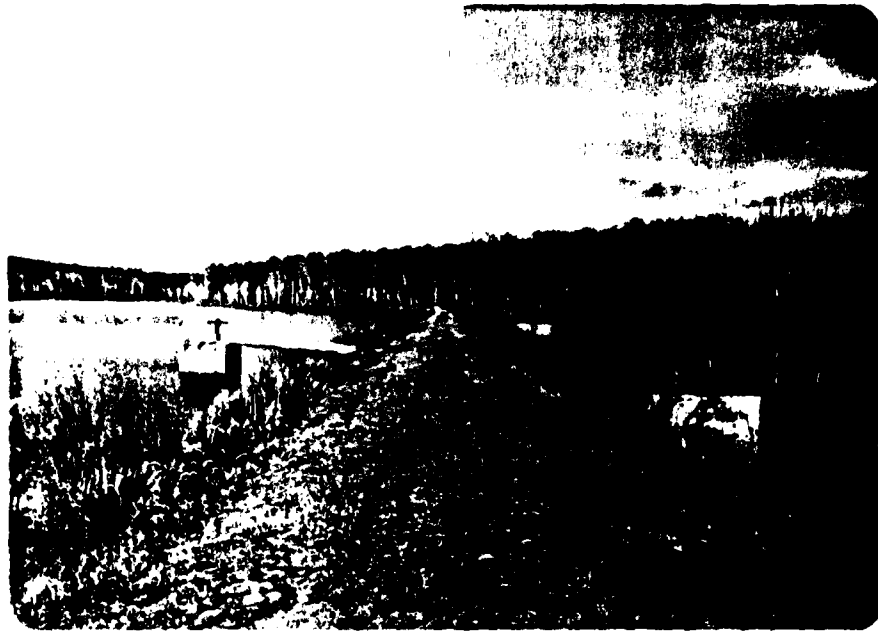
C. Top of Dam and Outlet Works

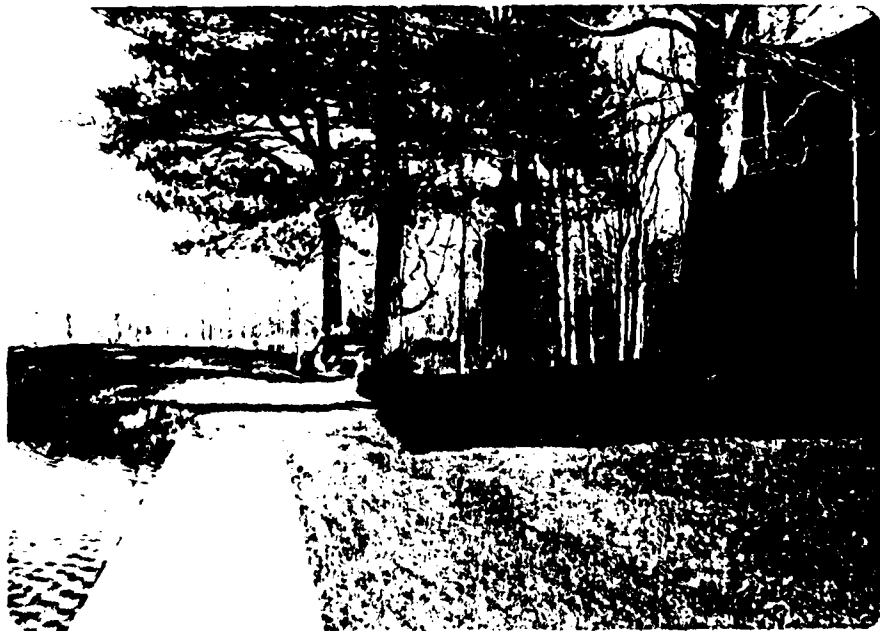
(2) Embankment. The low areas on the top of the dam limits the existing spillway capacity to less than the design capacity. The low areas at the right abutment beyond the clubhouse do not present a hazard to the dam because any flow through them would be directed away from the toe of the embankment.

F. Low Area at Right Abutment
