PANTHER LAKE DAM

(NDI ID No. *PA-00416*,  
DER ID No. *52-157*),

PHASE I INSPECTION REPORT,  
NATIONAL DAM INSPECTION PROGRAM

FEBRUARY 1980

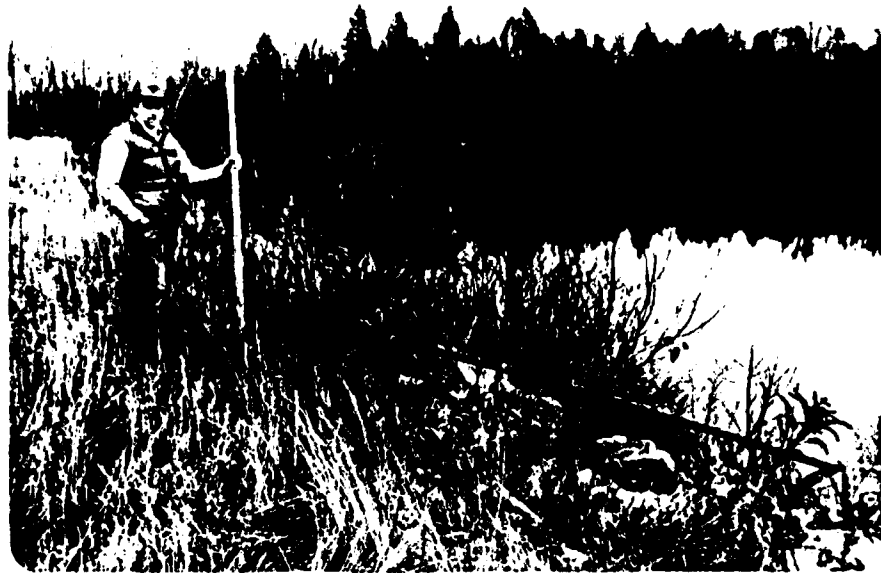
| <u>Feature and Location</u> | <u>Observed Deficiency</u> |
|---|---|
| <u>Outlet Works:</u> | Handle for gate operating mechanism missing; operational adequacy uncertain. |

| VISUAL EXAMINATION OF | OBSERVATIONS | REMARKS OR RECOMMENDATIONS |
|---|---|---|
| EMERGENCY GATE | Gate operator at top of dam. No apparent deficiencies but not operated. Stem rusty. | Gate was tightly sealed and had no leakage. Owner was not on site during inspection. |

G. Gate Operating Mechanism.

(1) Ensure the operational adequacy of the outlet works and operate the gate at regular intervals.

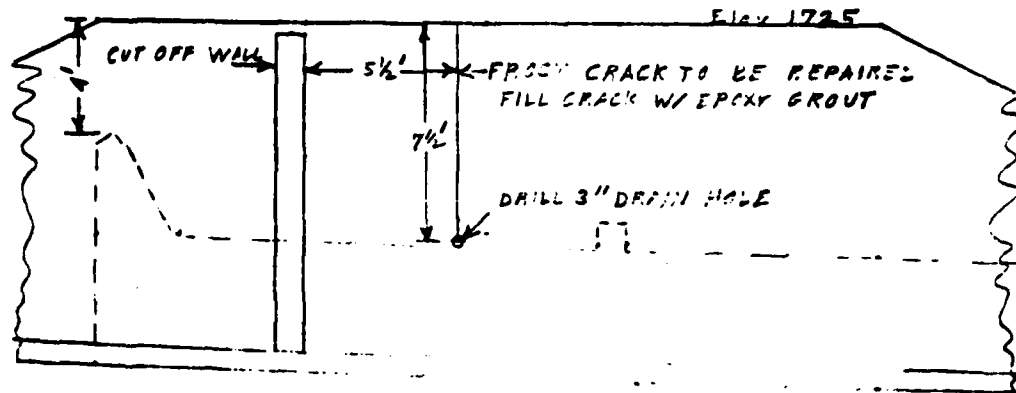
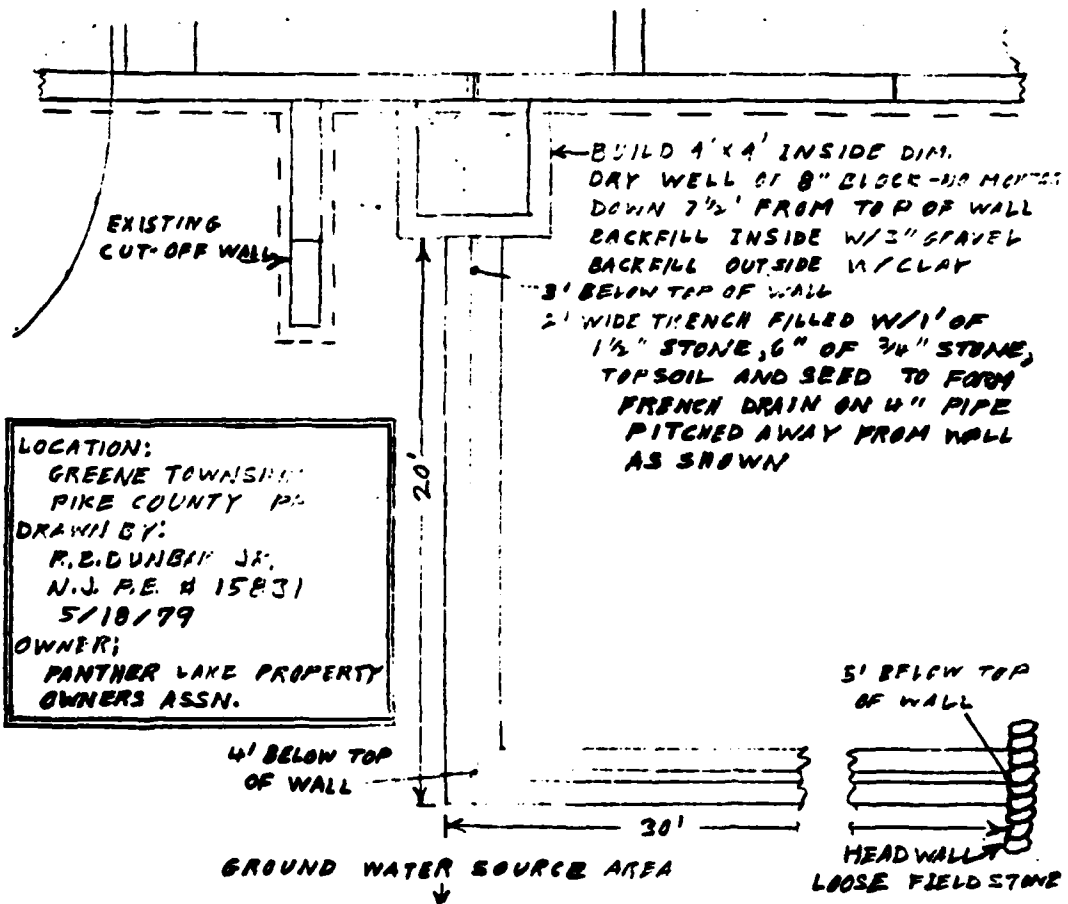
PHASE I INSPECTION REPORT  
NATIONAL DAM INSPECTION PROGRAM  
PANTHER LAKE DAM  
PANTHER LAKE PROPERTY  
OWNERS ASSOCIATION  
PROPOSED REPAIRS TO  
STILLING BASIN WALL  
FEBRUARY 1980 PLATE E-5

# PROPOSED REPAIR OF SPILLWAY WALL - PANTHER LAKE

(3) Appurtenant Structures. Construction of drainage facilities behind the right wall of the stilling basin was in progress at the time of the inspection. The presence of flowing water from the hillside above the area to be repaired indicates that drainage facilities, as are now being constructed, are warranted. Details of the proposed repairs are shown on Plate E-5.
