OHIO RIVER BASIN
TRAVERSE RUN, BEAVER COUNTY
PENNSYLVANIA

GROUP CAMP DAM

NDI No. PA 00259

PHASE I INSPECTION REPORT
NATIONAL DAM INSPECTION PROGRAM

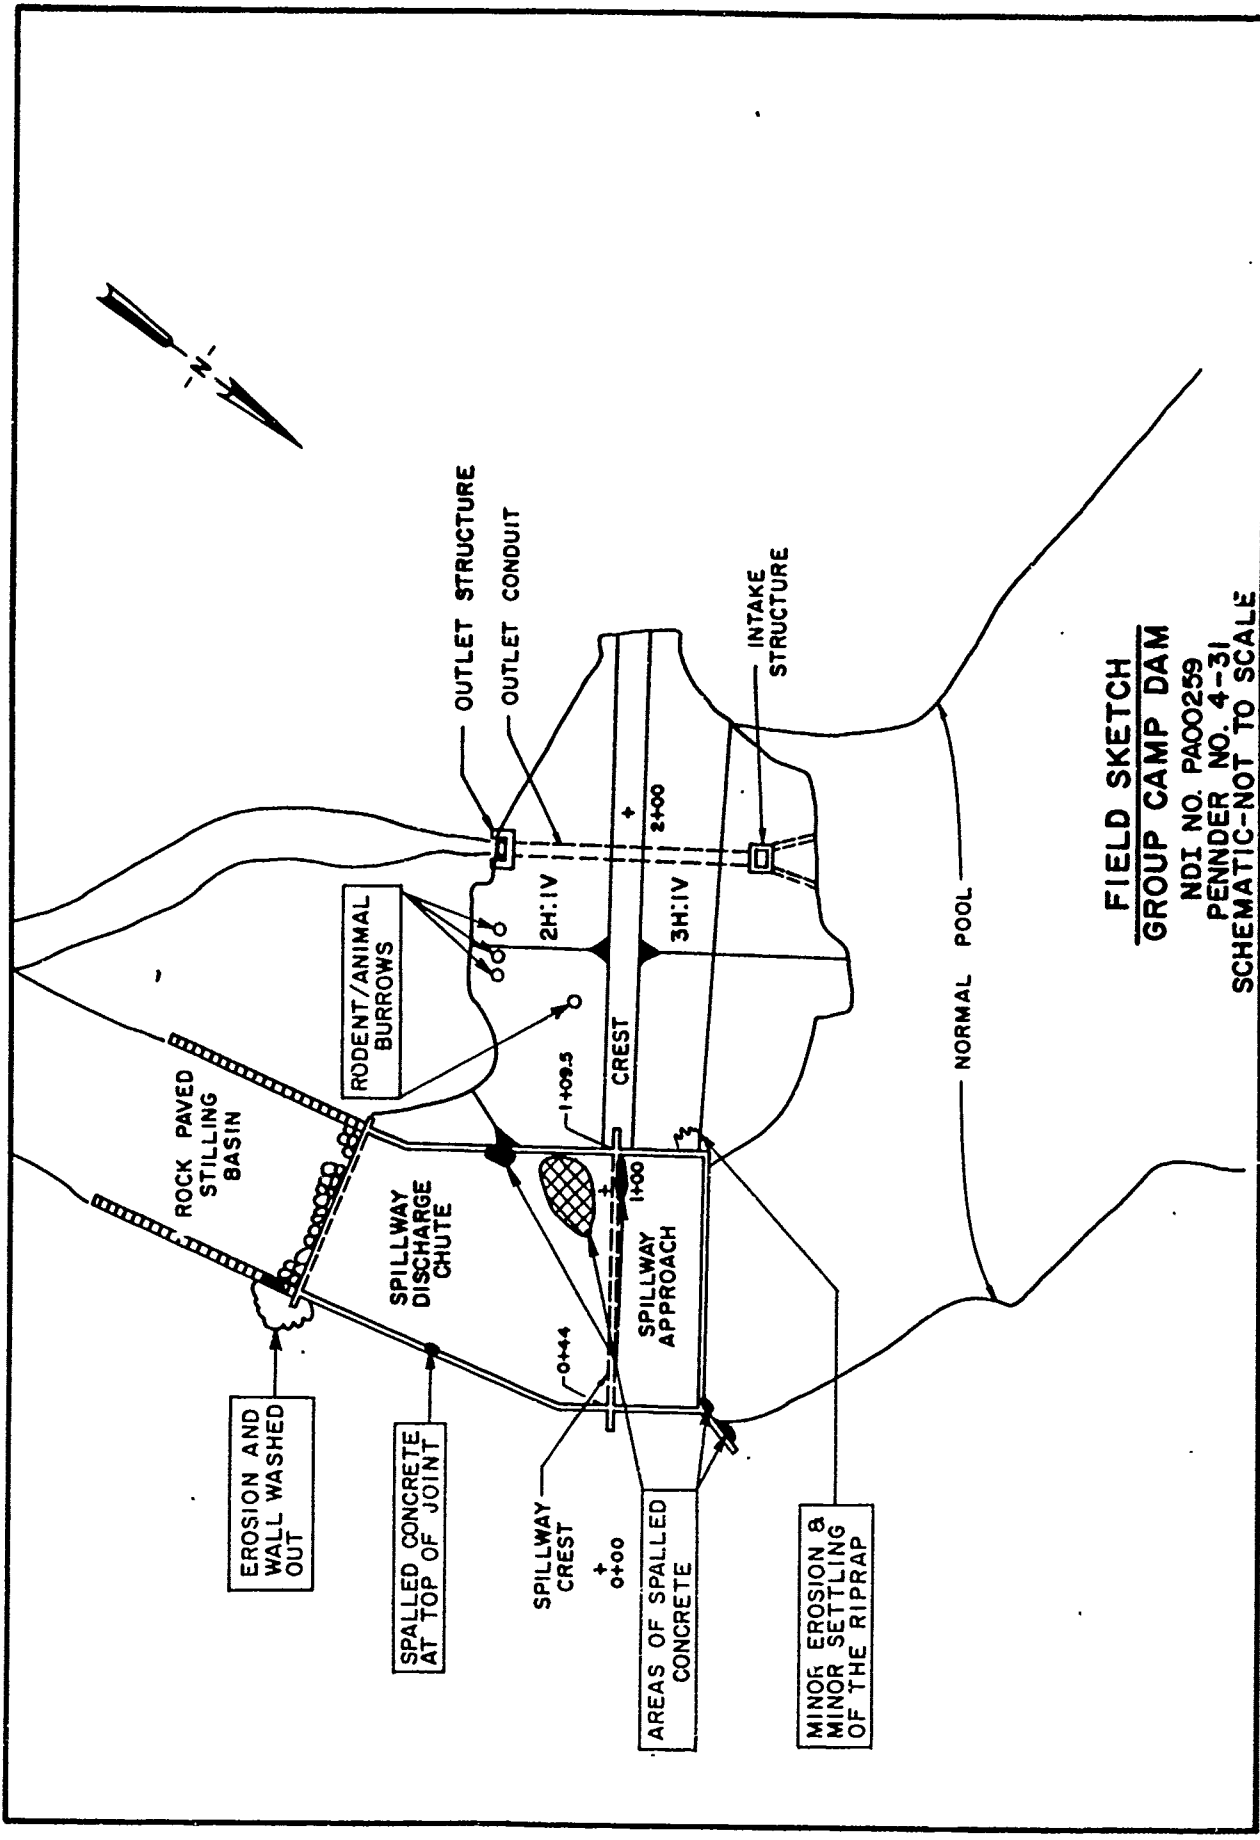
FIELD SKETCH
GROUP CAMP DAM

Several rodent holes were observed in the embankment. (See Field Sketch for approximate location).

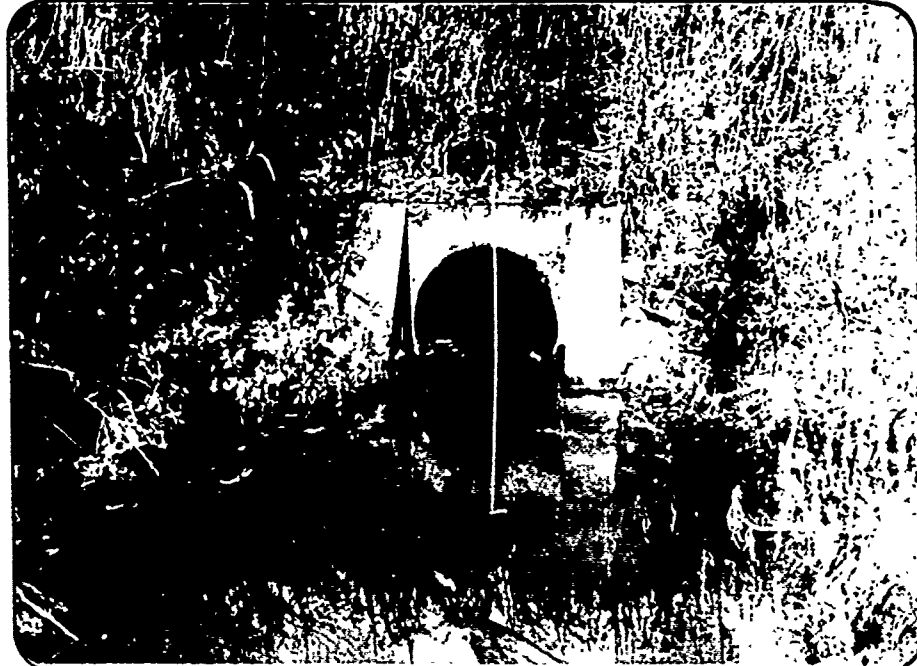
6. The condition of the conduit at the outlet works showed some corrosion of the 36 inch corrugated metal pipe. There was also erosion around the head wall and some debris and sediment in the discharge channel.

PHOTO 6. View of Outlet Conduit and Outlet Head Wall
