CANONSBURG DAM No. 2 (JOHNSONS RUN DAM)
~~WASHINGTON COUNTY, COMMONWEALTH OF PENNSYLVANIA~~

NDI Number PA 00506

PHASE I INSPECTION REPORT
NATIONAL DAM INSPECTION PROGRAM

Prepared for: DEPARTMENT OF THE ARMY
Baltimore District, Corps of Engineers
Baltimore, Maryland 21203

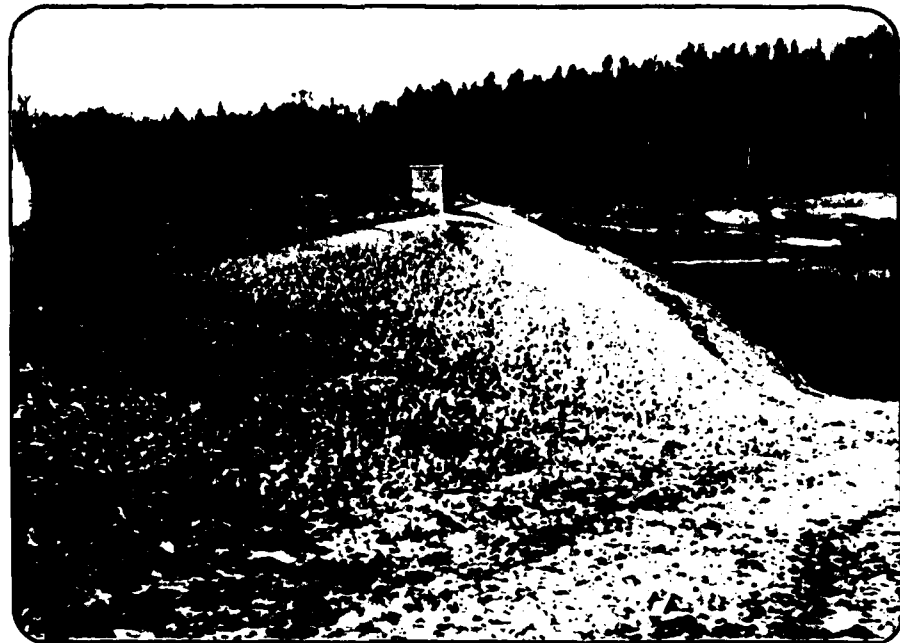
View of Upstream Slope from Left Abutment

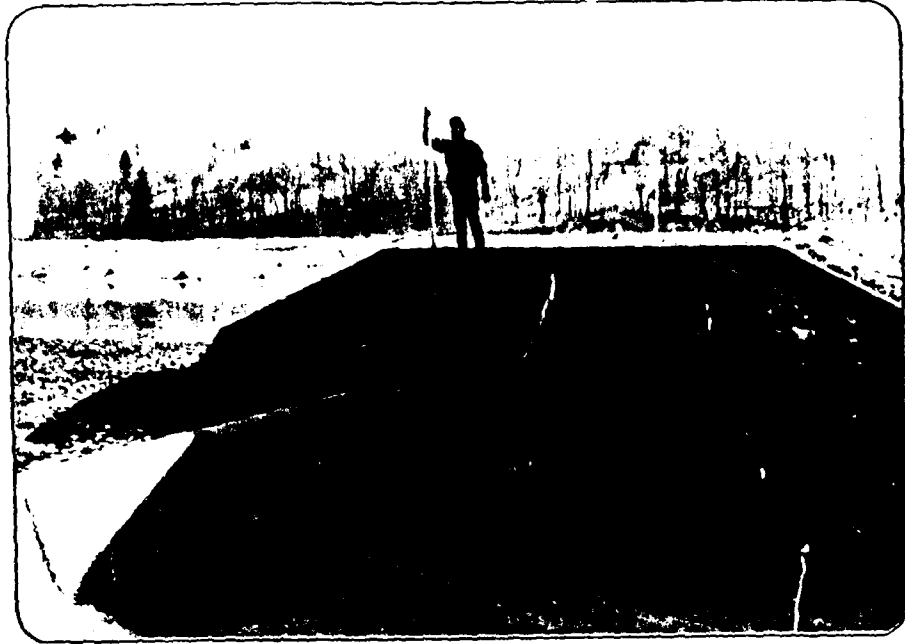
PHOTO 3. View of Spillway Overflow Weir and Training Wall

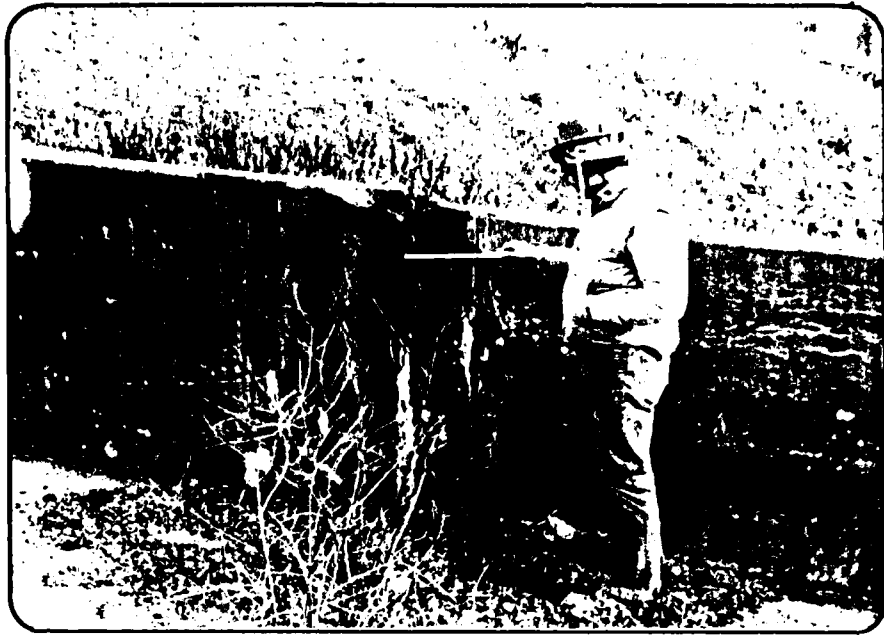
PHOTO 5. Close-up View of Spillway Training Wall Joint

- 1) Fill the low areas of the embankment on both the right and left side of the spillway structure.
- 2) Repair the spalled concrete of the spillway structure at the entrance to the spillway, the joints of the chute channel walls, and the end sill of the chute channel.

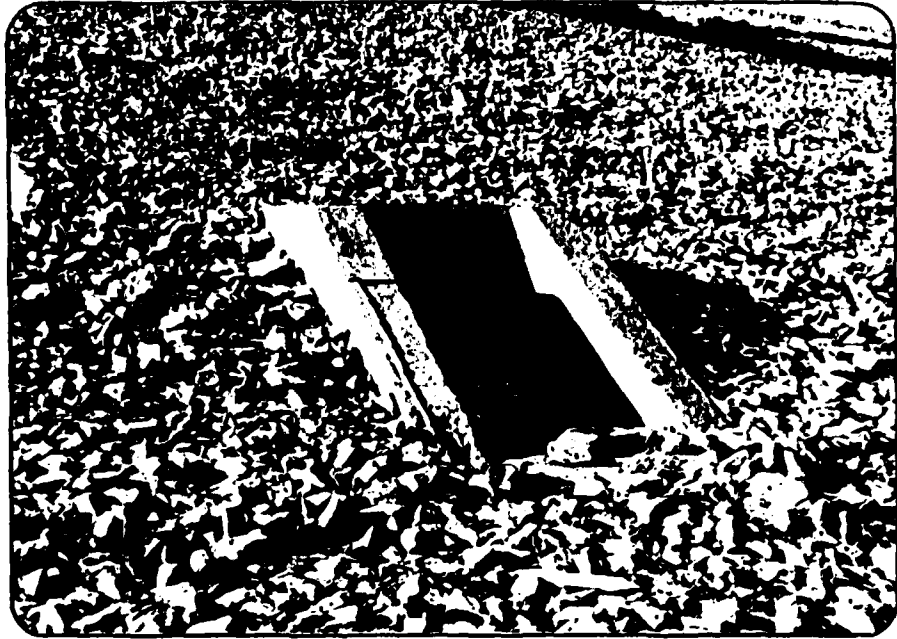
PHOTO 7. View of Upper Level Water Intake
