6
National Dam Inspection Program - Big Brown Dam
SUSQUEHANNA RIVER BASIN,
BROWNS RUN, CAMBRIA COUNTY

BIG BROWN DAM

(NDI I.D. NO: PA-00502,
DER I.D. NO: 11-1)

PHASE I INSPECTION REPORT
NATIONAL DAM INSPECTION PROGRAM

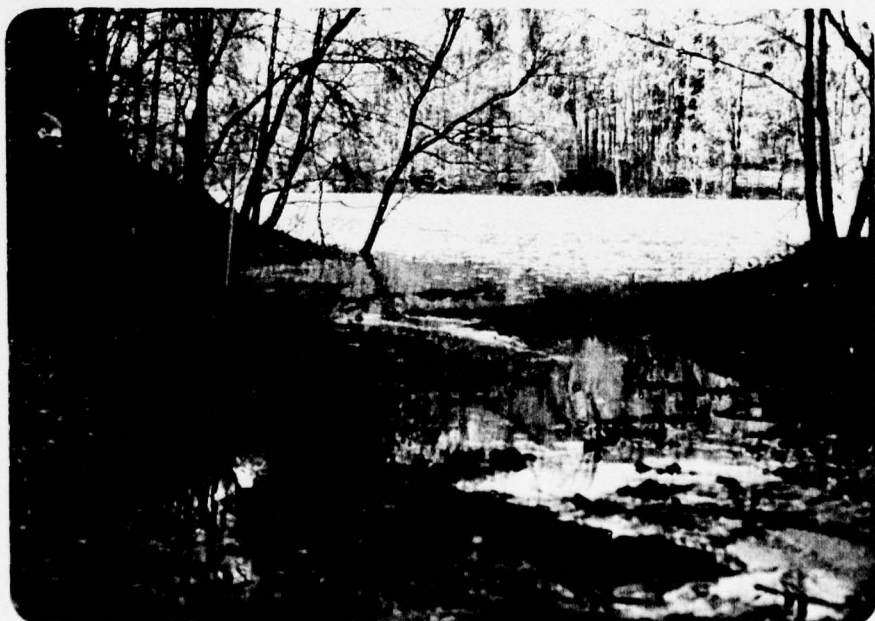
Photograph No. 2
Emergency spillway approach channel.

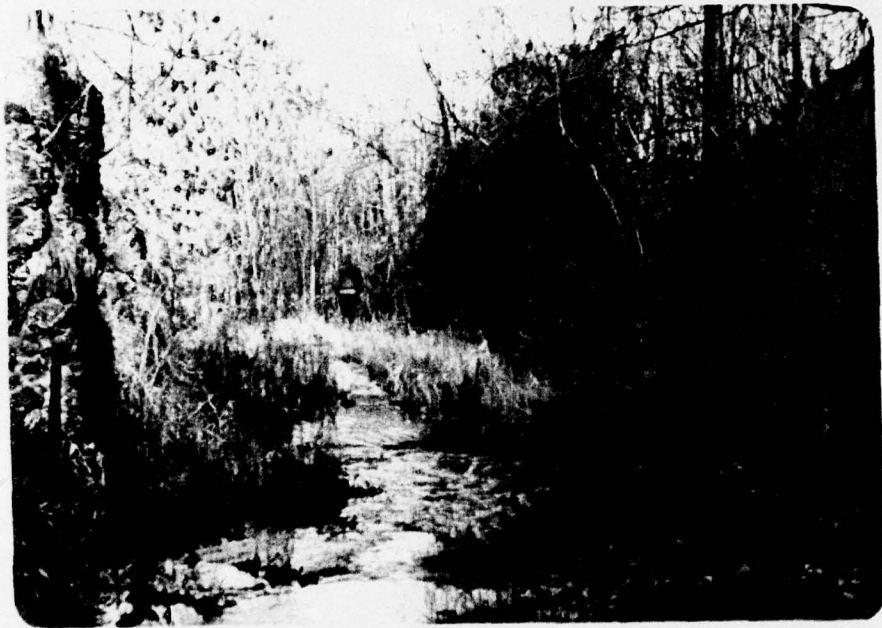
Photograph No. 3

c. Appurtenant Structures. The emergency spillway and the equipment at the operating level of the control tower, which consisted of two valve operators, were inspected. The water authority personnel indicated that although a ladder extends into the control tower from the operating level, due to the age of the dam, the strength of the ladder was questionable. Therefore, the inside of the control tower below the operating level was not inspected. The rock-cut emergency spillway channel was found to be free of obstructions to flow and in good condition.

Emergency spillway control section and discharge channel.

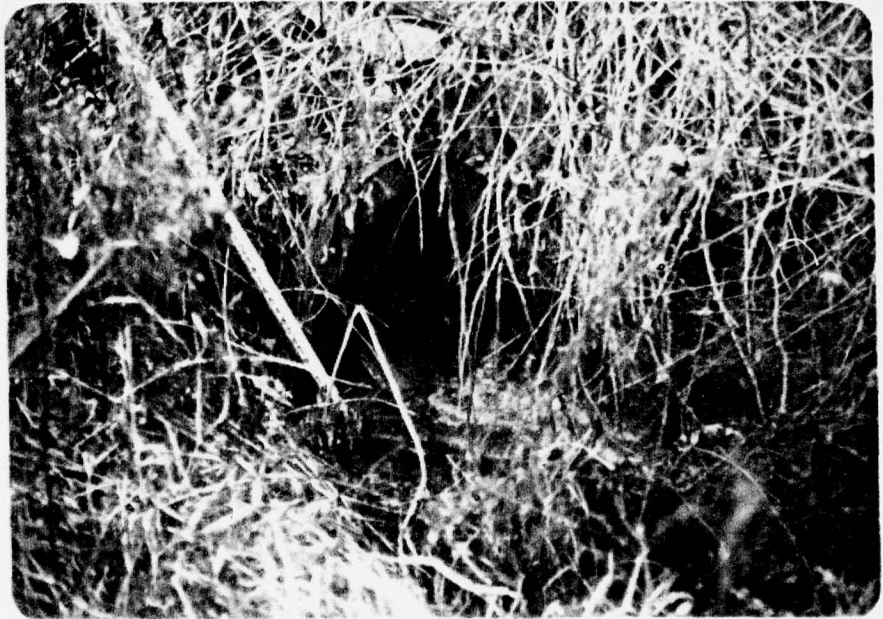
VISUAL EXAMINATION OF	OBSERVATIONS	REMARKS OR RECOMMENDATIONS
CRACKING AND SPALLING OF CONCRETE SURFACES IN OUTLET CONDUIT	(The outlet facilities were not accessible for inspection.)	
INTAKE STRUCTURE	Submerged	
OUTLET STRUCTURE	The outlet pipe directly discharges into an earth channel. There is no outlet structure.	
OUTLET CHANNEL	In fair condition.	
EMERGENCY GATE	The water authority personnel reported that the operational condition of the reservoir blow-off valve was questionable. The operational condition of this valve was not observed.	The operational condition of the blow-off valve and other outlet facilities should be reevaluated and necessary maintenance performed.

Photograph No. 5
Primary spillway outlet pipe.

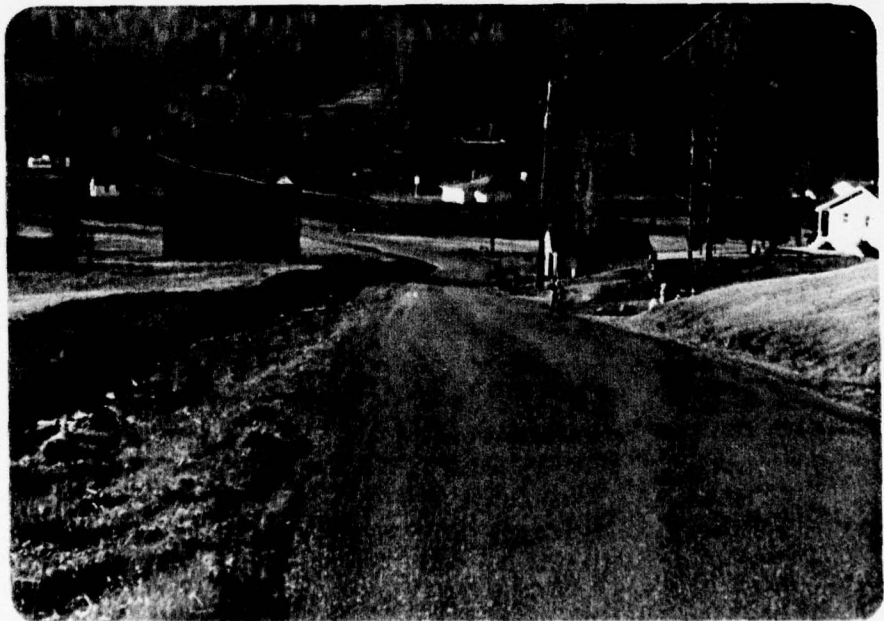
Photograph No. 6
Flood plain (Mile 1.0). Brown Run flowing
left to right.

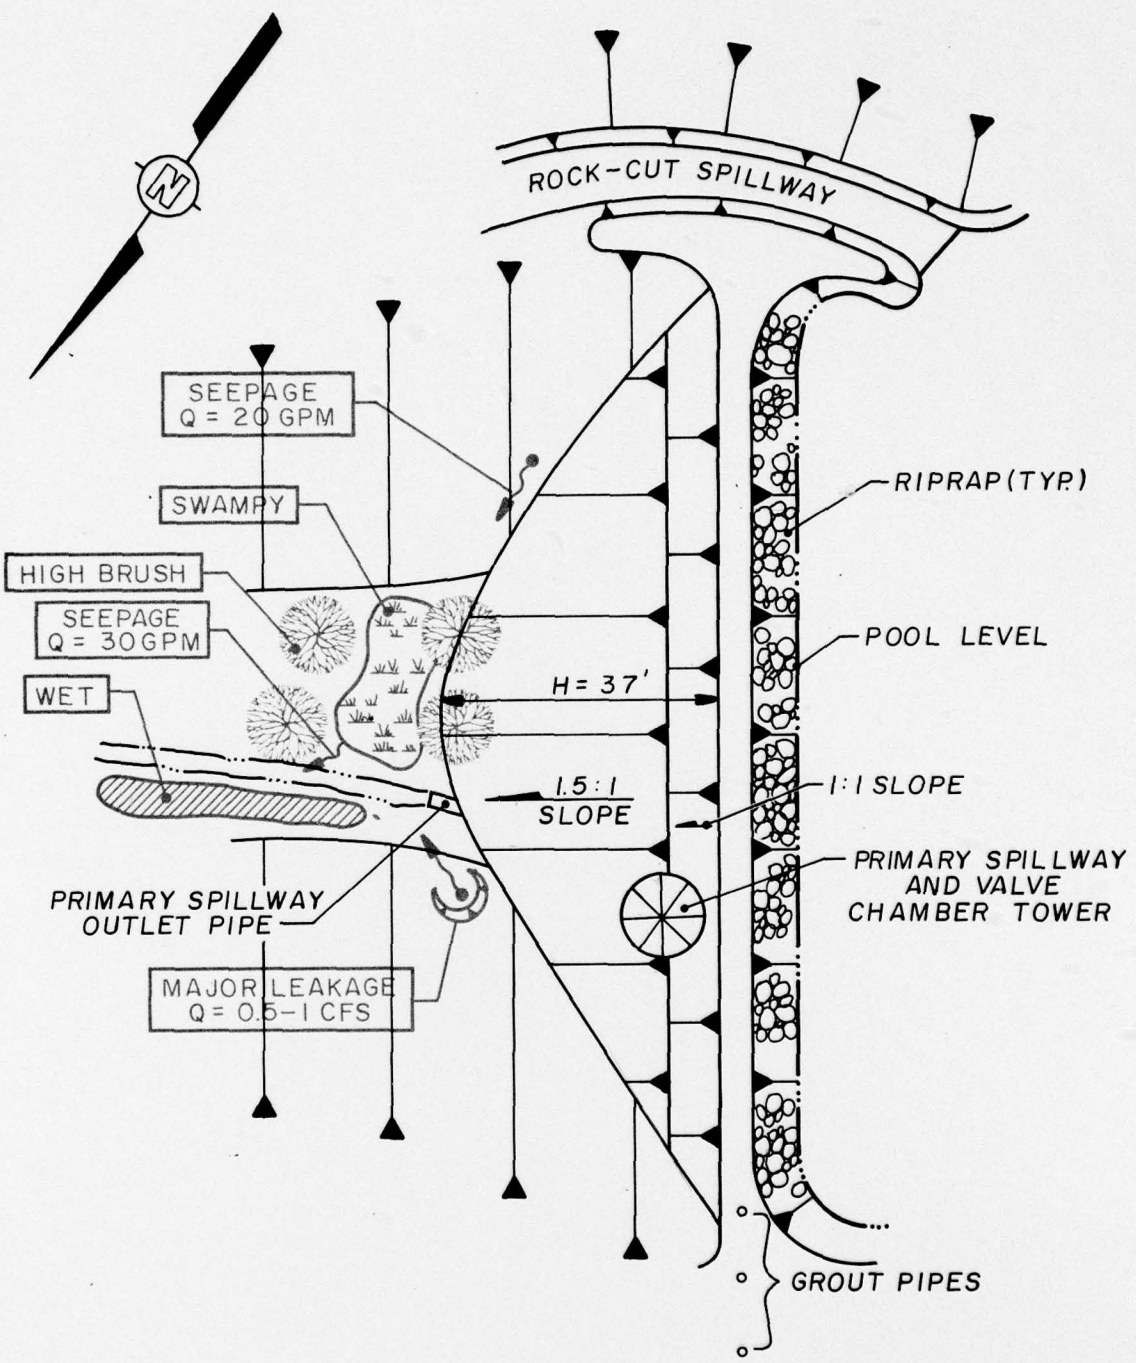
The most significant condition noted at the dam site was the presence of extensive swampy areas immediately below the toe of the dam. Ground in this area was found to be very soft. It appears that this swampy condition is caused by flow discharging into this area from the right abutment and underseepage. The flow from the right abutment seepage point was estimated to be on the order of 20 gallons per minute. This seepage point is located at the abutment/embankment interface about midheight of the dam. Flow from the swampy areas along the toe of the dam discharges into the primary spillway discharge channel through a small stream. Flow in this stream was estimated to be on the order of 30 gallons per minute. The flow at the major leakage point on the left abutment, which was reported to have existed since the completion of the dam, was estimated to be on the order of one-half to one cfs. Flow from the seepage points was found to be clear, showing no signs of internal erosion.

VISUAL EXAMINATION OF JUNCTION OF EMBANKMENT AND ABUTMENT, SPILLWAY AND DAM	OBSERVATIONS	REMARKS OR RECOMMENDATIONS
ANY NOTICEABLE SEEPAGE	No signs of distress other than the seepage condition described below and shown in Plate 5.	This seepage should be monitored.
STAFF GAGE AND RECORDER	An inclined pipe with elevation markers serves as a staff gage. There is no recorder.	
DRAINS	None

- a. Controlling swampy conditions at the downstream toe of the dam and evaluating the stability of the embankment in view of these conditions. The detailed evaluation of the dam should include, but not be limited to, subsurface investigations, material testing, and seepage and stability analyses.

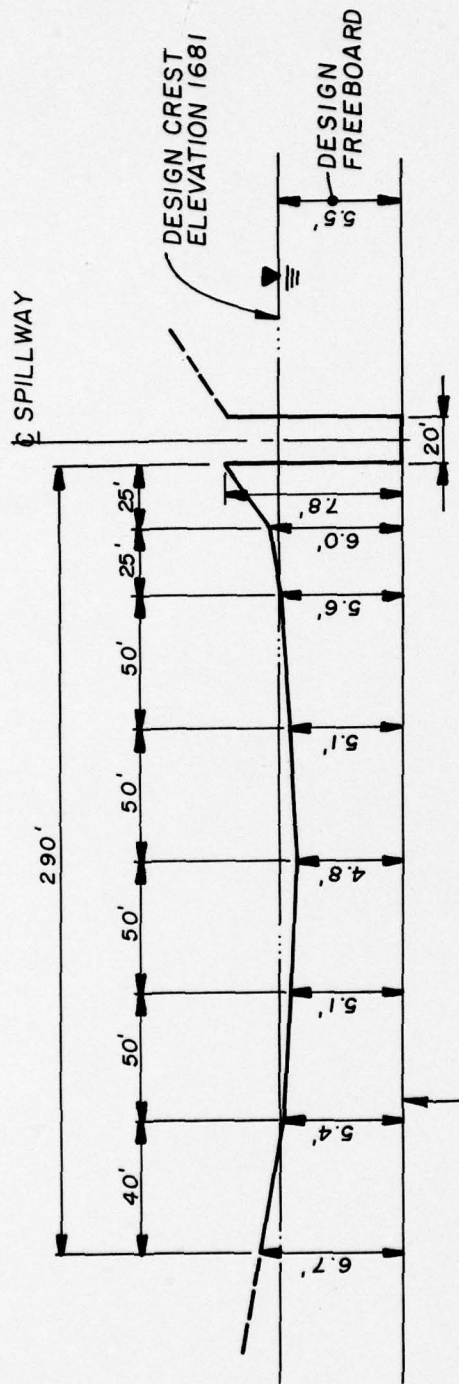
DAM CREST PROFILE
(LOOKING DOWNSTREAM)

one vertical; on the remaining portions the slope was reasonably within the design slope of one and one-half horizontal to one vertical. The crest of the dam was surveyed relative to the emergency spillway crest elevation and was found to be generally below the design crest elevation. The crest profile of the dam is illustrated in Plate 6.

VISUAL EXAMINATION OF	OBSERVATIONS	REMARKS OR RECOMMENDATIONS
SURFACE CRACKS	None	
UNUSUAL MOVEMENT OR CRACKING AT OR BEYOND THE TOE	None	
SLOUGHING OR EROSION OF EMBANKMENT AND ABUTMENT SLOPES	None	
VERTICAL AND HORIZONTAL ALIGNMENT OF THE CREST	See Plate 6 for the crest profile.	
RIPRAP FAILURES	None

2. The structural and operational condition of the outlet facilities should be evaluated and necessary maintenance performed.
3. The crest of the embankment should be surveyed and low spots filled to design elevation.
