STOUGHTON LAKE DAM  
(BEAVER DAM)

NDI No. PA 00468  
PennDER No. 56-78

**PHASE I INSPECTION REPORT**  
NATIONAL DAM INSPECTION PROGRAM

February 1980

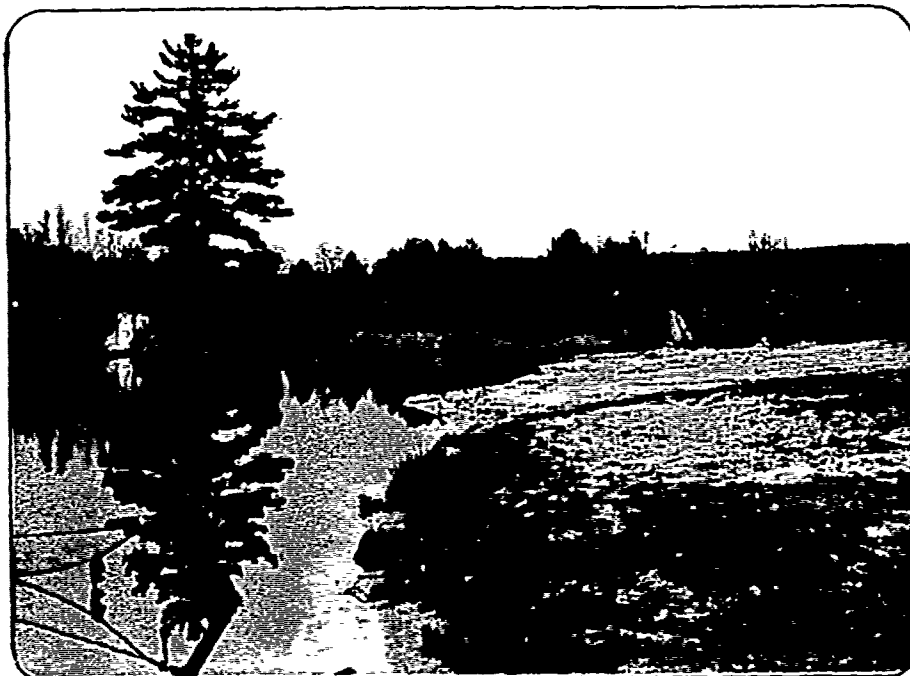
- c. Appurtenant Structures - At the time of inspection the right spillway training wall was being reconstructed. The embankment/abutment behind the wall had been excavated and the downstream half of the wall removed. The wall footing was left in place to serve as the foundation for the replacement wall consisting of masonry stone construction. The remaining upstream portion of the training wall was tilted and disjointed from the cut-off section (transition buttress). It should be noted

PHOTO 1. View of Spillway Entrance  
(Note excavation behind the right training wall)

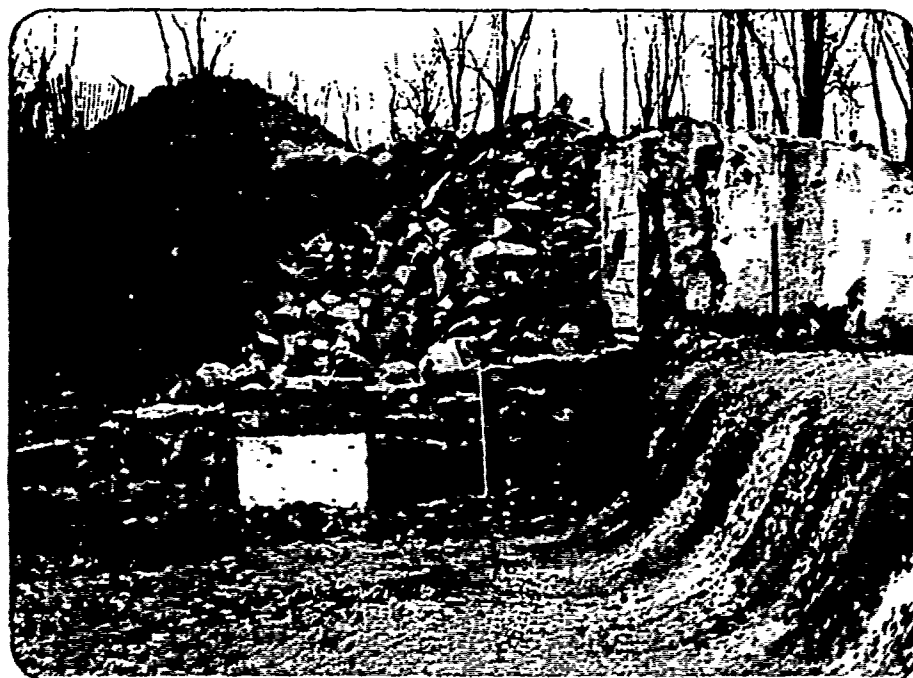
that these repairs were being performed under normal pool conditions which is an undesirable construction practice. In addition, some of the backfill material may be susceptible to piping if proper transition filters and proper drainage systems are not installed. Evidence of this could be seen along the downstream end of the completed wall where minor amounts of seepage/drainage from the backfill was carrying fine particles and also around the outlet head wall where erosion has occurred.

The right downstream half of the spillway training wall was currently being replaced with a stone and masonry wall. The original section reportedly was tilted and fell into the discharge channel. The remaining upstream half and cut-off wall are in a deteriorated condition and the cut-off wall is separated from the spillway section. The embankment (abutment) material has been removed from behind these walls. The left spillway training wall has two major cracks. One is at the junction of the cut-off wall and the upstream and downstream sections of the training wall (see Photo 6). The other is approximately 5 ft. from the downstream end of the wall.

**PHOTO 3. View of Repairs to Right Spillway Training Wall**

- 1) Reconstruct the spillway training walls.
- 2) Repair or reconstruct the spillway discharge apron. It would be advantageous for the continued stability of the ogee section to have the engineer examine for undermining of the ogee section after the reservoir has been drawn down.

It is recommended that the owner engage the services of a professional engineer experienced in the design and construction of spillways for earth dams to design and supervise the construction/repairs necessary for the spillway. It is further recommended that the pool be drawn down 5 ft. while such repairs are being made.
