BIG BEAVER DAM

(PA No Name No. 14)

PHASE I INSPECTION REPORT  
NATIONAL DAM INSPECTION PROGRAM

February 1980

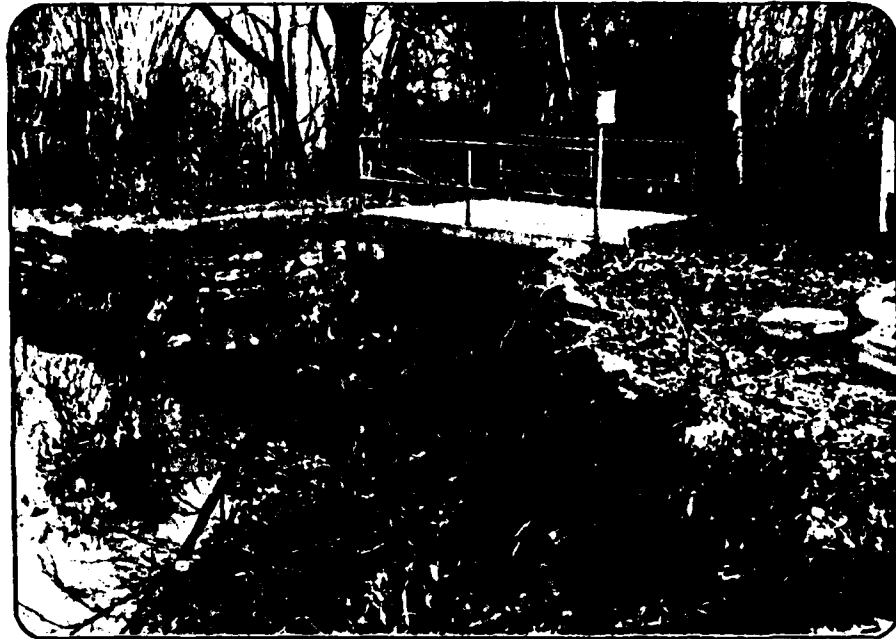
VISUAL EXAMINATION OF	OBSERVATIONS	REMARKS OR RECOMMENDATIONS
CONCRETE WEIR	The weir and spillway structure consist of sandstone blocks.	
APPROACH CHANNEL	Some silt and trash was present at the entrance to the spillway. This is reportedly cleaned periodically.	Remove the silt and trash at the entrance to the spillway.
DISCHARGE CHANNEL	Some fallen trees and debris are located in the channel. Some of the channel walls (masonry stone) have fallen into the channel and need to be reconstructed. The channel is constructed along the toe of the dam and during heavy flows minor erosion of the toe of the dam may occur. (Note: After reviewing the results of the H/H analysis, it is felt that this erosion would be minimal.)	
BRIDGE AND PIERS	The concrete slab (bridge) over the spillway was installed in 1963 and is in good condition. The ends of the concrete slab rest on the original masonry stone spillway training walls.

**PHOTO 1. View of Entrance to Spillway**
