KEHLY RUN DAM NO. 3

NDS ID NO. PA-657

PHASE I INSPECTION REPORT

NATIONAL DAM INSPECTION PROGRAM

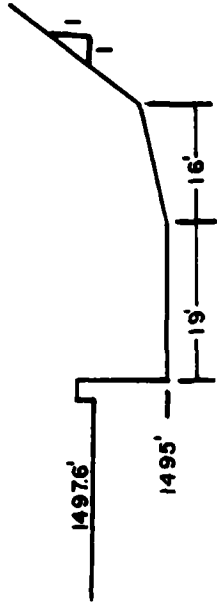
SPILLWAY PROFILE
(Not to Scale)

c. Visual Observations. The spillway appeared to be in poor condition. The spillway crest is badly deteriorated, sedimentation and debris has destroyed the original overflow channel. The discharge channel is narrow and flow is partially restricted by occasional large boulders.
