OHIO RIVER BASIN  
BEAR ROCK RUN, CAMBRIA COUNTY

BEAR ROCK NO. 2 DAM

NDI I.D. NO: PA-0441

PHASE I INSPECTION REPORT  
NATIONAL DAM INSPECTION PROGRAM

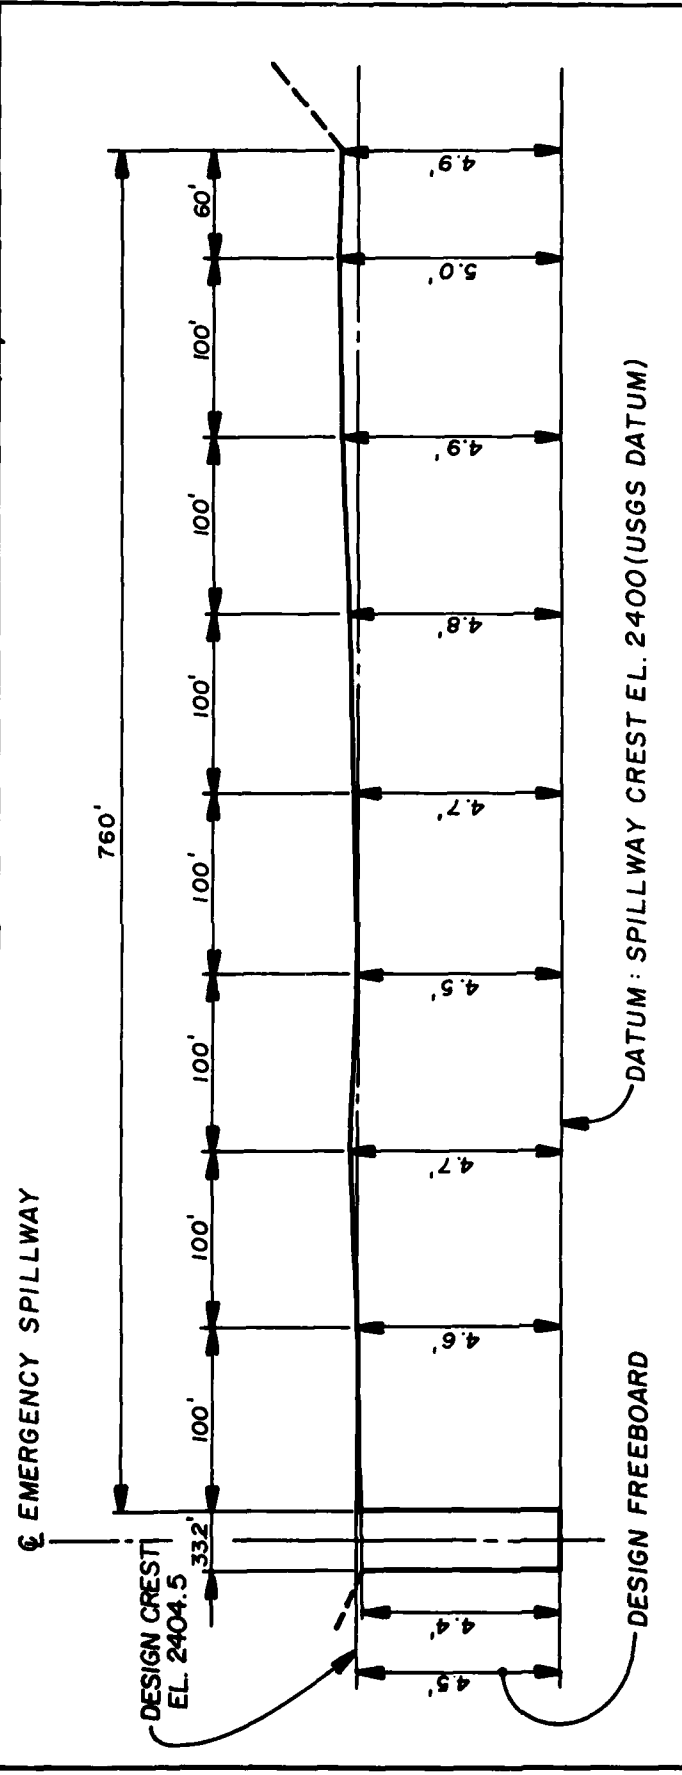
DAM CREST PROFILE  
(LOOKING DOWNSTREAM)

The top of the dam was surveyed relative to the spillway crest level and was found to be at or slightly above the design crest elevation, assuming the design crest level to be 4.5 feet above the spillway crest elevation. The crest of the dam is illustrated in Plate 6. Several measurements taken along the downstream slope indicated the slope is reasonably within the design slope of 2 horizontal to 1 vertical.
