BEAR ROCK NO.1 DAM

NDI I.D. NO: PA-00439

PHASE I INSPECTION REPORT
NATIONAL DAM INSPECTION PROGRAM

NAME OF DAM: Bear Rock No. 1 Dam
STATE LOCATED: Pennsylvania
COUNTY LOCATED: Cambria
STREAM: Bear Rock Run
SIZE CLASSIFICATION: Small
HAZARD CLASSIFICATION: High
OWNER: Highland Sewer and Water Authority
DATE OF INSPECTION: November 13 and December 28, 1979

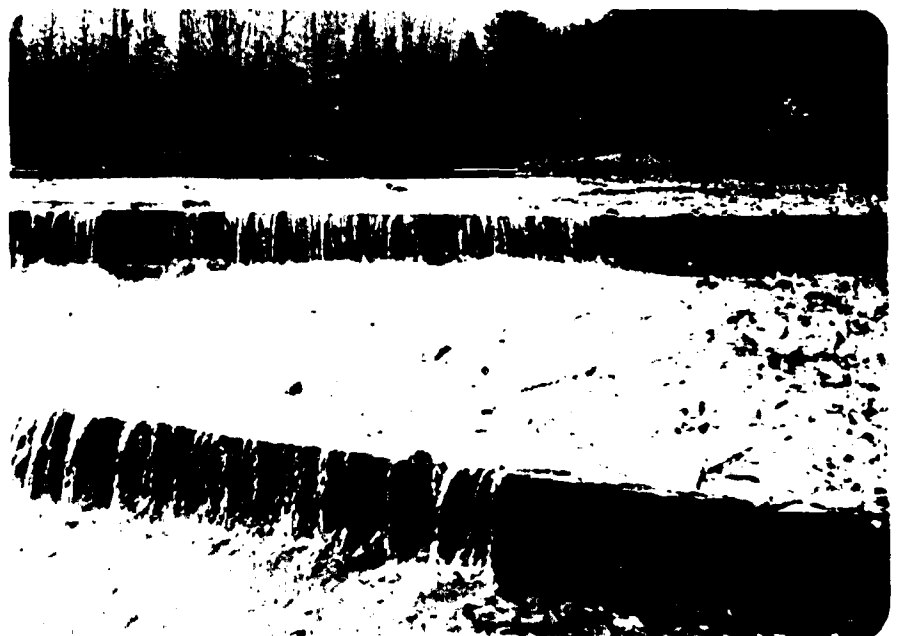
Photograph No. 2
Spillway crest.

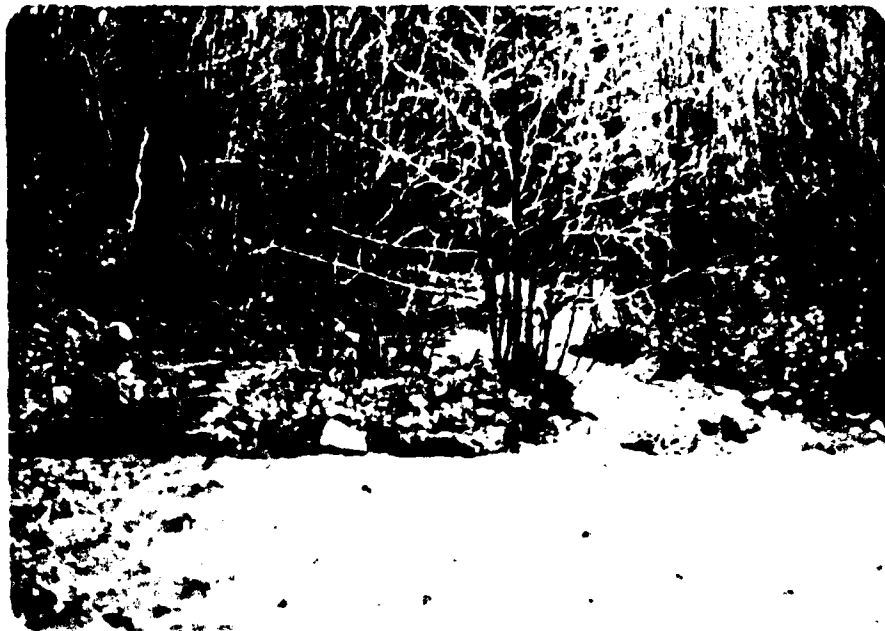
Photograph No. 3
Spillway discharge channel.

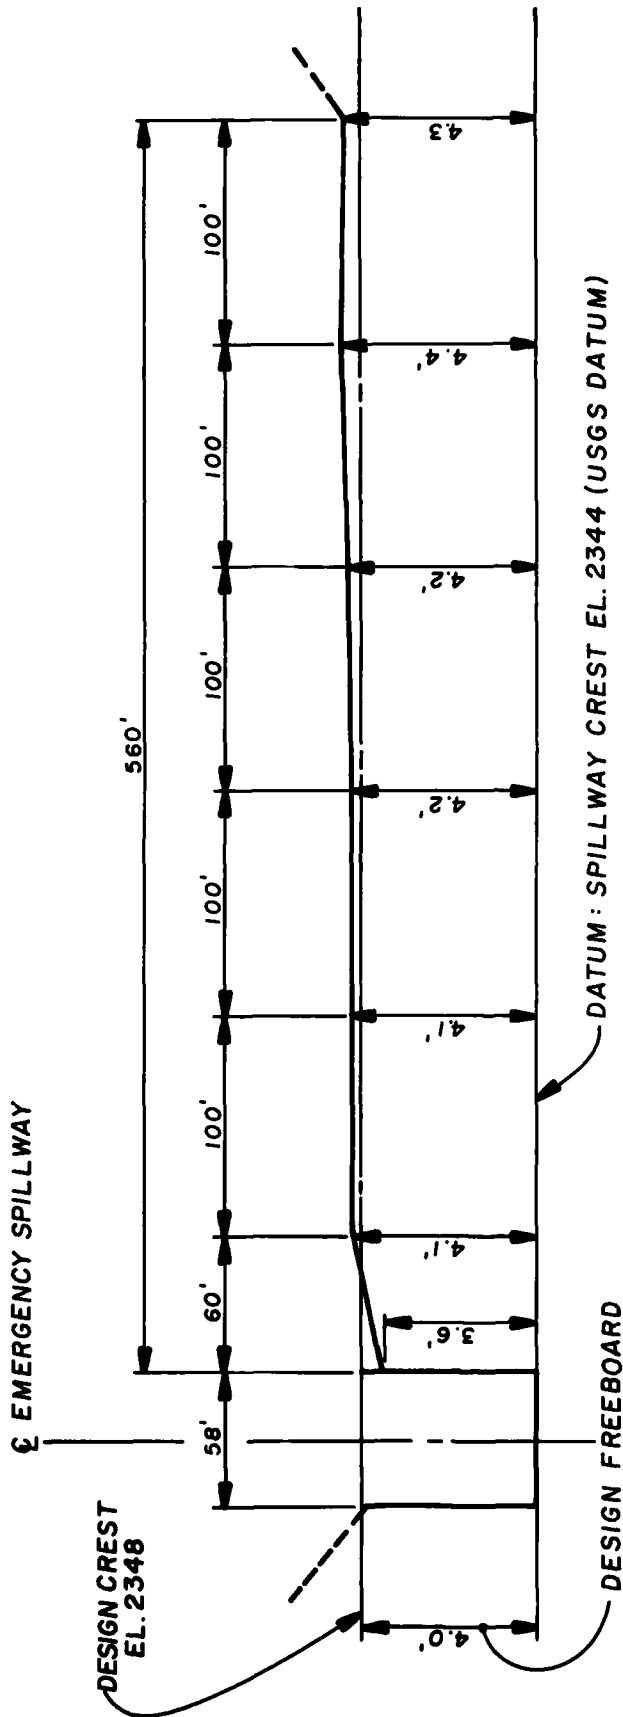
DAM CREST PROFILE
(LOOKING DOWNSTREAM)

The top of the dam was surveyed relative to the emergency spillway crest and was found to be at or slightly above the design crest elevation. Only a small section adjacent to the spillway wall was found to be about 4 inches below the design level. The crest profile of the dam is illustrated in Plate 5. Several measurements taken along the downstream slope indicated the slope to be 1-3/4 horizontal to 1 vertical, which is steeper than the design value of 2 horizontal to 1 vertical.
