MARINE CASUALTY REPORT: M/V CHESTER A. POLING; SINKING IN THE A--ETC(U)

1. Report No. USCG-16732/73448	2. Government Accession No. AD-A084834	3. Recipient's Catalog No. 11
4. Title and Subtitle Marine Board Casualty Report: M/V CHESTER A. POLING; Sinking in the Atlantic Ocean on 10 January 1977 With Loss of Life.	5. Report Date 27 Dec 1979	6. Performing Organization Code G-MMI-1/TP24

M/V CHESTER A. POLING; SINKING IN THE ATLANTIC OCEAN ON 10 JANUARY 1977 WITH LOSS OF LIFE

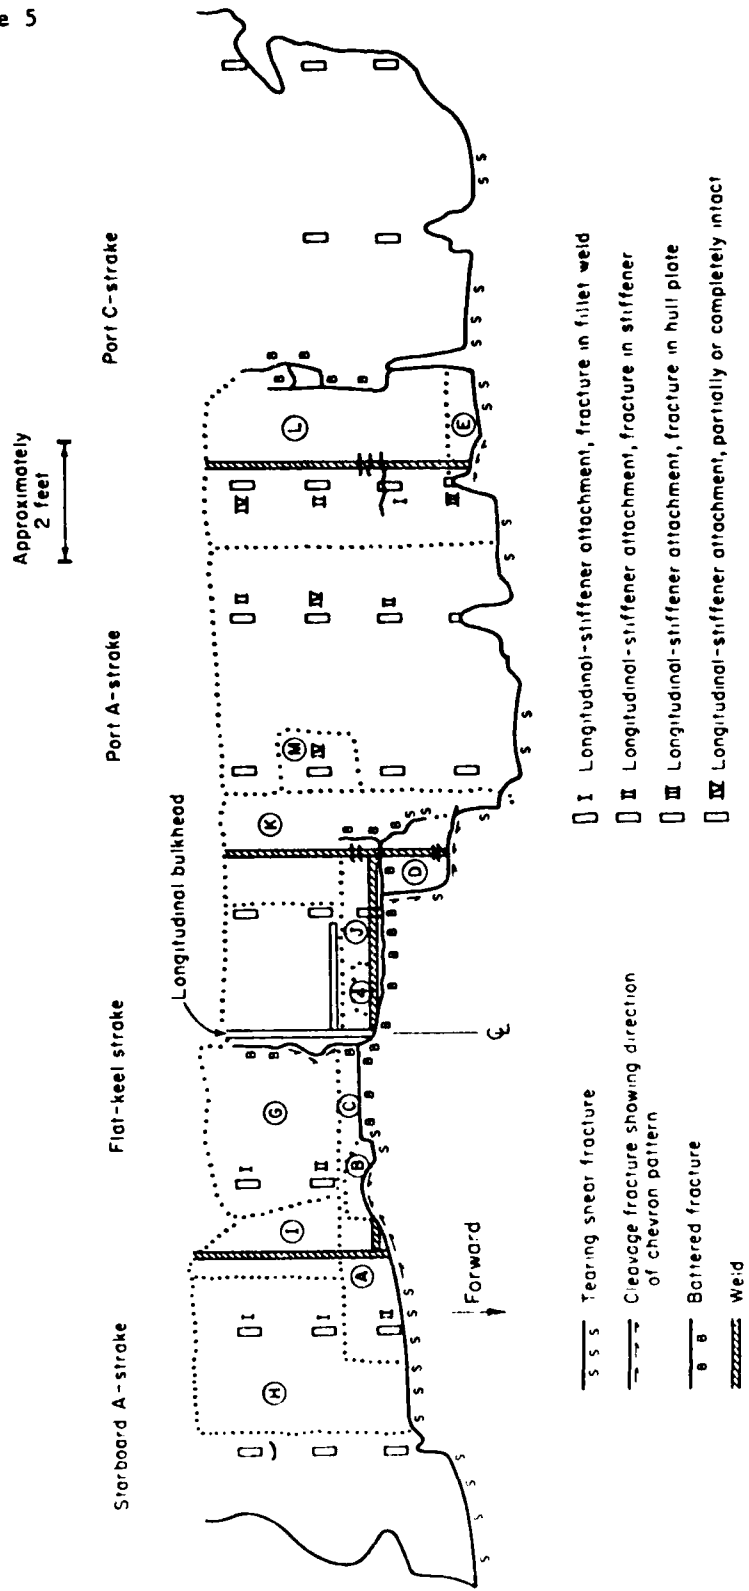
Figure 5

(d) Fractures—A map of the portion of the fracture studied is shown in figure (5). The circled letters designate the pieces that were sent to Battelle. The pieces of the bottom plate were bent with the concave side of the bend generally being upward, especially along the fracture. The centerline bulkhead also was bent, and a vertical stiffener on the bulkhead had been bent backward approximately 90 degrees. Four of the longitudinal stiffeners remained attached to the plate at positions several feet from the fracture, but they had been torn from the plate near the fracture. The stiffeners also were severely bent as though they had been pushed toward the stern. Fractures in the attached stiffeners occurred in one of three places: in the fillet weld, in the stiffener, or in the plate. The locations of some of the individual fractures are indicated by Roman numerals in figure 5. Most of the fracture in the flat keel plate was badly battered, giving the appearance that it had been pounded by the mating fracture surface prior to the ultimate failure. This implies that the two halves of the hull maintained their alignment for some time after some plating and stiffeners failed. The flat keel plate fracture surface was probably a brittle mode failure. Most of the fractures in both A-strakes and the port C-strake were tearing shear fractures. The surfaces were smooth and at approximately 45 degrees to the top and bottom surfaces. Battelle's metallographic examination revealed that the deformation associated with the tearing shear fractures was all downward, indicating that the forward half of the ship was moving downward with respect to the aft half as the bottom hull plate tore apart. A tearing shear fracture, as opposed to a tensile or propagating shear fracture, generally is the final event in a fracture process and is not associated with fracture initiation.

(e) Secondary Cracks—Many secondary cracks were observed in the top surface of the longitudinal seam welds and the plate within a couple of feet of the fracture. Secondary cracks were also observed in the bottom surface of the flat keel within an inch of the fracture. Some of the cracks were opened fairly wide, suggesting that the plate had previously been bent upward and the cracks probably formed when the plate was bent back downward.

FIGURE 5. MAP OF FRACTURE IN THE BOTTOM HULL PLATE OF THE CHESTER A. POLING
The top (inside) surface of the plate is shown.
