Roof leaks in cold regions: School at Chevak, Alaska

Wayne Tobiasson and Philip R. Johnson

April 1980

ROOF LEAKS IN COLD REGIONS: SCHOOL AT CHEVAK, ALASKA

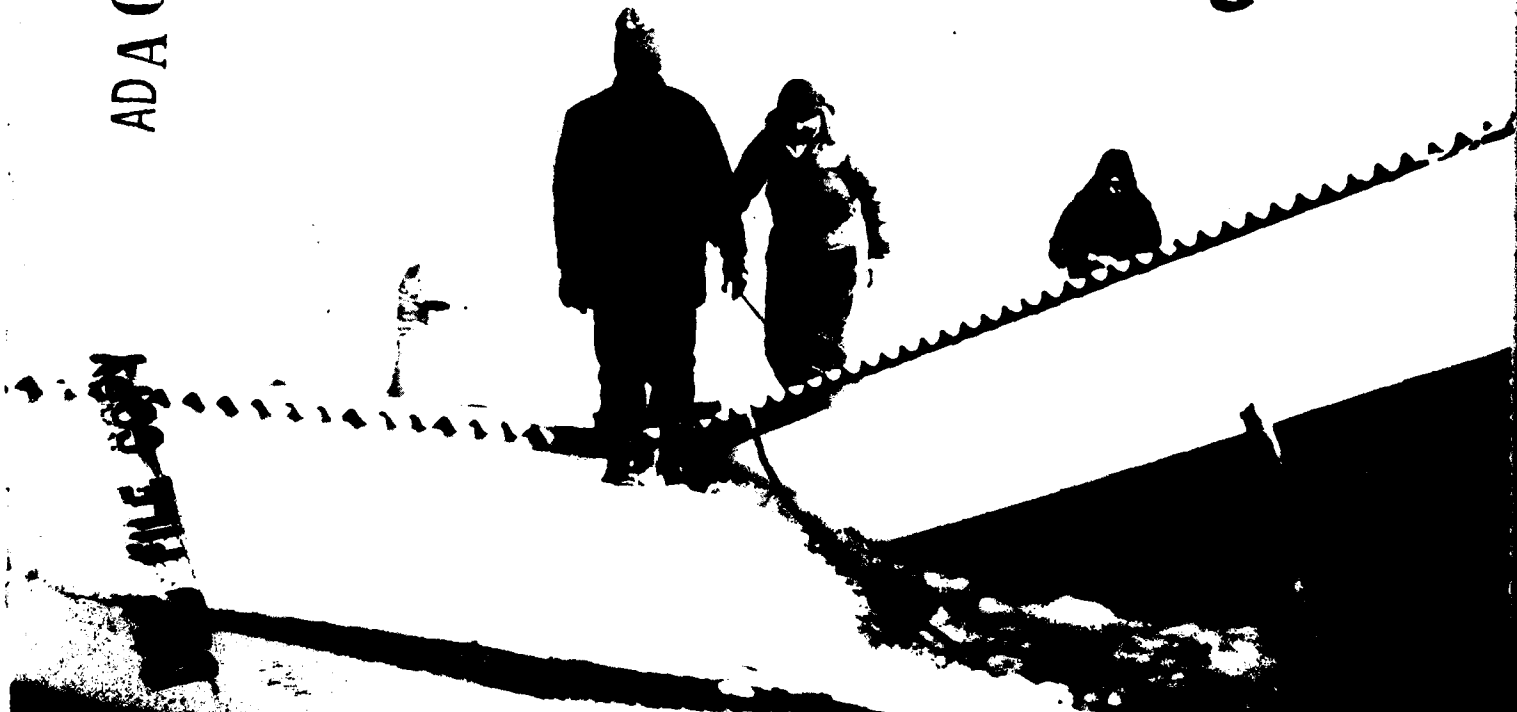
*Cover: Inspecting "problem valley" of BIA
school roof. (Photograph by P. Johnson.)*

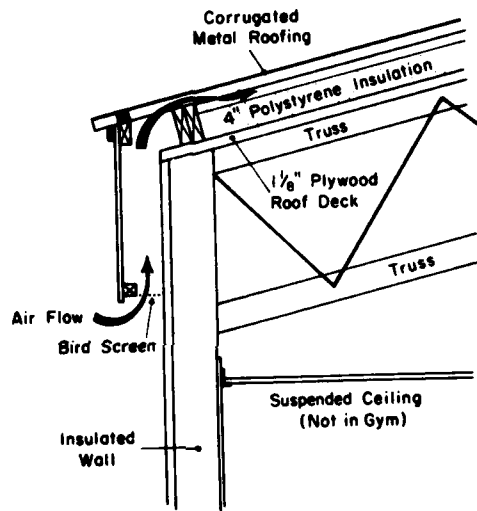
Figure 4. Detail of ventilated eave.

Snow infiltration leaks developed during the late fall and early winter of 1975 while the buildings were closed-in but still being finished. Water entered the building in many areas at seams in the plywood roof deck. Some of the metal roofing was removed and it was found that snow had blown into the roof through the eave vents (Fig. 4) and was packed in the shallow ventilation space between the top of the insulation and the metal roofing. When the building was heated, the snow melted and the meltwater entered the building.

These leaks were easily cured. BIA personnel sealed the vents with plywood, making it impossible for snow to blow into the roof at the eaves.

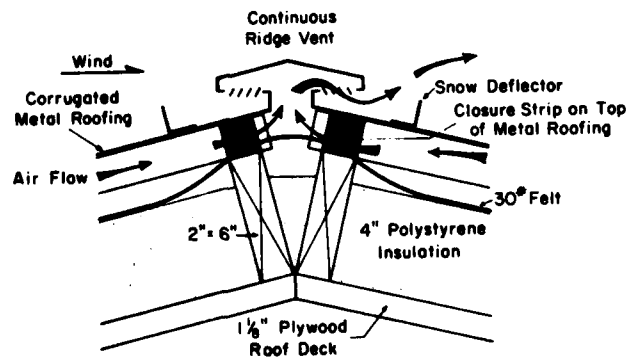
Figure 5. Detail of ventilated ridge.

The ridge is the only safe place for maintenance personnel to walk along these roofs, particularly when there is snow on them. Accordingly, the ridges have been used as foot paths and the ridge vents (Fig. 5) have been flattened against the ridges. Although crushed, some air can still pass through them. The flattened ridge vents should be removed and replaced with elastomeric closure strips and a solid galvanized cap, robust enough to sustain foot traffic. Every 20-ft, the ridge cap should be penetrated with a 2-½-to 3-in.-diam, 24-in.-high black-painted vent stack (upside-down J). The eaves should remain blocked to preclude snow infiltration. If the roof is vapor-sealed as recommended above, we expect that the combination of local winds, air leaks in the metal roofing, and the modified ridge ventilation system will provide enough air movement to facilitate the small amount of summer drying required by the roof.

The ventilated ridge cap was replaced with a solid ridge cap vented every 20 ft with an inverted J.

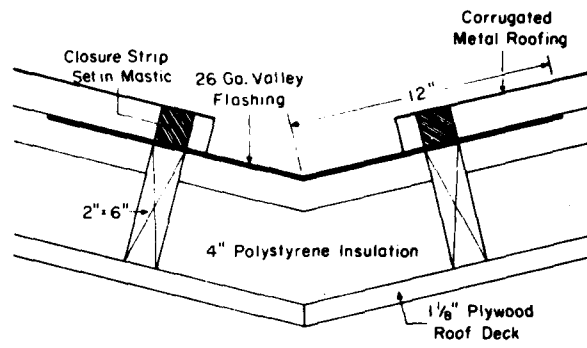
Figure 8. Valley detail.

Figure 8 is a cross section of the Chevak school's roof valley. Considering the thermal movements to which the metal is subjected, it must be assumed that the seals between the flashing, closure strip and corrugated metal are not water-tight. As long as the valley is clear, water drains down the valley and off the roof. However, when the valley contains slush and ice, meltwater rises in the valley and gets behind the closure strips (Fig. 8). Since the depth of the channel provided by the valley flashing is only about 2 in., it does not take much ice and slush to cause water to overtop the flashing and enter the roof.

With the corrugated metal roofing temporarily removed, the valley flashing should be widened. The existing width of 2 ft may be adequate near the ridge, but a width of 4 ft or more seems necessary at the eaves. A quality sealant should be used when placing the new valley closure strips. Permanent electrical heating cables should be installed in each valley.

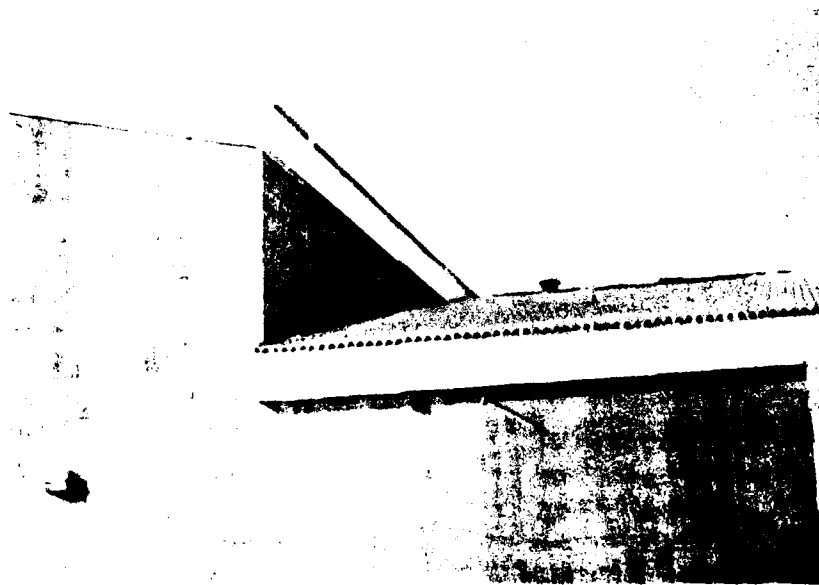
Leaks also developed at the intersection of the locker room roof and the gymnasium wall (Fig. 11). Water from these leaks damaged walls in the boys' and girls' locker rooms.

We did not investigate the leaks at the intersection of the gymnasium wall and the locker room roof. BIA personnel speculated that meltwater from the gymnasium roof was entering the ridge vent of the locker room roof where that roof intersects the wall of the gymnasium (Figs. 2 and 11).

When the roof was opened for repair and modification in 1979, the actual cause of this problem was found to be a missing piece of flashing along the gymnasium wall. This finding emphasized the difficulty of determining the cause of roof problems by visual examination only.

Figure 11. Intersection of gymnasium wall and locker room roof.

When the corrugated metal roofing was removed it was found that flashing had not been installed along the upper 4 ft of the roof at the gymnasium wall/locker room roof intersection. Water draining from the gymnasium roof found easy entry into the building because of this construction deficiency. Flashing was installed.
