LAUREL RUN DAM

NDI ID No. PA-00380  
DER ID No. 35-6

PENNSYLVANIA GAS AND WATER COMPANY.

PHASE I INSPECTION REPORT

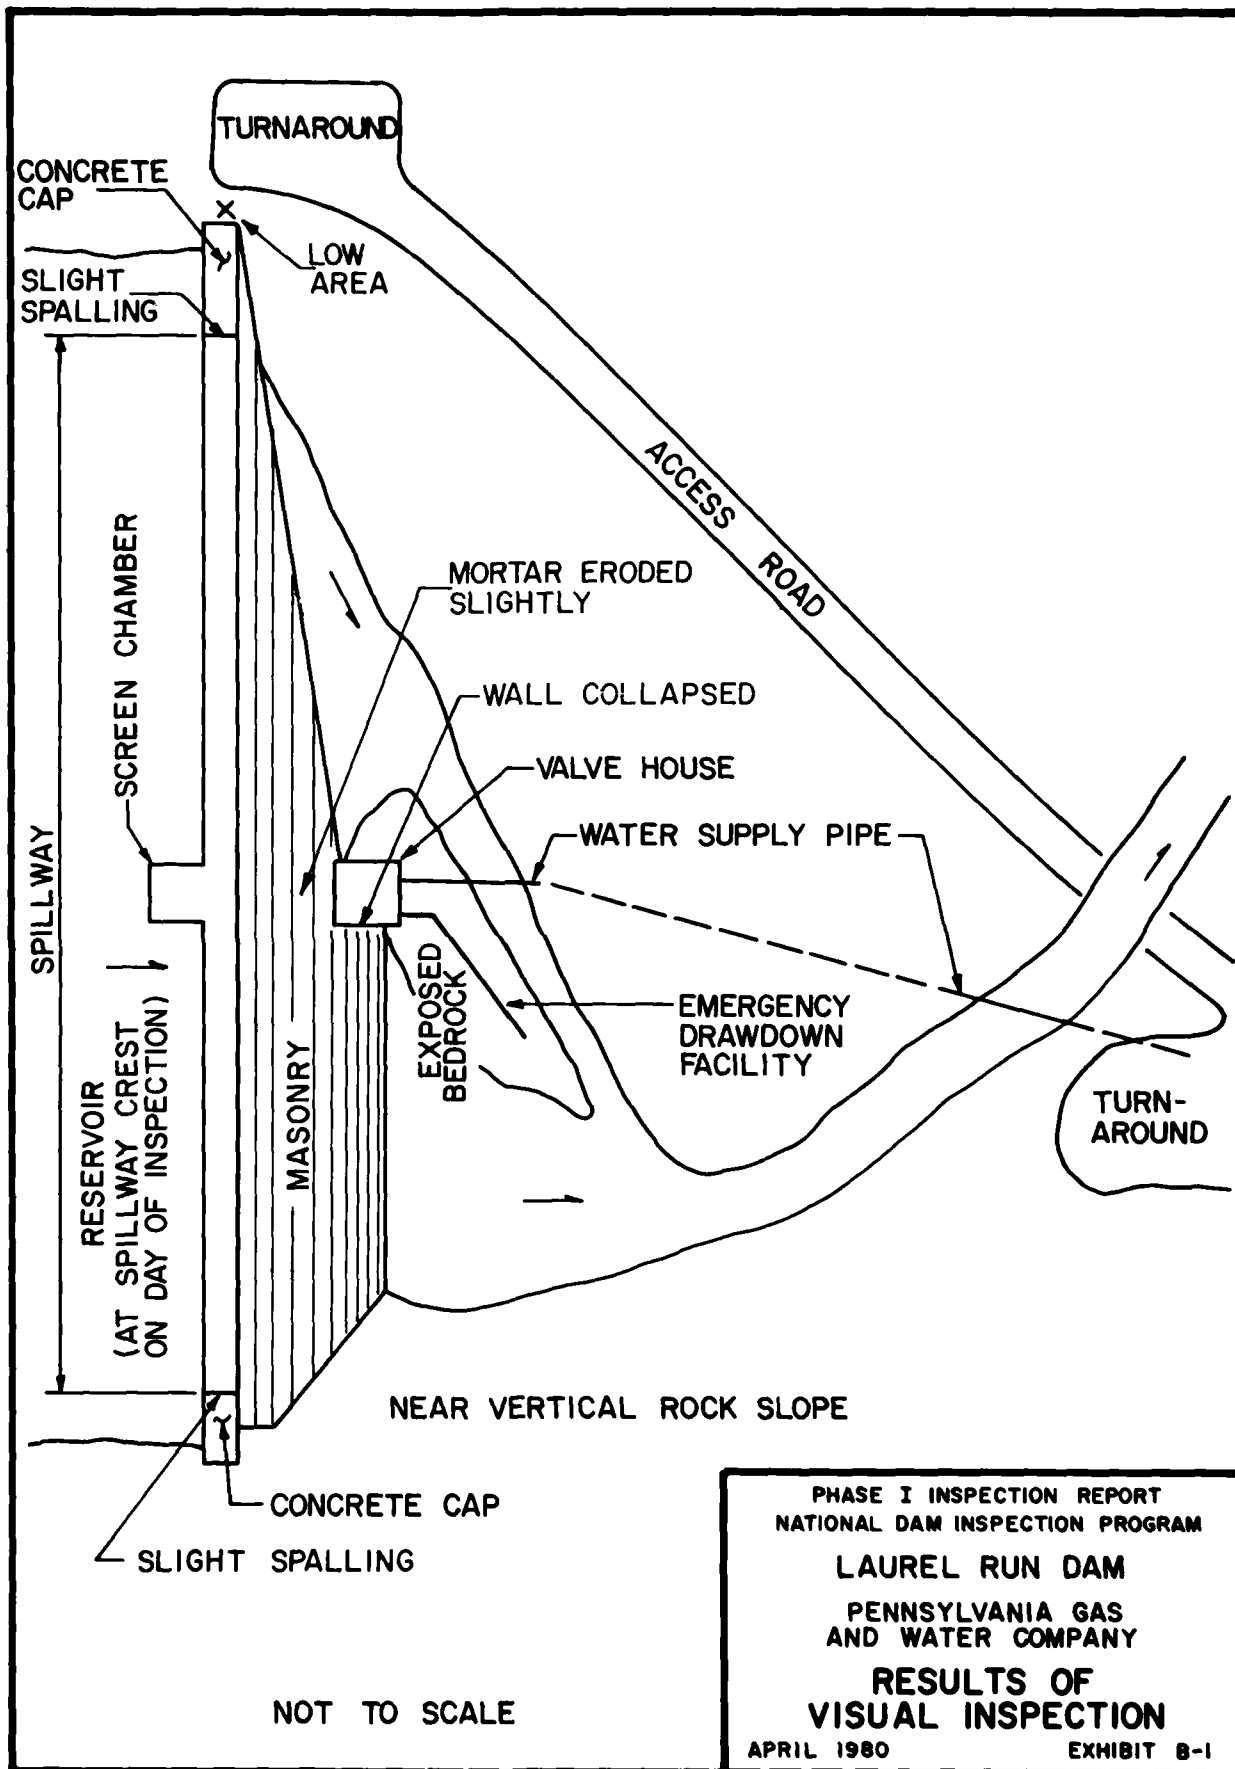
PHASE I INSPECTION REPORT  
 NATIONAL DAM INSPECTION PROGRAM  
 LAUREL RUN DAM  
 PENNSYLVANIA GAS  
 AND WATER COMPANY  
 RESULTS OF  
 VISUAL INSPECTION  
 APRIL 1980 EXHIBIT B-1

a. General. The overall appearance of the dam is good. A few deficiencies were observed as noted below. A sketch of the dam with the locations of deficiencies is presented on Exhibit B-1 in Appendix B. Survey information acquired for this Report is summarized in Appendix B. On the day of the inspection, the pool was at the spillway crest. Another visit to the dam was made about two weeks after the inspection to obtain additional photographs. No observations that differed from the original inspection were noted. Flow conditions on that day varied from the flow conditions on the day of the inspection.
