RAHWAY RIVER BASIN  
WEST BRANCH RAHWAY RIVER  
ESSEX COUNTY  
NEW JERSEY

**CAMPBELLS POND DAM**

**NJ 00517**

**PHASE 1 INSPECTION REPORT  
NATIONAL DAM SAFETY PROGRAM**

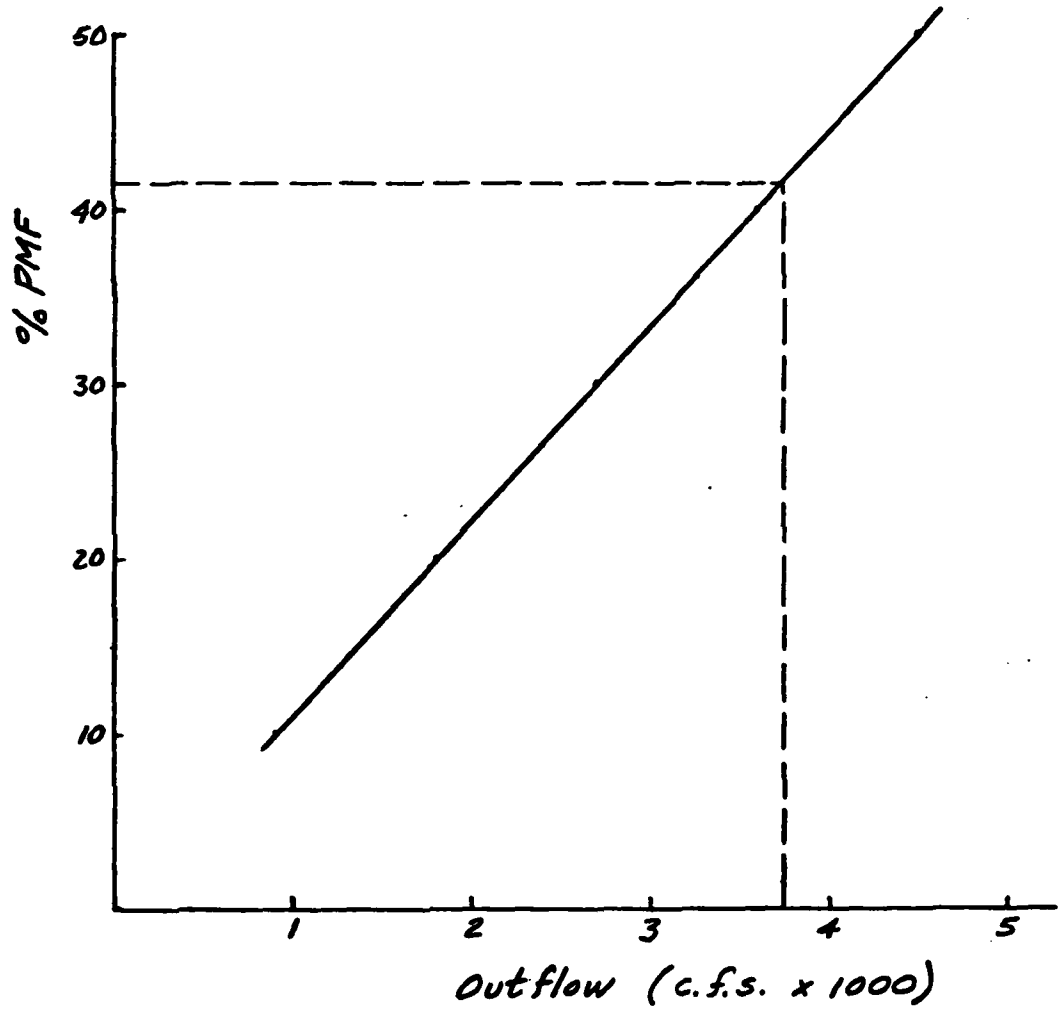
Overtopping Potential

Overtopping occurs at elev. 218.5  
with  $Q = 3748$  c.f.s.

$\therefore$  Dam can pass approx 42% PMF
