RARITAN RIVER BASIN
SOUTH BRANCH OF RARITAN RIVER
HUNTERDON COUNTY
NEW JERSEY

CLINTON MILLS DAM

NJ 00122

**PHASE 1 INSPECTION REPORT
NATIONAL DAM SAFETY PROGRAM**

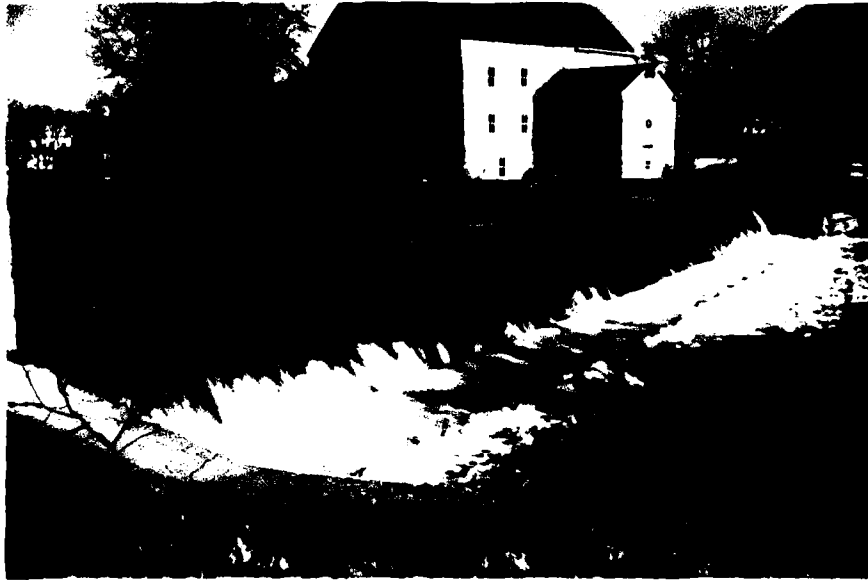
PHOTO 1 28 DECEMBER 1979
SPILLWAY

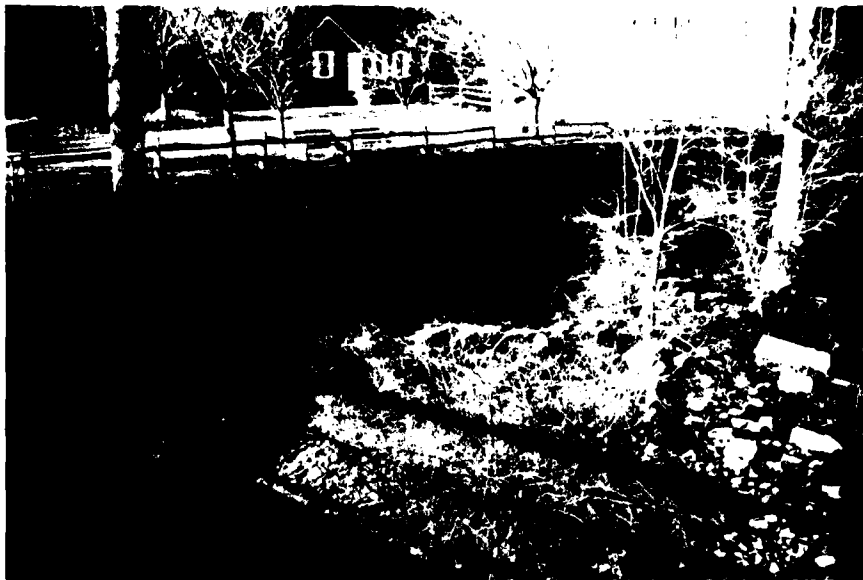
PHOTO 9 28 NOVEMBER 1979

TRAINING WALL ALONG WEST EDGE OF DOWNSTREAM CHANNEL
