SMITH RESERVOIR DAM
ERIE COUNTY, COMMONWEALTH OF PENNSYLVANIA
NDI No. PA 00017
PennDER No. 25-28

⑥ PHASE I INSPECTION REPORT
NATIONAL DAM SAFETY PROGRAM

Smith Reservoir Dam, Erie County, Pennsylvania
NDI No. PA 00017, PennDER No. 25-28
West Branch of Sixteen Mile Creek
Inspected 12 May 1980

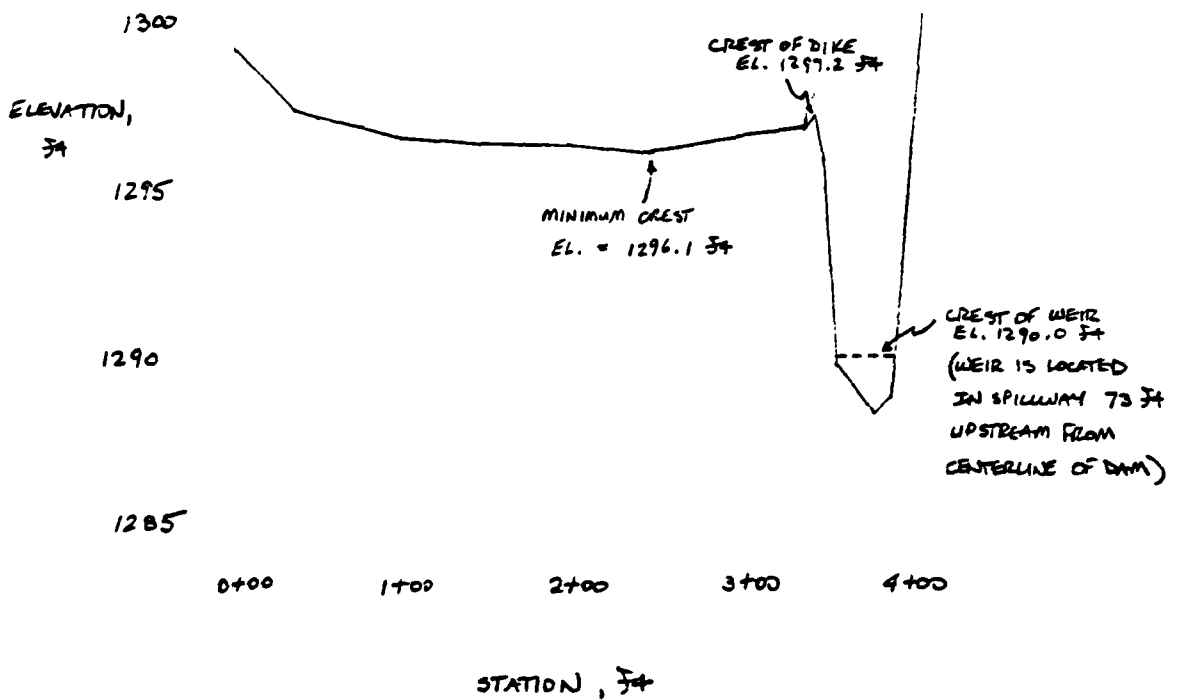
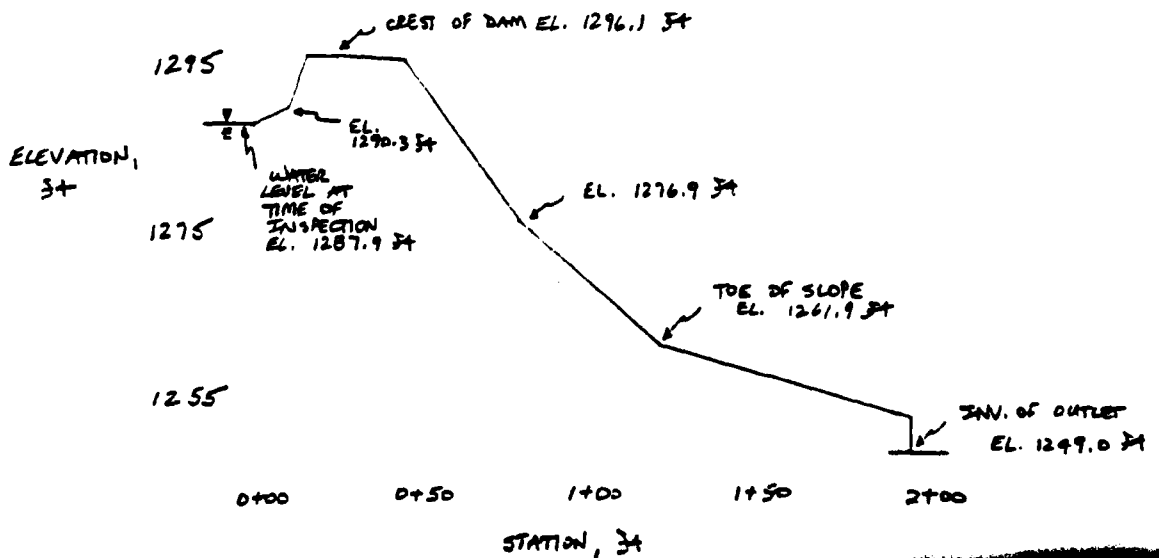
Subject SMITH RESERVOIR DAM S.O. No. _____
TOP OF DAM PROFILE AND TYPICAL Sheet No. 5 of 5
CROSS SECTION Drawing No. _____
 Computed by WDL Checked by _____ Date 5-30-80

- c. Visual Observation - At the time of the inspection, no conditions were observed which would seriously affect the functioning of the spillway or dam during a flood event. There is one low spot on the dam crest (Station 2+50) which is approximately 0.2 foot below the average crest elevation.
