MARYLAND
GUILFORD RESERVOIR

NDI ID NO. MD-106

PHASE I INSPECTION REPORT
NATIONAL DAM INSPECTION PROGRAM

JUNE 1980

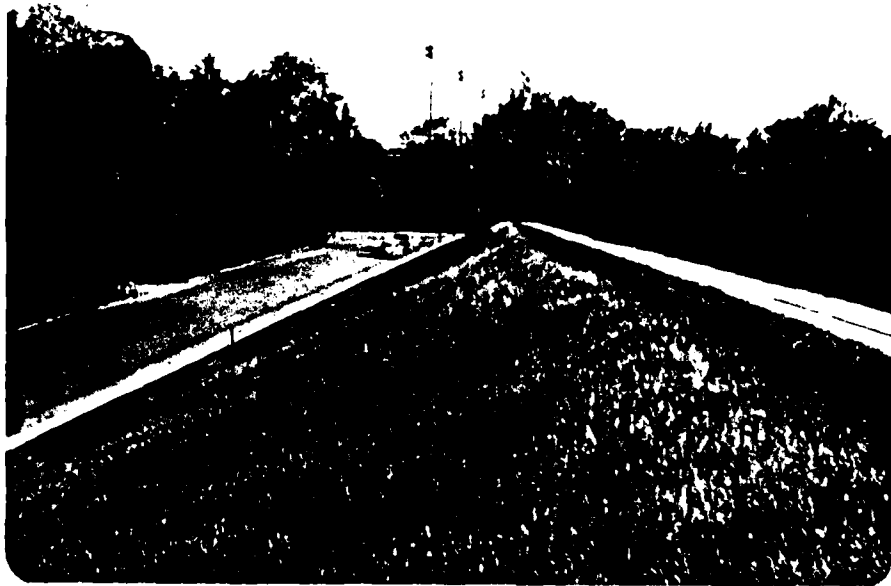
A. Western Embankment - Crest
and Downstream Slope

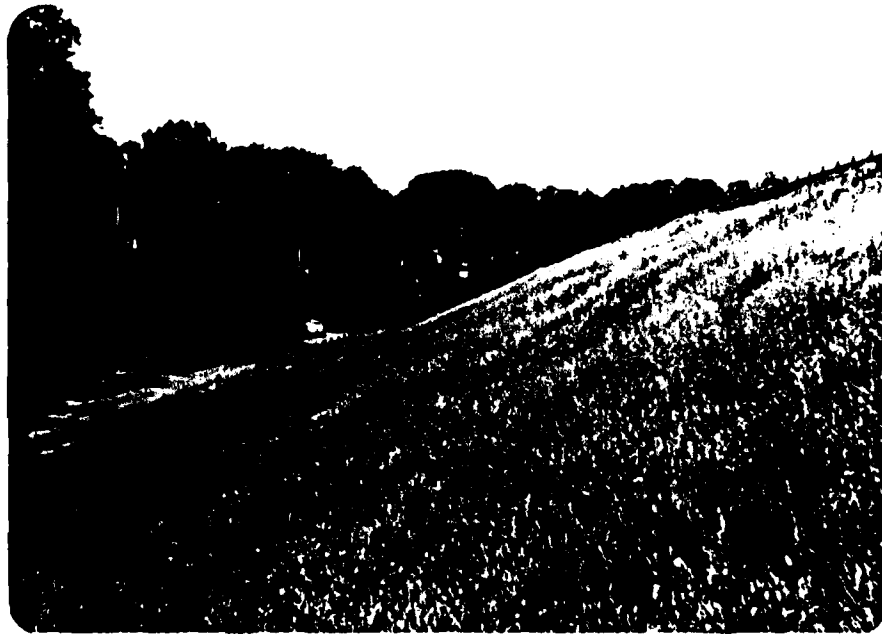
C. Southern Embankment -
Downstream Slope

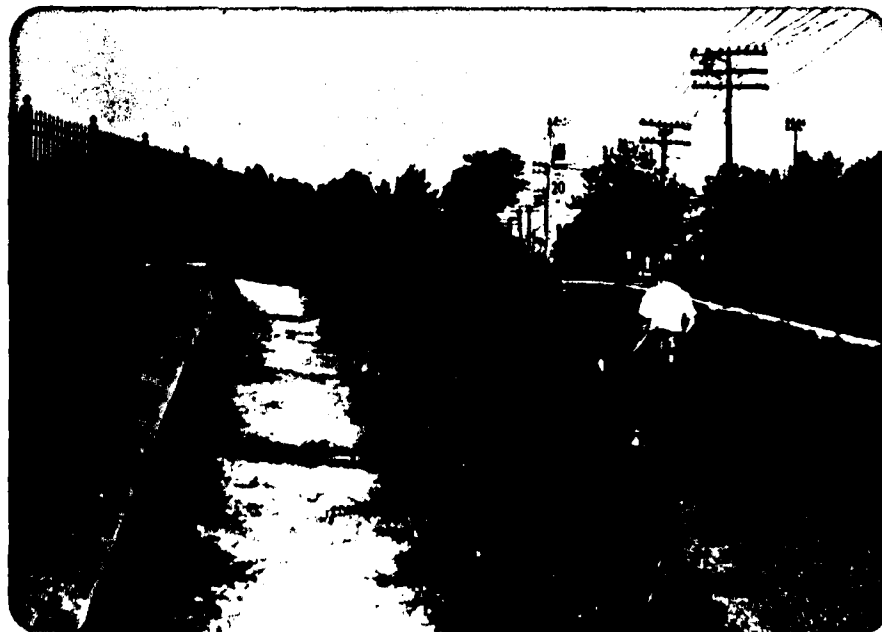
D. Northern Embankment -
Downstream Slope

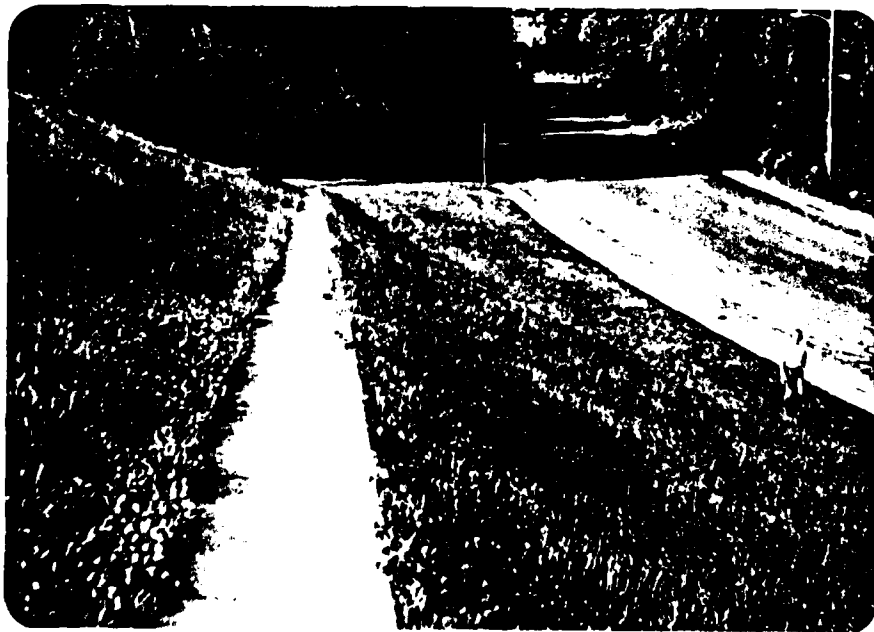
- a. Assessment. The visual observations indicate that Guilford Reservoir is in satisfactory condition. A zone of saturated soil was noted along the toe of the slope of the southwest corner of the reservoir, indicating a possible seepage area, but at this time it would not appear to be adversely affecting embankment stability.

F. Southwest Corner of Embankment-
Saturated Soil at Toe where man
stands.

- a. Investigate the seepage area in the southwest corner of the embankment using either experienced in-house personnel or by contract with a qualified engineering firm possessing geotechnical engineering expertise. After investigation, implement recommended corrective measures to eliminate or control the seepage.
- b. Repair the surface erosion located along the southern portions of the embankment.
- c. Expand the maintenance program to include regularly scheduled inspections of the embankment to determine whether surface erosion and/or future seepage is occurring and needs correction.

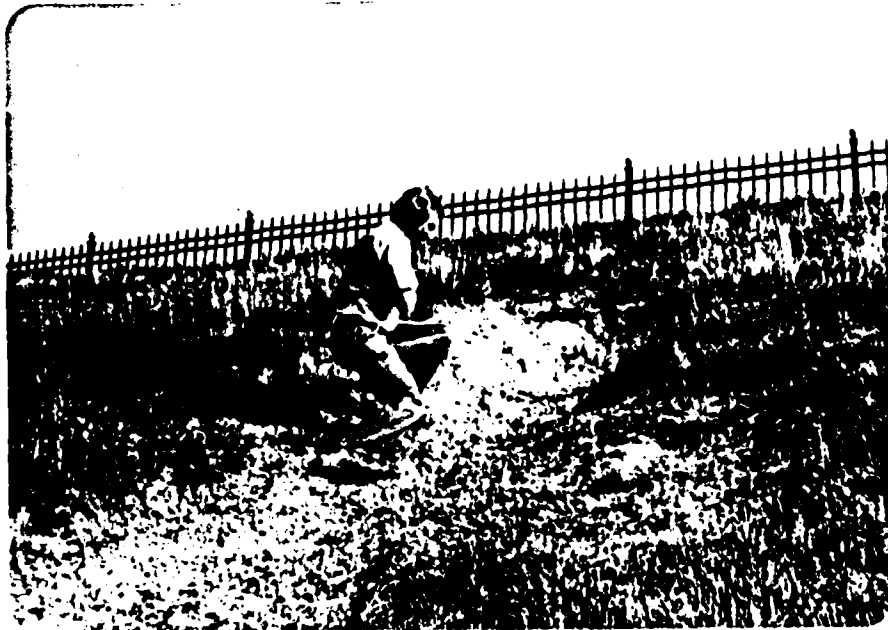
- b. Embankment. The general inspection of the embankment consisted of a searching for indications of structural distress, such as cracks, subsidence, bulging, wet areas, seeps and boils, and observing general maintenance conditions, vegetative cover, erosion, and other surficial features. Saturated soil was noted along the toe of the slope at the southwest corner of the reservoir indicating a possible seepage area or a leak from a 48-inch water line approximately 30 feet down slope from the seepage area. Surface erosion was noted along the southern side of the reservoir, and an erosion gully was observed near the eastern end of the top of the south embankment.

G. Erosion Gully at Top of
Souther Embankment

- 4.5 Evaluation. The maintenance of the operating equipment is good, and the maintenance of the embankment is fair. It is recommended that the Owner repair the surface erosion of the embankment and investigate the possible seepage zone at the embankment toe near the southwest corner.

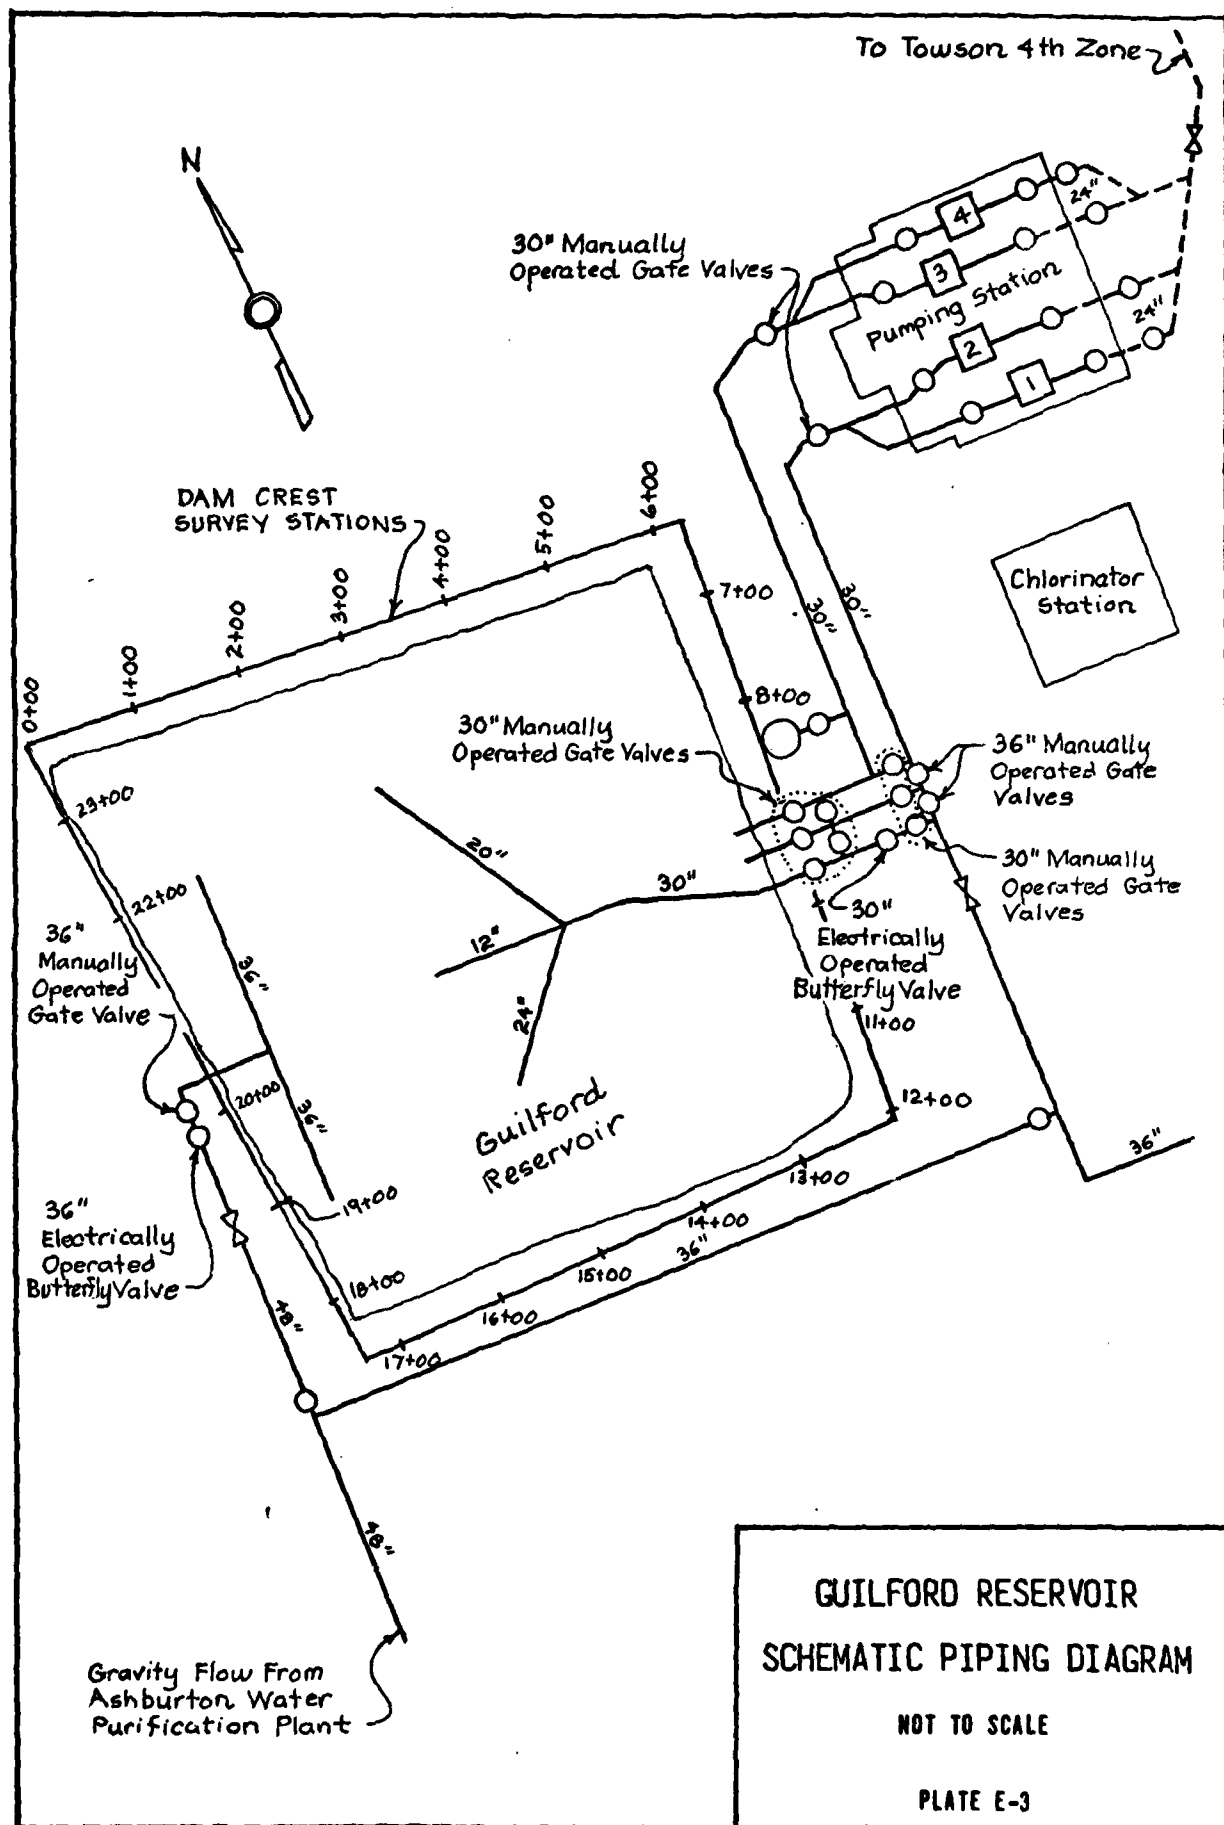
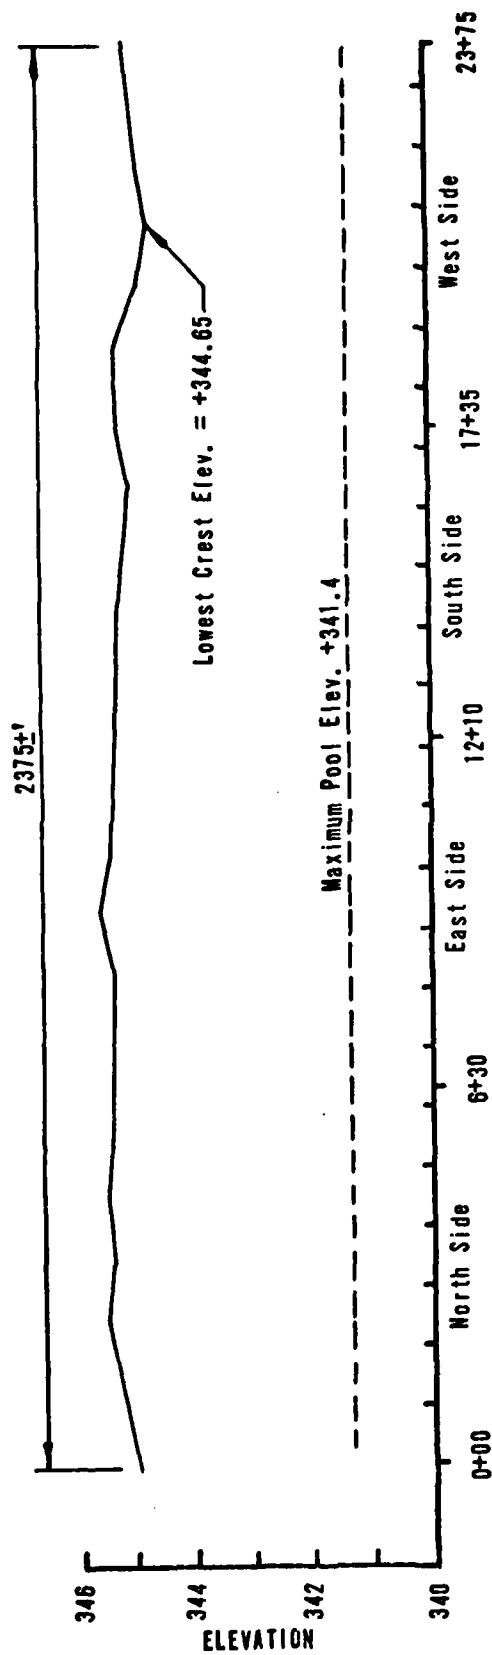
DAM CREST PROFILE (LOOKING DOWNSTREAM)

The crest of the embankment varies in elevation by approximately 11 inches. Freeboard at the time of the inspection was approximately 6 feet. The embankment crest profile is included as Plate E-4.
