MAINTENANCE AND PRESERVATION OF CONCRETE STRUCTURES

REPAIR OF EROSION-DAMAGED STRUCTURES

James E. McDonald

April 1980

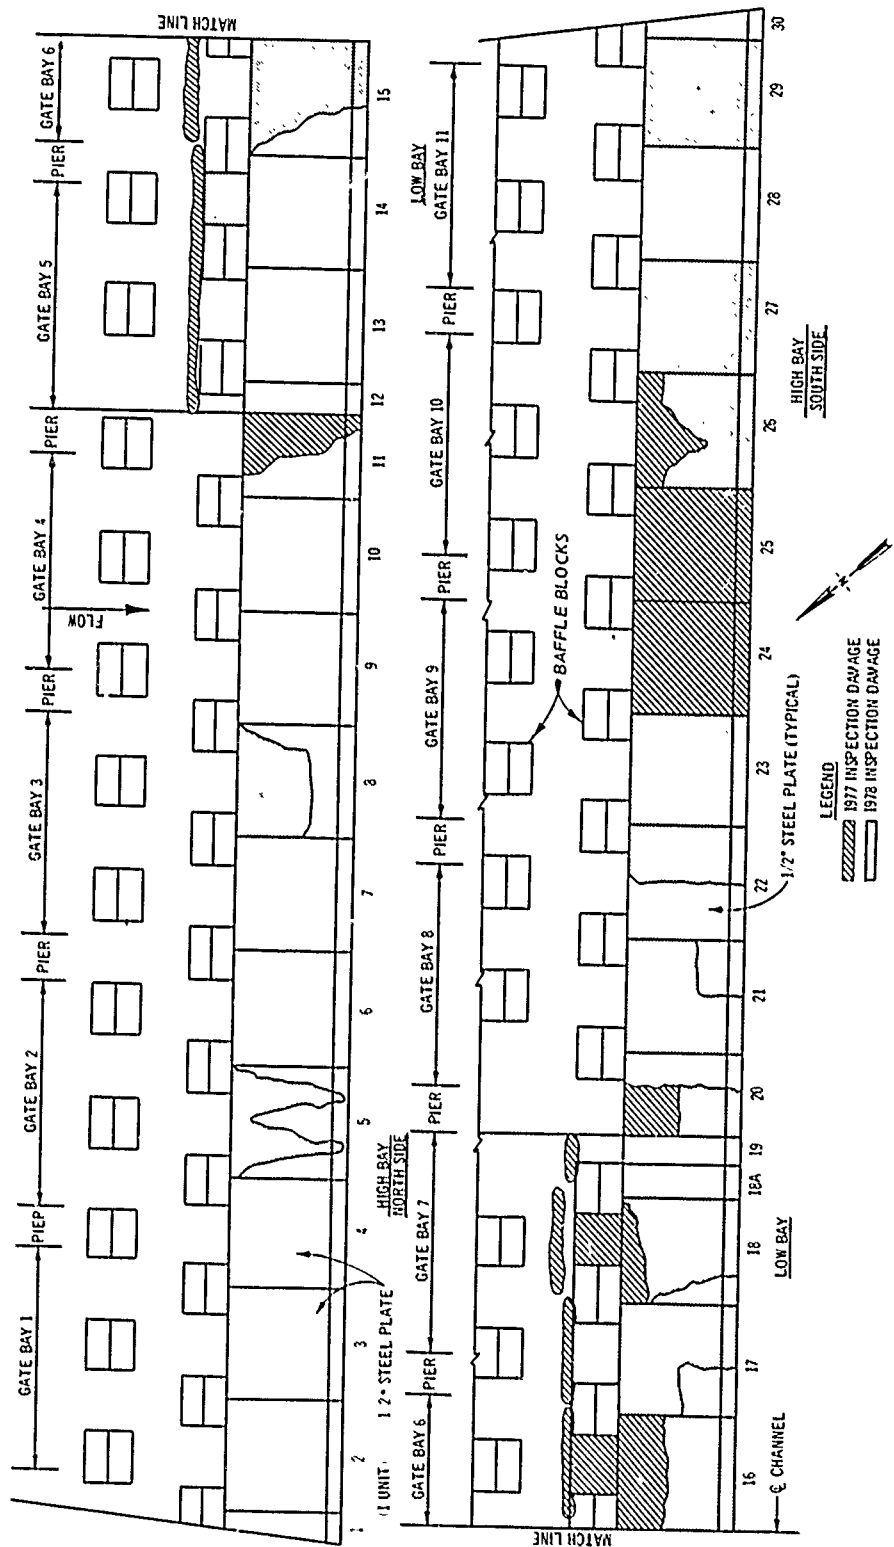
Figure 10. Damage to stilling basin repairs, Old River

23. Damage to the stilling basin repairs was generally confined to loss of some of the steel plating from the modules used to form the voids for placement of the grout (Figure 10). Seven of the 30 module plates and all six of the flat plates sustained varying degrees of damage. All spoilers were missing. In those areas where steel plating was lost, the exposed grout surface showed no evidence of erosion. The loss of the structureward one third of the plate of module 16 and its associated flat plate revealed that no grout had been placed under the flat plate and that grout had not entirely filled the void between the

top plate of the module and the stilling basin slab. Portions of the plates in modules 11, 18, 20, 24, 25, and 26, ranging from about 20 to 100 percent, were lost. A number of anchor bolts were found broken either flush with the module plate, flush with the grout, or pulled completely out.

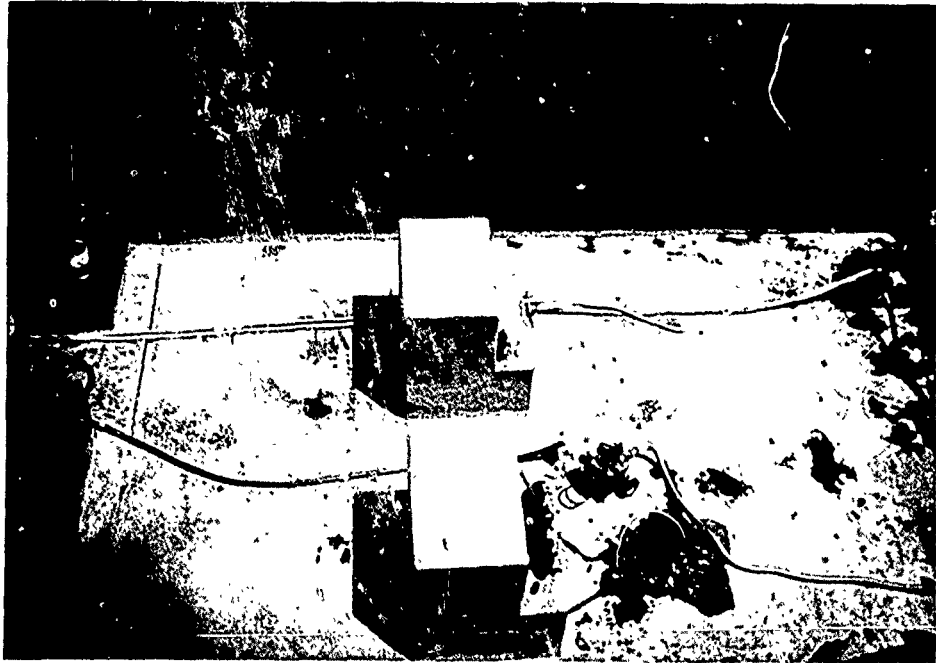
a. Overall erosion pattern

Figure 25. Erosion of repair in south passage, Enid Dam

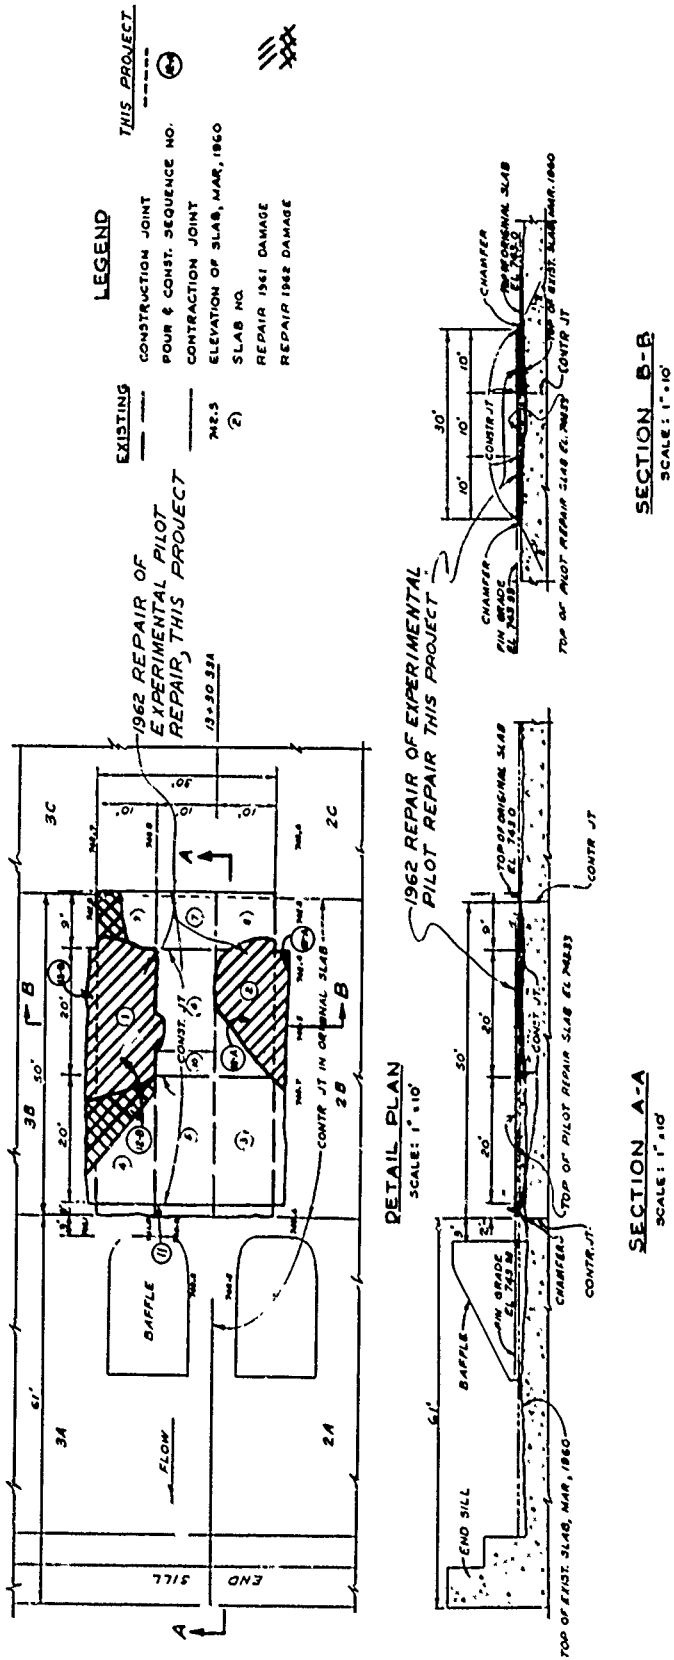
Figure 76. November 1962 inspection and repair of experimental pilot repair, Chief Joseph Dam (from Seattle District 1963)

140. The second inspection of the experimental repair slab in November 1962 (Seattle District 1963) revealed that additional damage had occurred since the first inspection of November 1961. This damage occurred in sections 4 and 9 and amounted to approximately 50 and 35 sq ft, respectively (Figure 76). The eroded concrete surface of the original stilling basin floor was exposed in these areas, indicating an apparent bond failure of the repair concrete. This damage was similar to that found after the first year of exposure to spillway discharge. The maximum and average discharges during 1962 were 300,000 and

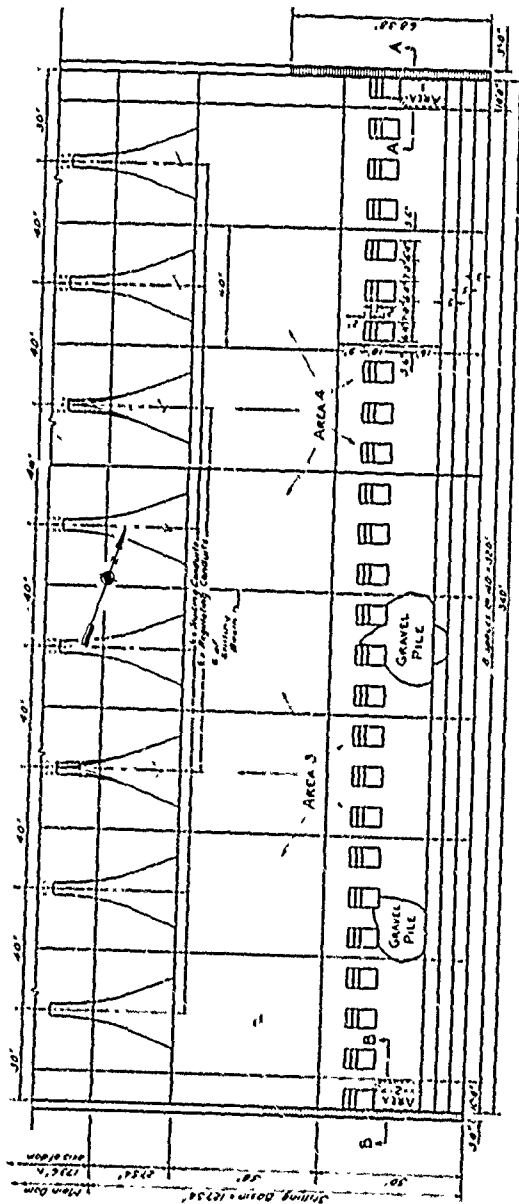
Figure 163. Stilling basin inspection and repair, Conchas Dam

298. When the basin was dewatered in September 1944, pronounced erosion was noticeable in only four areas on the floor of the stilling basin (Figure 163). The most noticeable erosion, designated Area 1, occurred between the end sill and the baffle adjacent to the north training wall. The maximum depth of erosion in this area was 1 ft 6 in. at one point on the north side where the floor mat of reinforcing steel was exposed for about a 1-ft length. In general, however, the depth of erosion was from 9 to 12 in. in a roughly elliptical-shaped trough bounded by the baffle, training wall, and end sill, and extended about 18 in. south of a line extending from the south side of the baffle. The wear in this area also extended into the downstream face of the baffle and into the training wall as much as 6 in., exposing the vertical reinforcing
