NEW YORK STATE DEPT OF ENVIRONMENTAL CONSERVATION ALBANY F/6 13/13  
NATIONAL DAM SAFETY PROGRAM. WARNER DAM, CHAUTAUGUA LAKE OUTLET--ETC(U)  
SEP 80 B L THOMSEN, G L WOOD DACW51-79-C-0001

REPORT DOCUMENTATION PAGE		READ INSTRUCTIONS BEFORE COMPLETING FORM
1. REPORT NUMBER	2. GOVT ACCESSION NO. AD-A090 937	3. RECIPIENT'S CATALOG NUMBER
4. TITLE (and Subtitle) Phase I Inspection Report Warrer Dam-Chautauqua Lake Outlet Allegheny River Basin, Chautauqua County, New York Inventory No. 750		5. TYPE OF REPORT & PERIOD COVERED Phase I Inspection Report National Dam Safety Program

PHASE I INSPECTION REPORT  
NATIONAL DAM SAFETY PROGRAM  
WARNER DAM  
I.D. NO. N.Y. 750  
ALLEGHENY RIVER BASIN  
CHAUTAUQUA COUNTY, NEW YORK

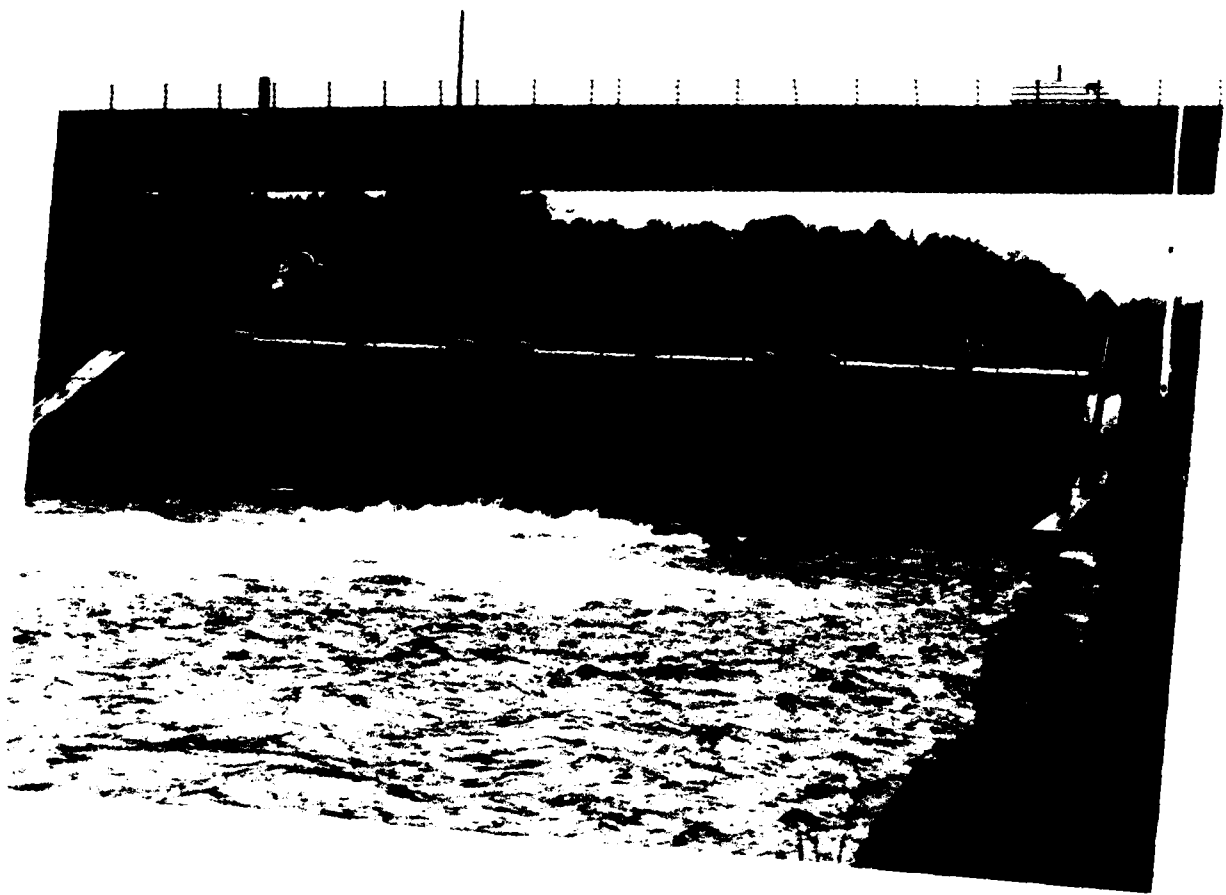
View of Downstream  
face of Dam.
