| REPORT DOCUMENTATION PAGE | | READ INSTRUCTIONS BEFORE COMPLETING FORM |
|--|---|--|
| 4. TITLE (and Subtitle) Phase I Inspection Report Lake Placid Village Dam Lake Champlain River Basin, Essex County, NY Inventory No. 781 | | 5. TYPE OF REPORT & PERIOD COVERED Phase I Inspection Report National Dam Safety Program |

PHASE I INSPECTION REPORT
NATIONAL DAM SAFETY PROGRAM
NAME OF DAM - LAKE PLACID VILLAGE DAM ID# - NY 781

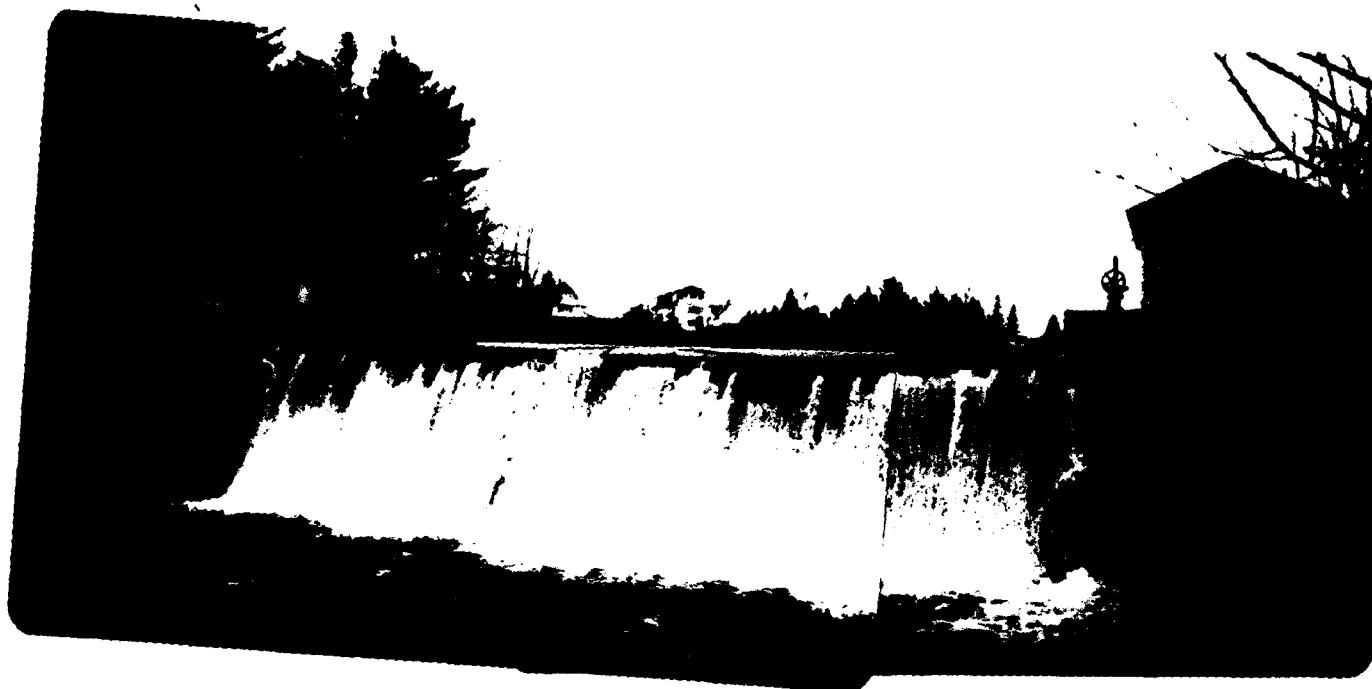
1. Overview of Lake Placid Village Dam NY 781.
Note deterioration of face of spillway as
evidenced by irregular pattern of flow.

At the time of the inspection, water was cresting the spillway at a depth of 5 inches. This flow obscured from view the surface of the spillway; however, the irregular pattern of the flow across the crest of the spillway indicates that surface deterioration has taken place on the face of the spillway. The northeast abutment of the spillway is severely deteriorated and partially undercut at the water surface. A similar condition exists, although to a somewhat lesser degree, on the southwest abutment. Visual observation did not disclose physical displacement of the alignment of this structure and despite the severe deterioration of the spillway abutments, the facility shows no visual signs of instability.

1. Repairs to restore the dam's deteriorated concrete on the spillway and both abutments should be undertaken.
2. The channel wall at the toe of the south abutment should be repaired to prevent further deterioration of the bank of the stream and protect the south abutment from erosion.

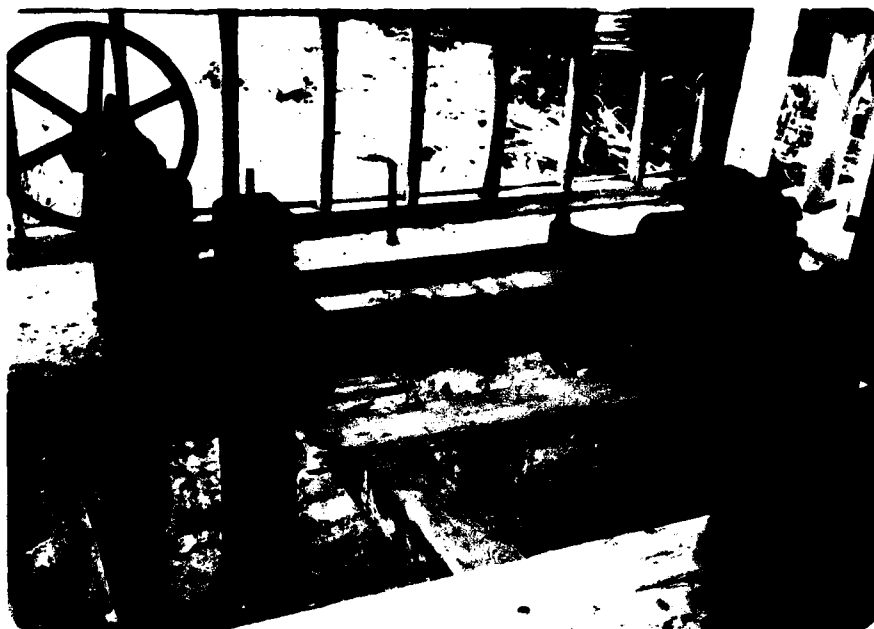
7. Operating mechanism for sluice gate controlling flow to penstock.

The northeast abutment accommodates the intake to the penstock which formerly fed the downstream power generating station. Although the house which encloses the sluice gate controls is somewhat deteriorated, the penstock inlet appears to be generally in good condition.

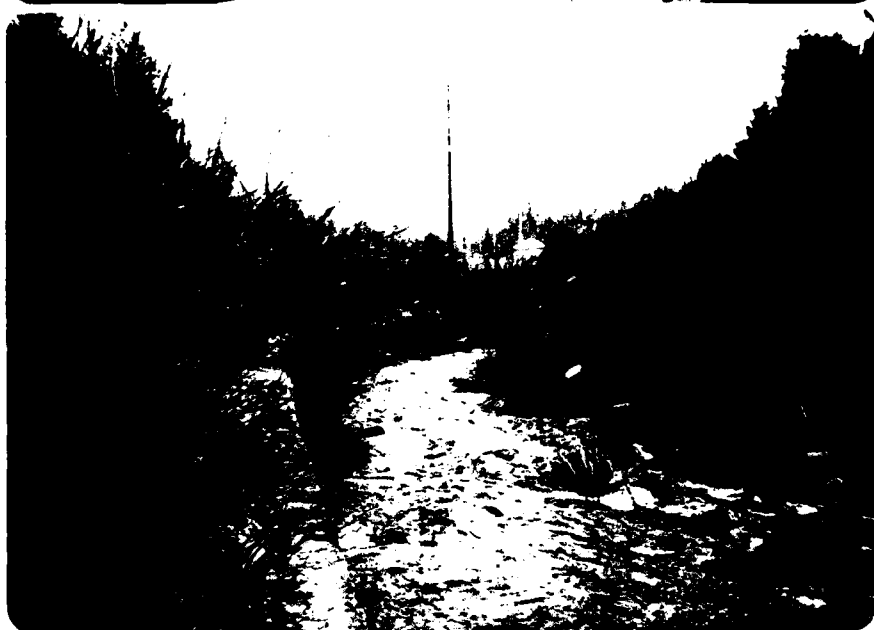
8. Downstream channel viewed from Dam. Note building 800 feet downstream.

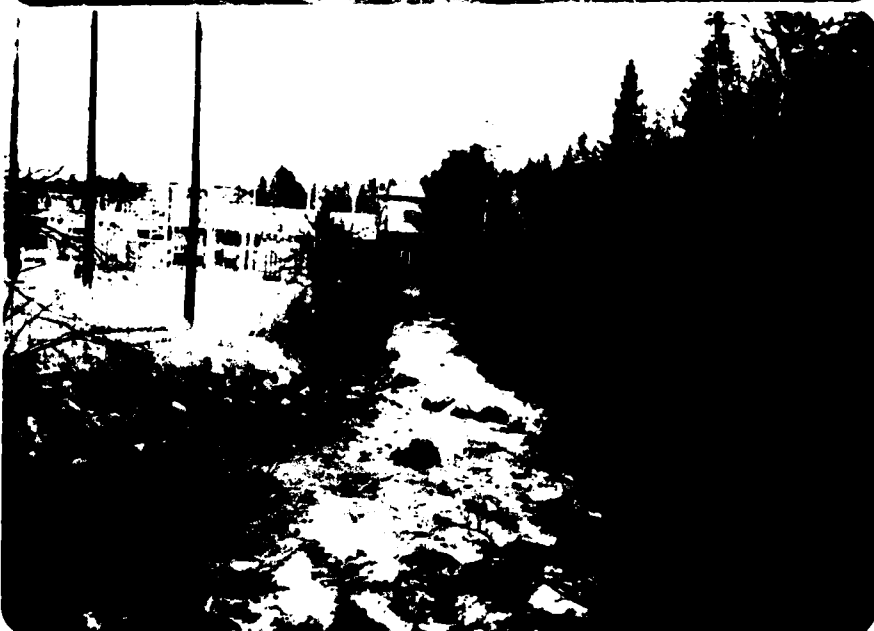
9. Downstream channel showing downstream hazard, electric substation and municipal power building.

The Chubb River, the receiving stream from the impoundment, flows immediately adjacent to a storage building and electric substation which is owned and operated by the Village of Lake Placid Municipal Electric Department. This facility is located approximately 800 feet downstream from the dam. Therefore, the dam is in the High Hazard Category as defined by the Recommended Guidelines for Safety Inspection of Dams.

3. A flood warning and evacuation plan should be developed and implemented to alert the public, should conditions occur which could result in failure of the dam.
4. A formalized inspection program should be initiated to develop data on conditions and maintenance operations at the facility.
