OGDENSBURG WATER POWER CO. DAM

INVENTORY NO NY 400

PHASE I INSPECTION REPORT  
NATIONAL DAM SAFETY PROGRAM

NEW YORK DISTRICT CORPS OF ENGINEERS  
AUGUST 1980

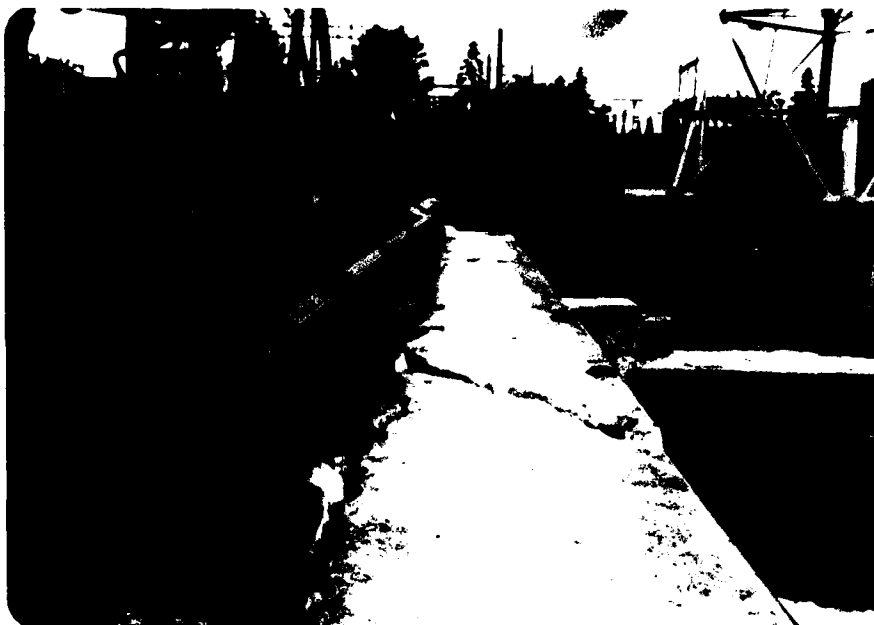
3. Cracked walkway with rail lashed to operating mechanism at sluice gate structure.

1. The existing sluice gate structure has suffered structural damage so as to render the gates inoperable. Repairs should be undertaken to place the sluice gate structure in proper operating condition.
