NEW YORK STATE DEPT OF ENVIRONMENTAL CONSERVATION ALBANY F/G 13/13  
NATIONAL DAM SAFETY PROGRAM, CLARKS MILLS DAM, (INVENTORY NUMBE--ETC(U)  
AUG 80 J B STETSON DACW51-79-C-0001

REPORT DOCUMENTATION PAGE		READ INSTRUCTIONS BEFORE COMPLETING FORM
1. REPORT NUMBER	2. GOVT ACCESSION NO. AD-A091130	3. RECIPIENT'S CATALOG NUMBER 130
4. TITLE (and Subtitle) Phase I Inspection Report Clarks Mills Dam Upper Hudson River Basin, Washington County, NY Inventory No. 120		5. TYPE OF REPORT & PERIOD COVERED Phase I Inspection Report National Dam Safety Program

PHASE I INSPECTION REPORT  
NATIONAL DAM SAFETY PROGRAM  
NAME OF DAM - CLARKS MILLS DAM ID# - NY 120

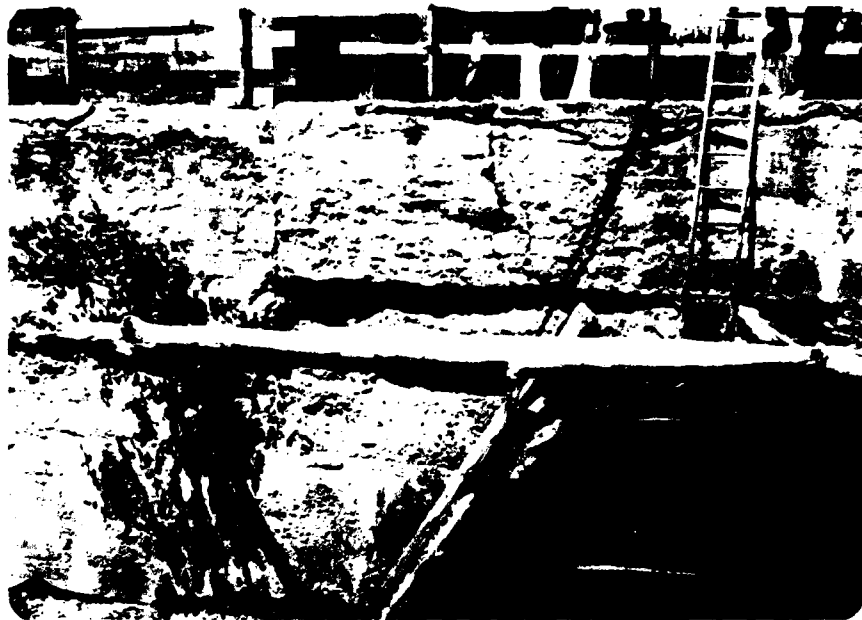
Leakage is occurring through the concrete into the core of the Northerly, Ambursen-Type-Section. Extensive deterioration has taken place at the north abutment and at the pier separating the two sections.

2. North abutment showing surface deterioration.

1. The visual inspection revealed minor deterioration on the crest of the spillway and at vertical joints in the spillway structure. Extensive deterioration was noted at the north abutment wall and at the pier which separates the two sections of the dam.
2. A cursory inspection of the interior of the buttressed section of the dam revealed leakage into the interior core.
3. The structural stability analysis indicates the south portion (left side looking downstream) of the structure demonstrates unsatisfactory stability under loading conditions which could occur during winter operations (including ice loading) and during the Probable Maximum Flood (PMF) and 1/2 PMF conditions. Lack of dimensions and design data for the north portion of the spillway did not allow the structural analysis of this section of the structure to be performed.

1. Eliminate leakage into the interior core of the dam and repair deteriorated concrete on the north abutment and at the pier separating the two sections of the dam.
2. A formalized inspection program should be initiated to develop data on conditions and maintenance operations at the facility.
3. A flood warning and emergency evacuation plan should be developed and implemented to alert the public in the event conditions occur which could result in failure of the dam.
