PANAMA DAM

CHAUTAUQUA COUNTY NEW YORK
INVENTORY NO. N.Y. 784

**PHASE I INSPECTION REPORT
NATIONAL DAM SAFETY PROGRAM**

Name of Dam: Panama Dam I.D. No. NY 784
State Located: New York
County: Chautauqua
Watershed: Allegheny River Basin
Stream: Little Brokenstraw Creek
Dates of Inspection: October 3 and November 9, 1979

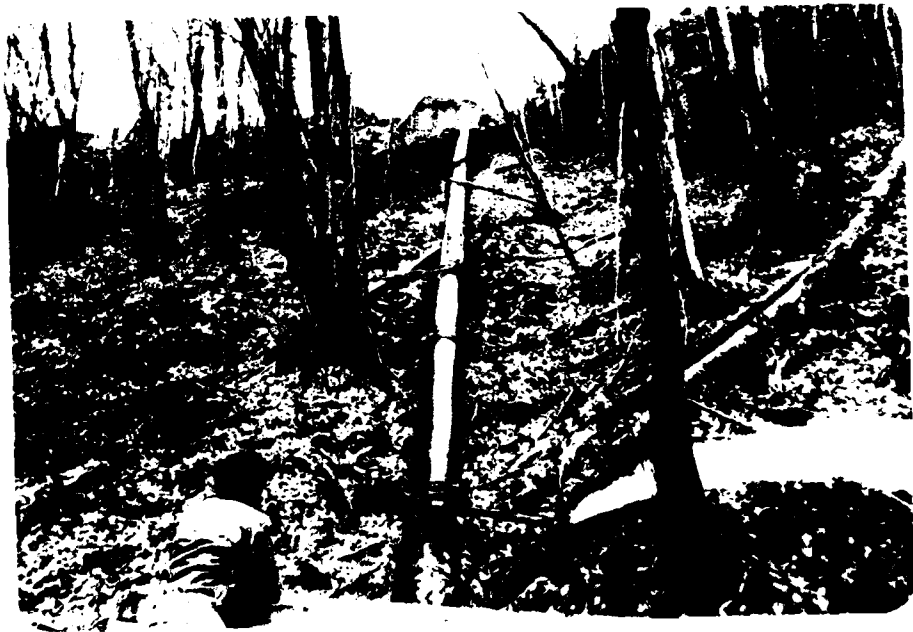
Penstock Viewed from Mill
Photo #7

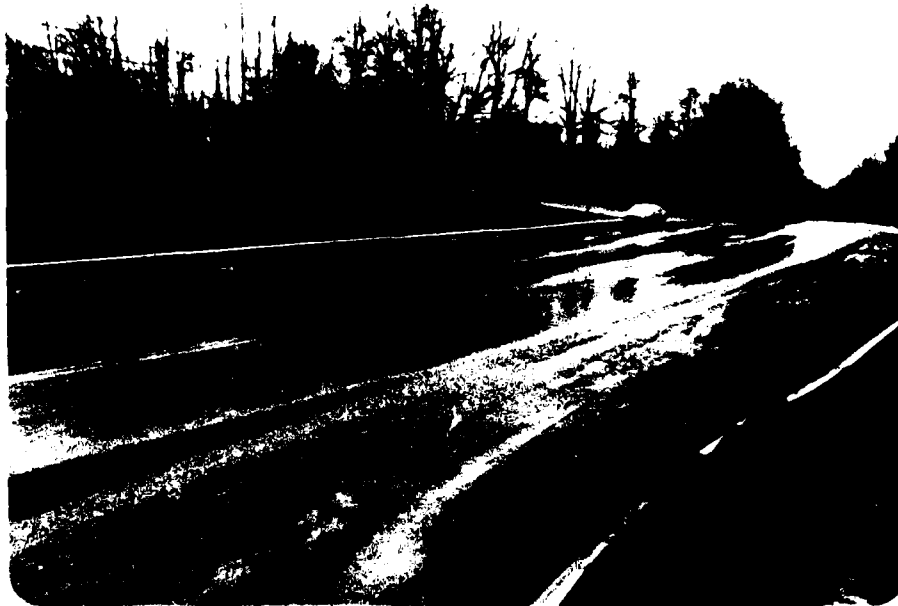
The highway embankment immediately below the dam appears stable. There was no evidence of movement, misalignment, seepage, surface cracks, erosion, or sloughing. Vegetative growth on the embankment must be removed to aid in future inspection of the area and avoid the problems associated with tree growth. (See Photos #9, 10 & 11)

Crest of Highway Embankment
Note Overtopping occurred by car
& flowed down highway at extreme right
Photo #9

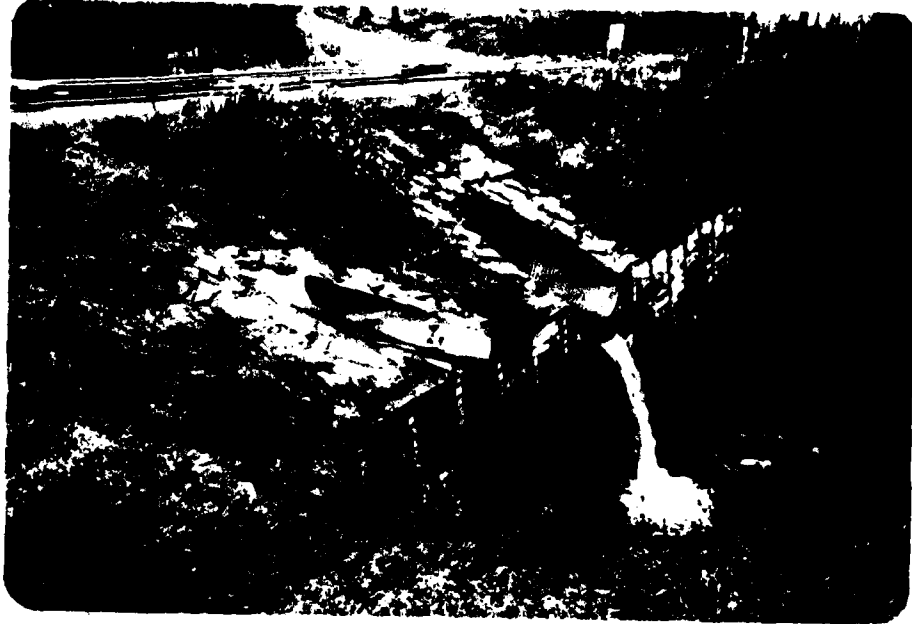
The downstream channel below the highway embankment is bedrock formed. Some debris and boulders were evident (See Photos #10 & 11) in the channel. The Little Brokenstraw Creek flows beneath the Lumber Mill (See Photos #12 & 13)

Downstream Face of Highway Embankment
Photo #10

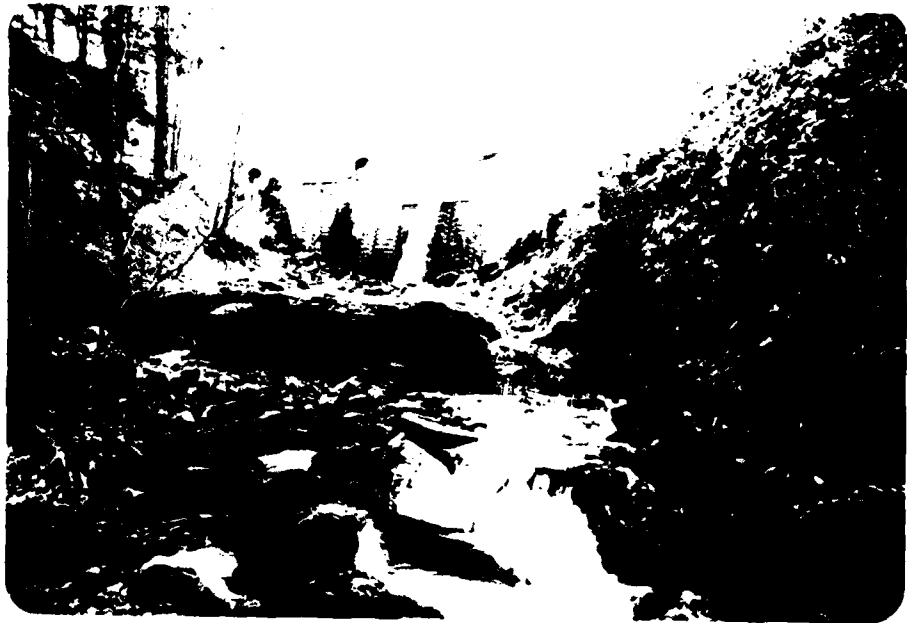
Highway Embankment viewed from
Downstream Channel
Photo #11

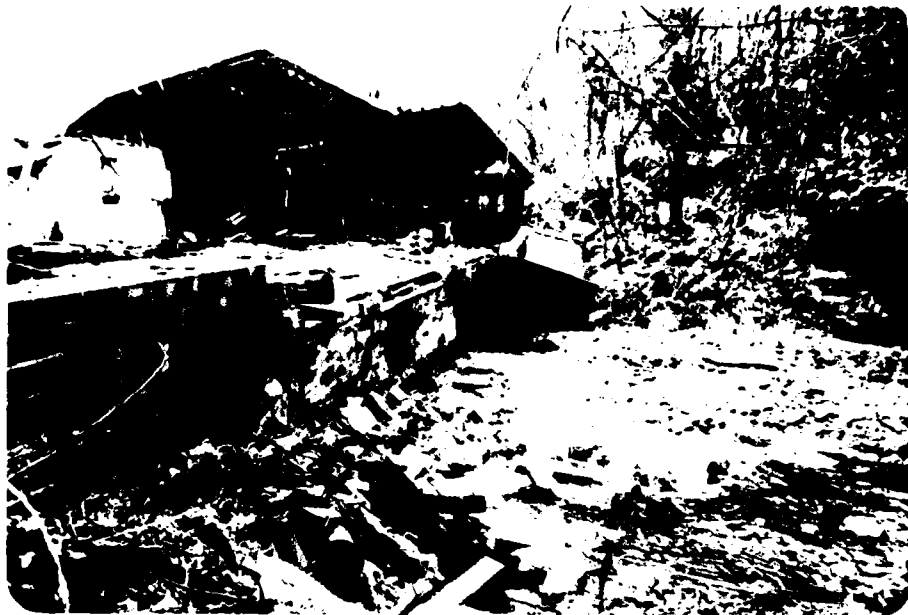
Burned-out Lumber Mill
Note flow beneath building
Photo #12
