1. REPORT NUMBER AD-A091133		2. GOVT ACCESSION NO.	3. RECIPIENT'S CATALOG NUMBER
4. TITLE (and Subtitle) Phase I Inspection Report Keuka Lake Outlet Dam Oswego River Basin, Yates County, NY Inventory No. 390		5. TYPE OF REPORT & PERIOD COVERED Phase I Inspection Report National Dam Safety Program

KEUKA LAKE OUTLET DAM

YATES COUNTY, NEW YORK
INVENTORY NO. N.Y. 390

PHASE I INSPECTION REPORT
NATIONAL DAM SAFETY PROGRAM

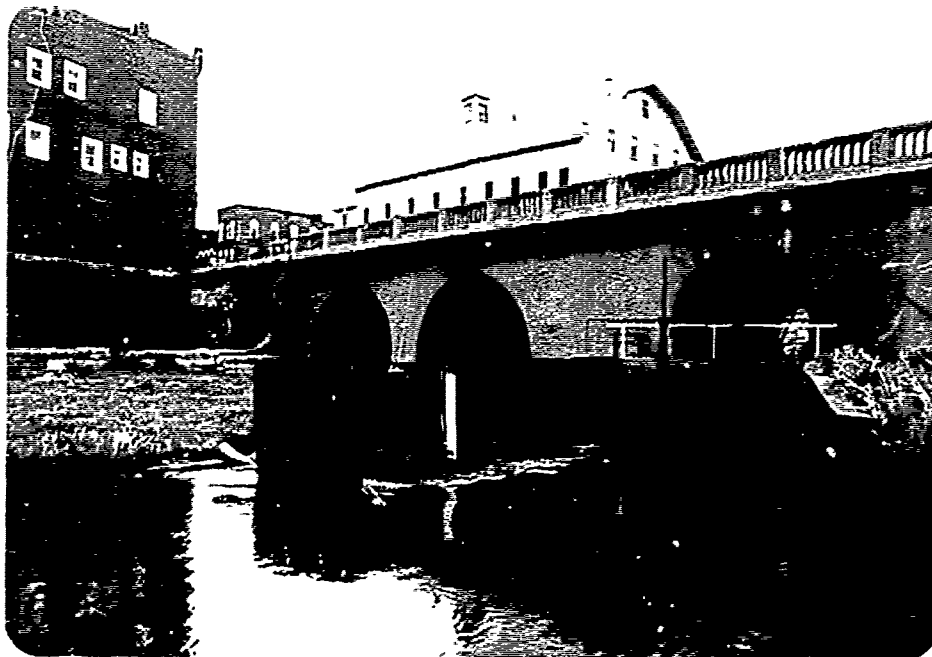
1. Deterioration and partial removal of concrete on post supporting northern slide gate control mechanism.
2. Minor scour behind the sheet pile walls on either side of the southern spillway channel.
3. Debris accumulated in the vicinity of the northern spillway gates.
4. Trees and brush lining the channel upstream of the dam.
5. A small amount of leakage from the base of the masonry wall (observed during a 1977 inspection).

Entrance Channel to Southern Service Spillway
Note Erosion Behind End of Sheet Piling

1. Repair the concrete on the post supporting the northern slide gate control mechanism.
2. Fill the small scoured areas behind the sheet pile walls and protect this area with riprap.
3. Monitor the leakage in the masonry wall and if it becomes worse, take remedial actions.
4. Remove the debris which has accumulated in the vicinity of the northern spillway gates.
5. Cut trees and brush which line the channel in the vicinity of the dam.
6. Develop and implement a detailed emergency operation-action plan and warning system.

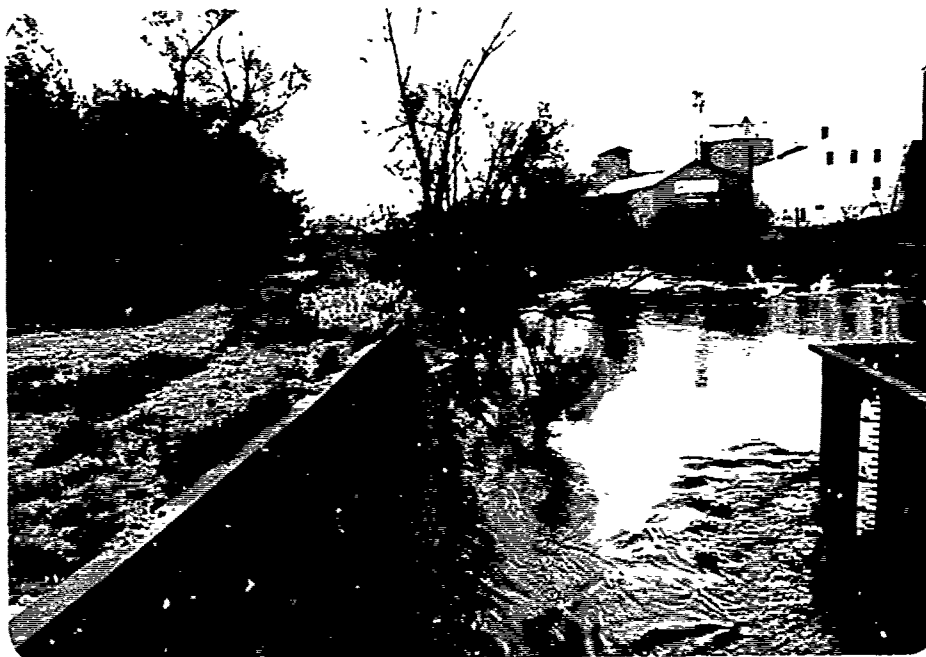
Entrance Channel Looking Upstream-Note trees
Hanging Over Approach Channel

- a. Slopes KEUKA LAKE & OUTLET CHANNEL - BRUSH & TREES GROWING ALONG CHANNEL SHOULD BE CUT TO REDUCE DEBRIS PROBLEM
- b. Sedimentation _____
- c. Unusual Conditions Which Affect Dam NARROW CHANNEL TO DAM RAILROAD BRIDGE UPSTREAM COLLECTS DEBRIS & POUNDS SOME H₂O.

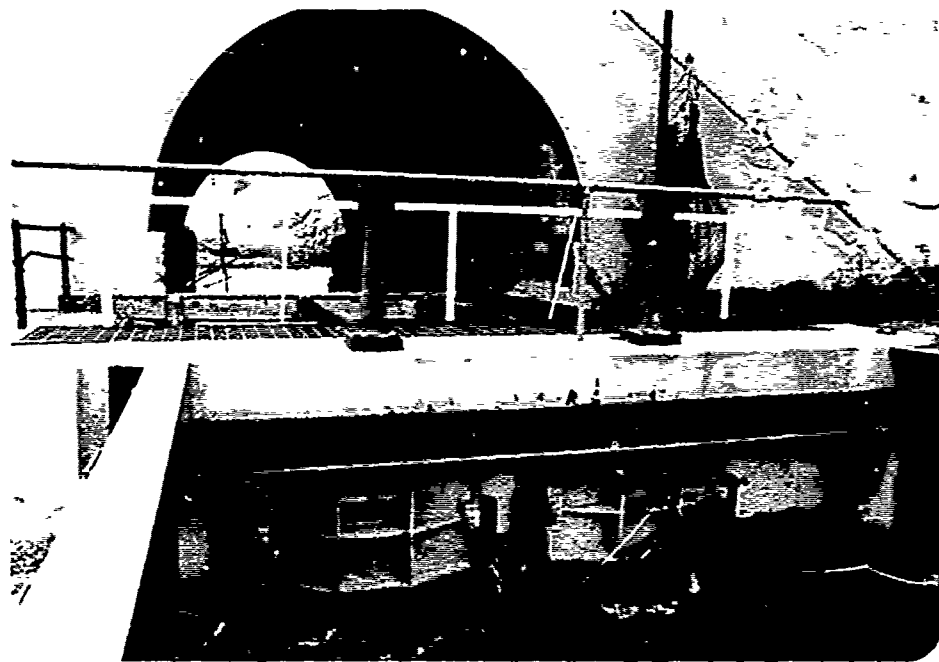
Southern Service Spillway-Rodney Hunt Gates

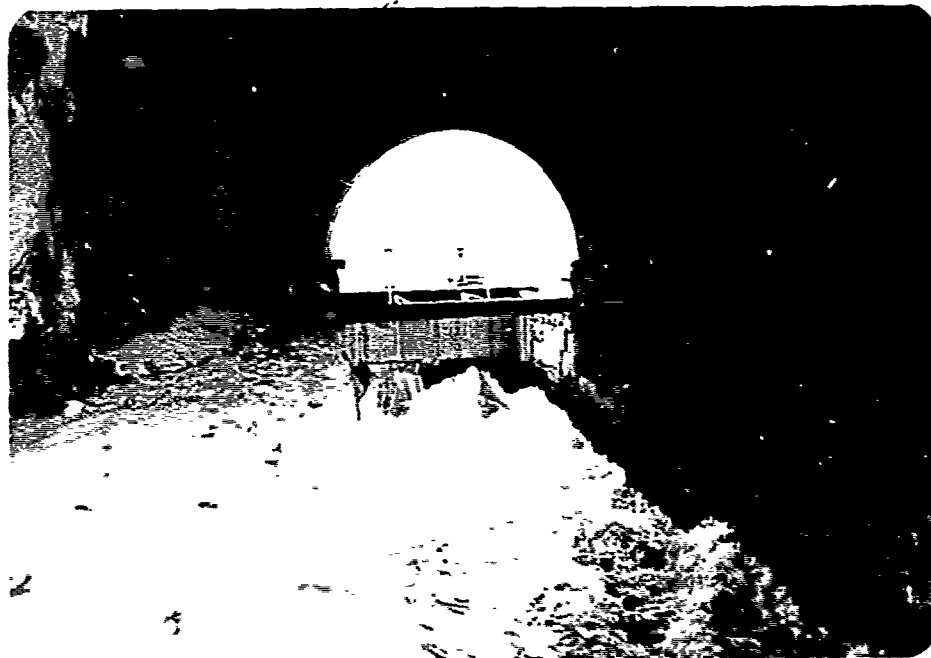
Southern Service Spillway-Looking Upstream

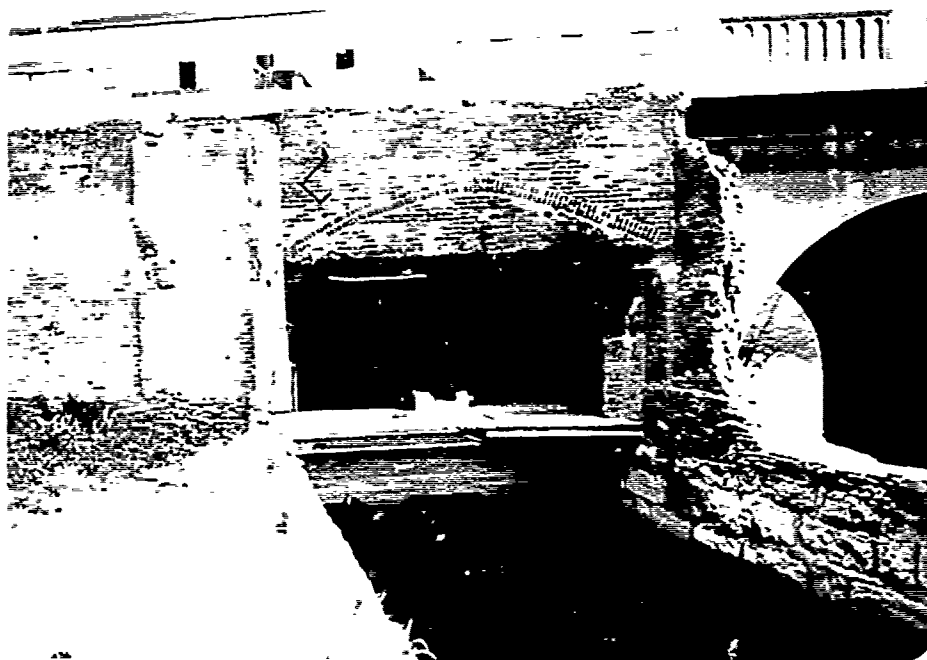
Northern Service Spillway-Birkett Gate

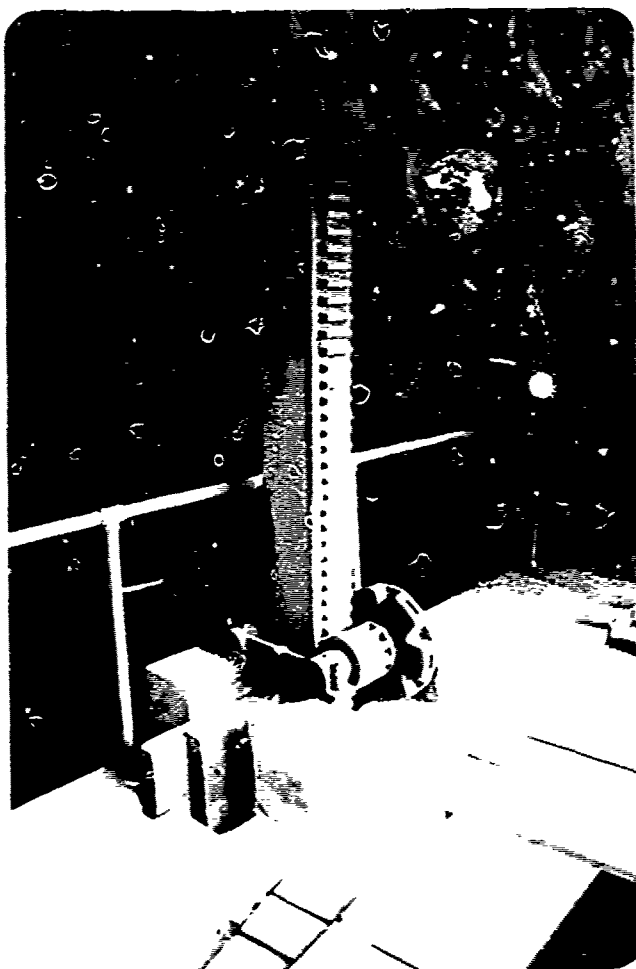
Control Mechanism For Birkett Gate

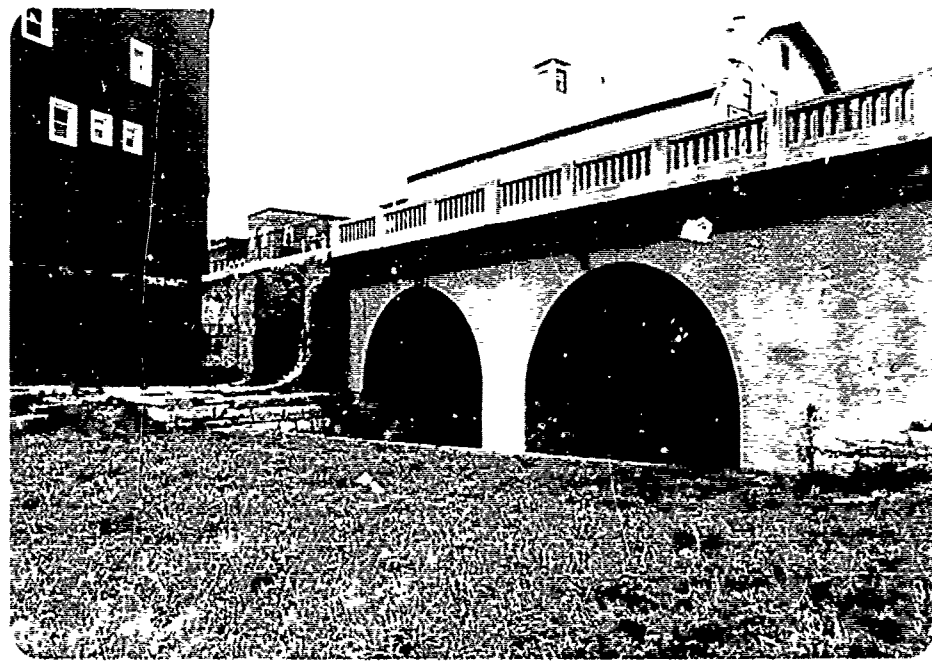
The auxiliary spillway is formed by the center portion of the dam. It appeared to be in satisfactory condition.

Auxiliary Spillway Channel with Earth Fill on Upstream Slope

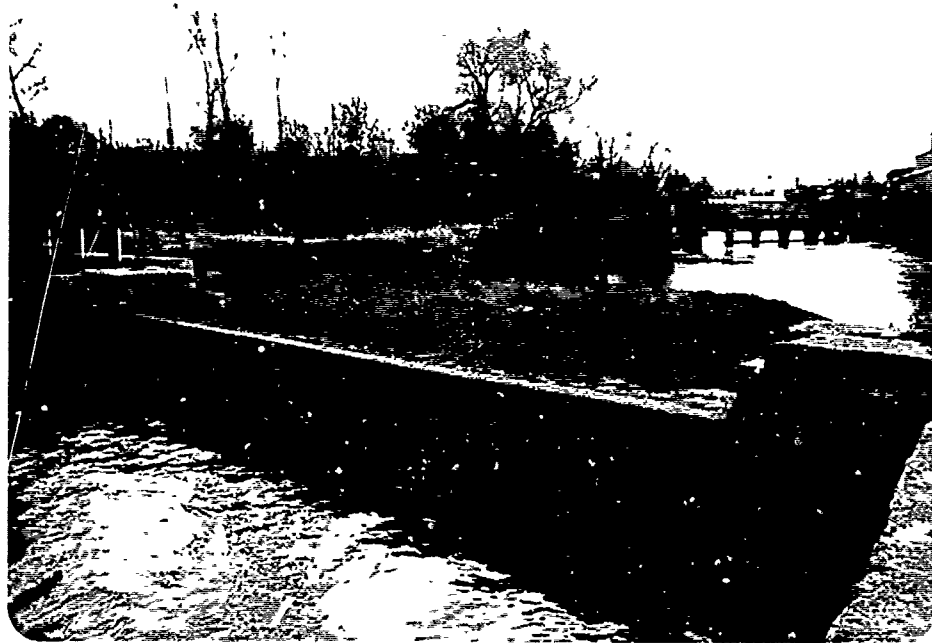
No serious deficiencies were noted on this structure. The embankment portion forming the upstream slope was in satisfactory condition. The masonry and concrete wall which formed the crest of the auxiliary spillway was also in satisfactory condition. An inspection report from 1977 (a copy of which has been included in Appendix D) indicated that there was a small amount of leakage exiting from the base of the masonry wall. This area could not be observed at the time of this inspection due to the tailwater level. Mr. Ryder, the village Utilities Manager, indicated that this leakage has been occurring for a number of years, with no noticeable increase in quantity.

Masonry Wall on Auxiliary Spillway-Slight
Leakage Reported at Base of Wall
